Michael A. Berardi
Director
Service Engineering Operations
Ford Customer Service Division

October 13, 2009

SUBJECT: Safety Recall 09S09
Certain 1992-2003 Model Year Vehicle Lines
Speed Control System Modification

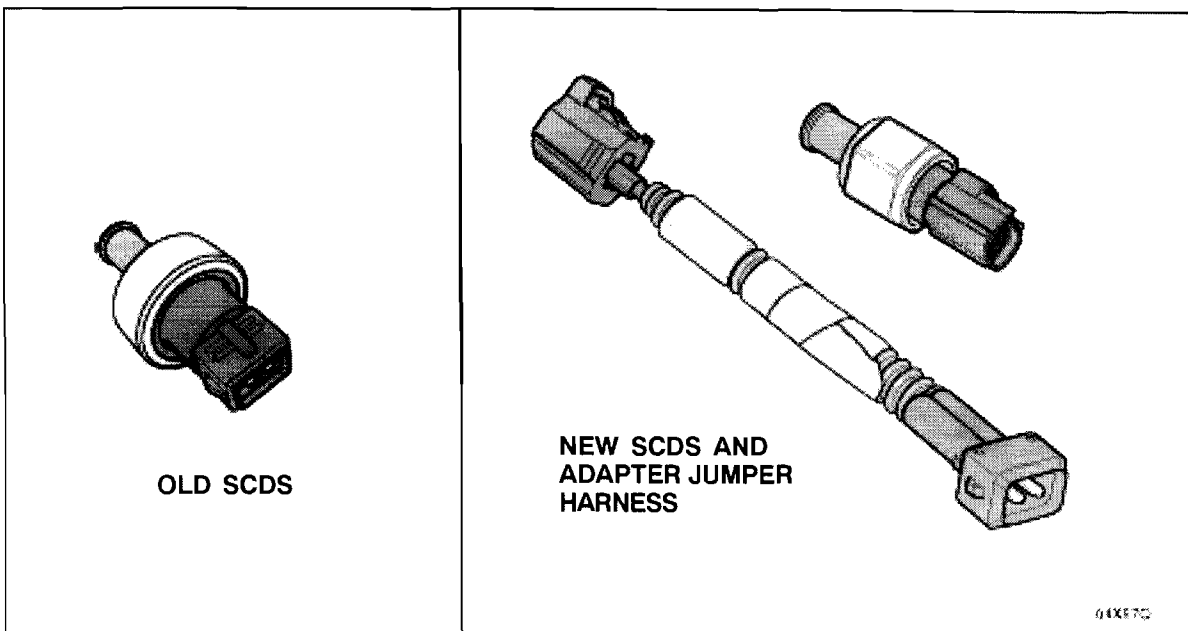
FIGURE 1

The Speed Control Deactivation Switch (SCDS) involved in Safety Recall 09S09 and the revised SCDS are illustrated below (See Figure 1).

Note that the revised SCDS has a different electrical connector. An adapter jumper harness (which is included in the parts kit) is required when replacing the old SCDS with the revised SCDS.

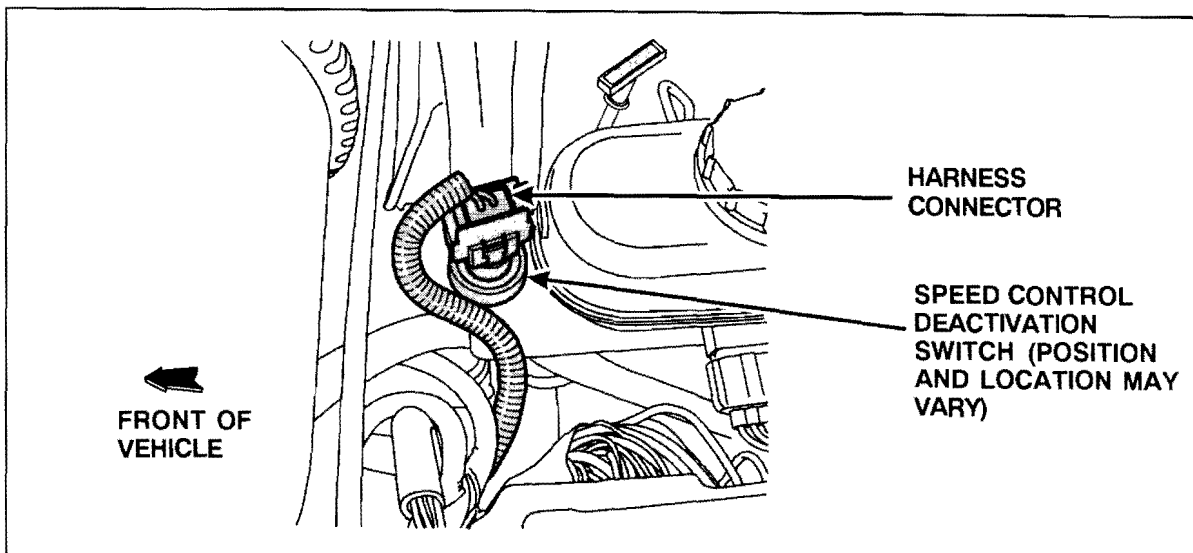
FIGURE 2

1. Disconnect the harness connector from the SCDS (See Figure 2).

2. Inspect the harness connector for the presence of brake fluid.
 - If there is **no** evidence of brake fluid on the connector, install Universal Fused Jumper Harness (UFJH). See page 6.
 - If there **is** evidence of brake fluid on the connector, replace SCDS. See page 7.

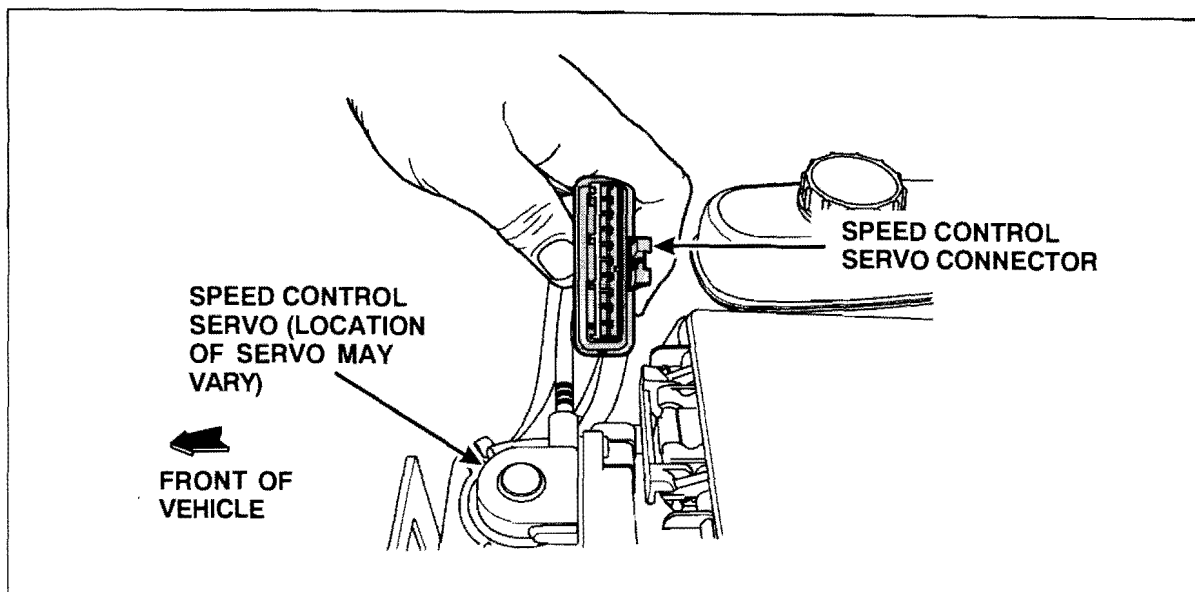
FIGURE 6

1. Disconnect the speed control servo and inspect the vehicle harness connector for heat damage (See Figure 6).
 - If no heat damage is found at the speed control servo connector (even if there is presence of brake fluid in the connector), proceed to step 2 for further instructions.
 - If heat damage is found, proceed as follows:
 - 1999-2003 Windstar, complete ABS inspection on page 11 before calling the Special Service Support Center for further instructions.
 - All other vehicles, call the Special Service Support Center for further instructions.

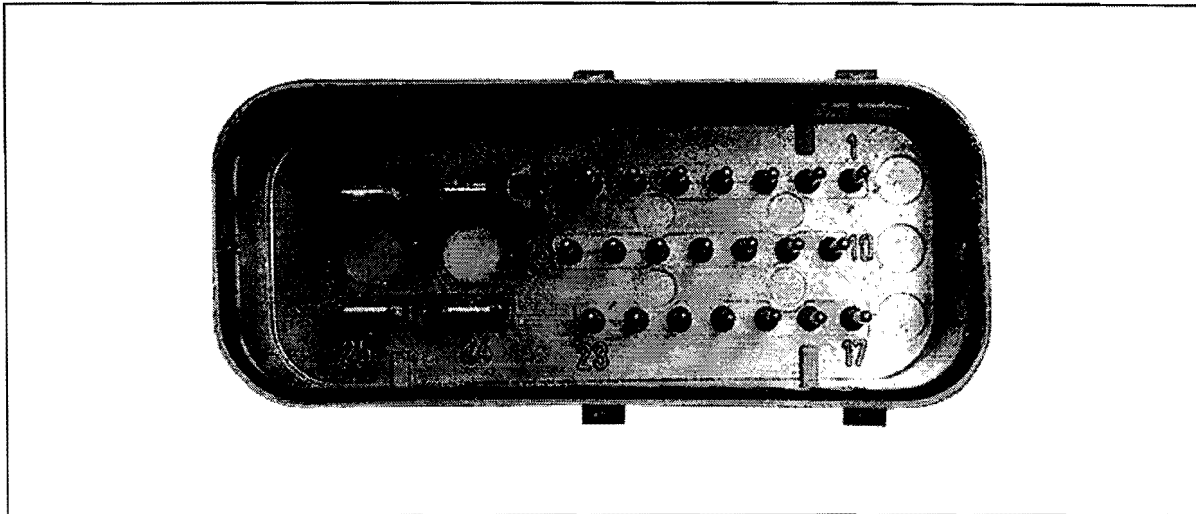
FIGURE 8

1. Lift vehicle and remove ABS cover.
2. Disconnect ABS module. Inspect the ABS harness and module connectors for the presence of brake fluid.
3. If brake fluid is present, use shop air to blow out any trace of brake fluid from the harness connector and module.
4. Inspect the ABS harness and module connectors for corrosion and/or heat damage (See Figure 8).

5. If evidence of corrosion and/or heat damage is found in either the ABS harness or module connector, call the Special Service Support Center for further instructions.
6. If there is no evidence of corrosion and/or heat damage, reconnect the ABS harness to the ABS module.
7. **Is the speed control servo heat damaged?**
 - If the speed control servo is heat damaged, call the Special Service Support Center for further instructions.
 - If the speed control servo is **not** heat damaged, no further action is required, release the vehicle.
