May 26, 2016

**TO:** All U.S. Ford and Lincoln Dealers

**SUBJECT:** **Safety Recall 09S09 – Supplement #1**  
Certain 1992-2003 Model Year Vehicle Lines  
Speed Control System Modification

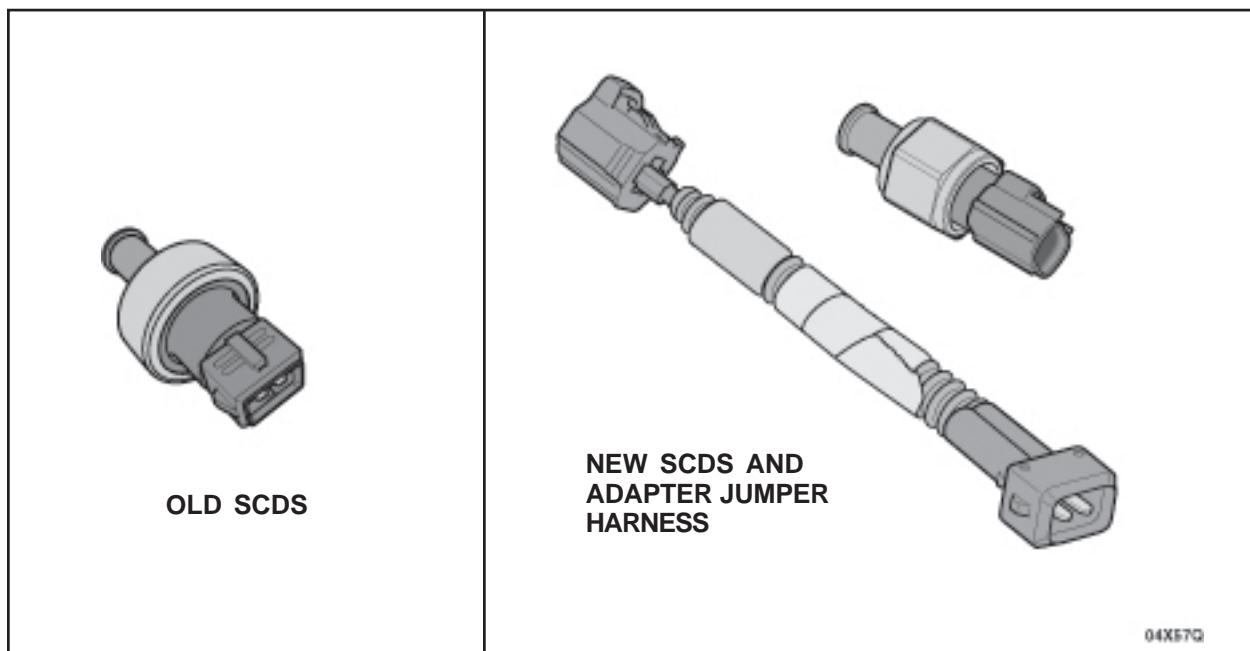
FIGURE 1

The Speed Control Deactivation Switch (SCDS) involved in Safety Recall 09S09 and the revised SCDS are illustrated below (See Figure 1).

Note that the revised SCDS has a different electrical connector. An adapter jumper harness (which is included in the parts kit) is required when replacing the old SCDS with the revised SCDS.

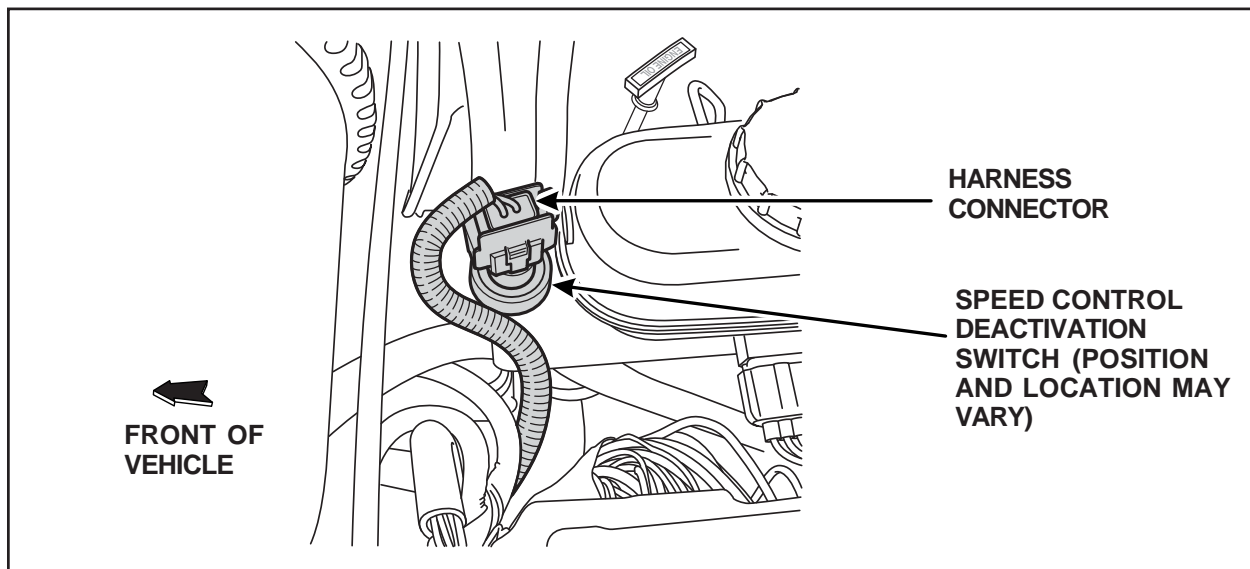
FIGURE 2

1. Disconnect the harness connector from the SCDS (See Figure 2).

2. Inspect the harness connector for the presence of brake fluid.
  - If there is **no** evidence of brake fluid on the connector, install Universal Fused Jumper Harness (UFJH). See page 6.
  - If there is **is** evidence of brake fluid on the connector, replace SCDS. See page 7.

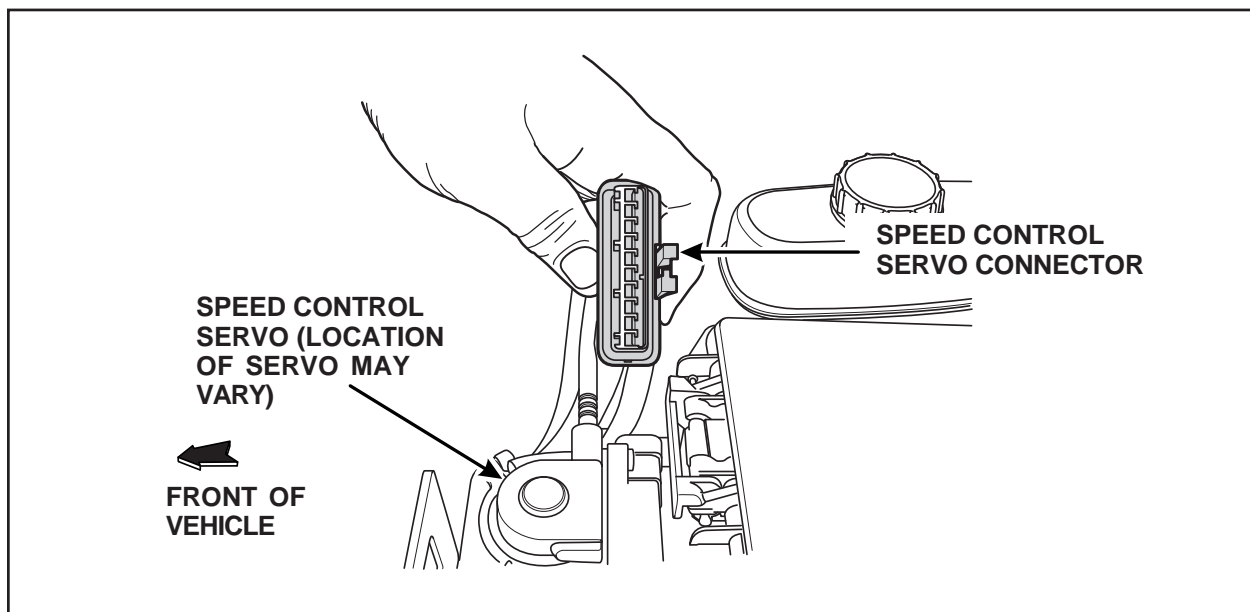
FIGURE 6

1. Disconnect the speed control servo and inspect the vehicle harness connector for heat damage (See Figure 6).
  - If no heat damage is found at the speed control servo connector (even if there is presence of brake fluid in the connector), proceed to step 2 for further instructions.
  - If heat damage is found, proceed as follows:
    - 1999-2003 Windstar, complete ABS inspection on page 11 before calling the Special Service Support Center for further instructions.
    - All other vehicles, call the Special Service Support Center for further instructions.

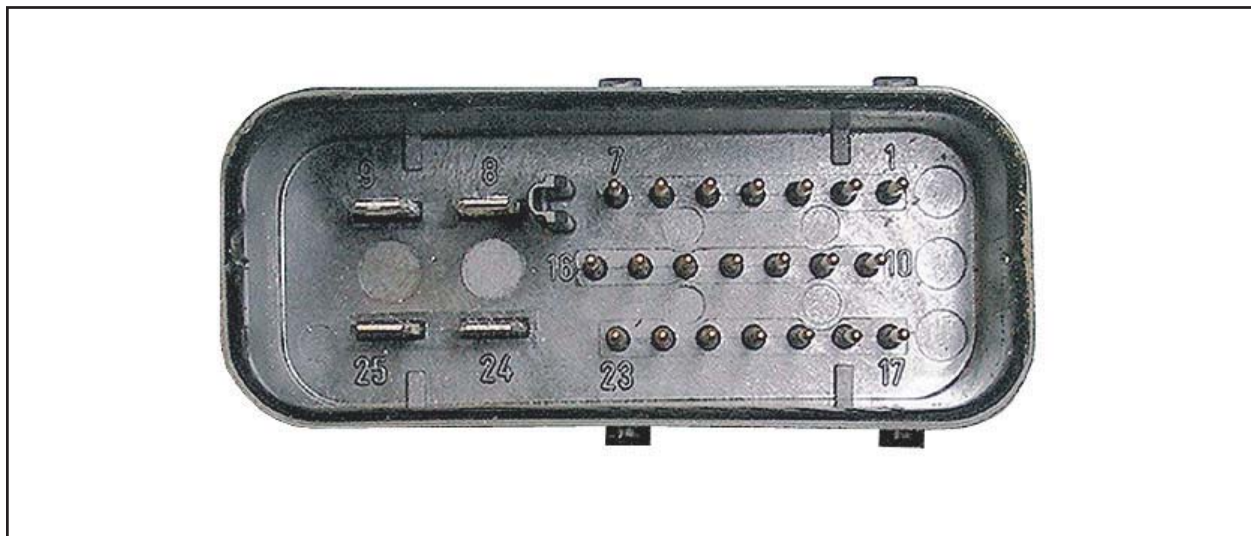
**FIGURE 8**

1. Lift vehicle and remove ABS cover.
2. Disconnect ABS module. Inspect the ABS harness and module connectors for the presence of brake fluid.
3. If brake fluid is present, use shop air to blow out any trace of brake fluid from the harness connector and module.
4. Inspect the ABS harness and module connectors for corrosion and/or heat damage (See Figure 8).

5. If evidence of corrosion and/or heat damage is found in either the ABS harness or module connector, call the Special Service Support Center for further instructions.
6. If there is no evidence of corrosion and/or heat damage, reconnect the ABS harness to the ABS module.
7. **Is the speed control servo heat damaged?**
  - If the speed control servo **is** heat damaged, call the Special Service Support Center for further instructions.
  - If the speed control servo **is not** heat damaged, no further action is required, release the vehicle.
