# RECALL CAMPAIGN BULLETIN

NTB09-112

## VOLUNTARY SAFETY RECALL CAMPAIGN 2008 – 2009 ROGUE; STEERING GEAR

**CAMPAIGN ID #:** R0906  
**NHTSA #:** 09V-411  
**APPLIED VEHICLES:** 2008 – 2009 Rogue (S35)

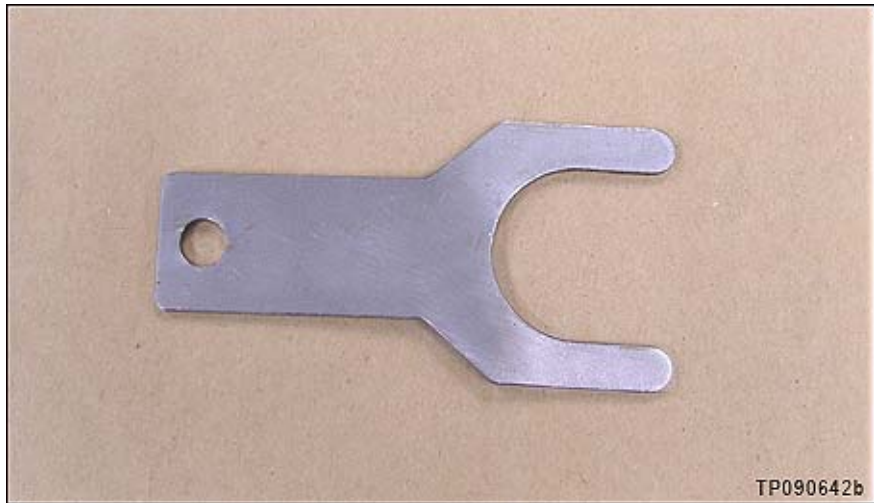
Figure 1

**REQUIRED SPECIAL TOOL (J-50278)**

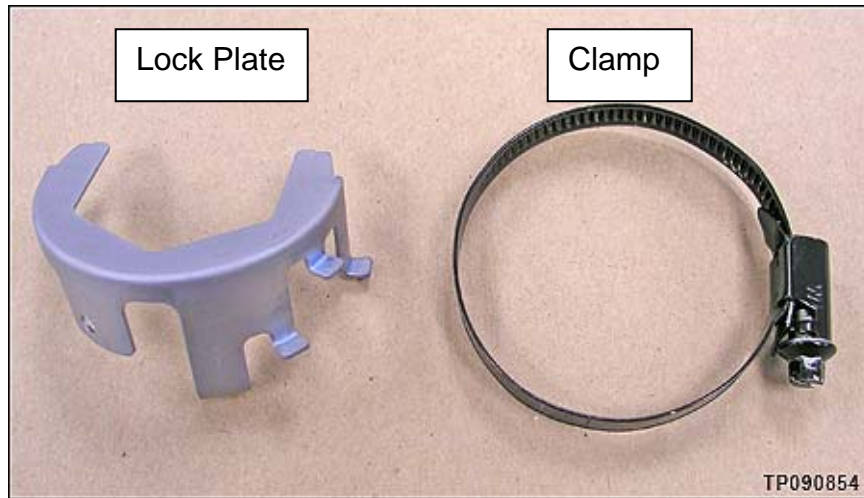
Figure 1A

**REPAIR KIT**

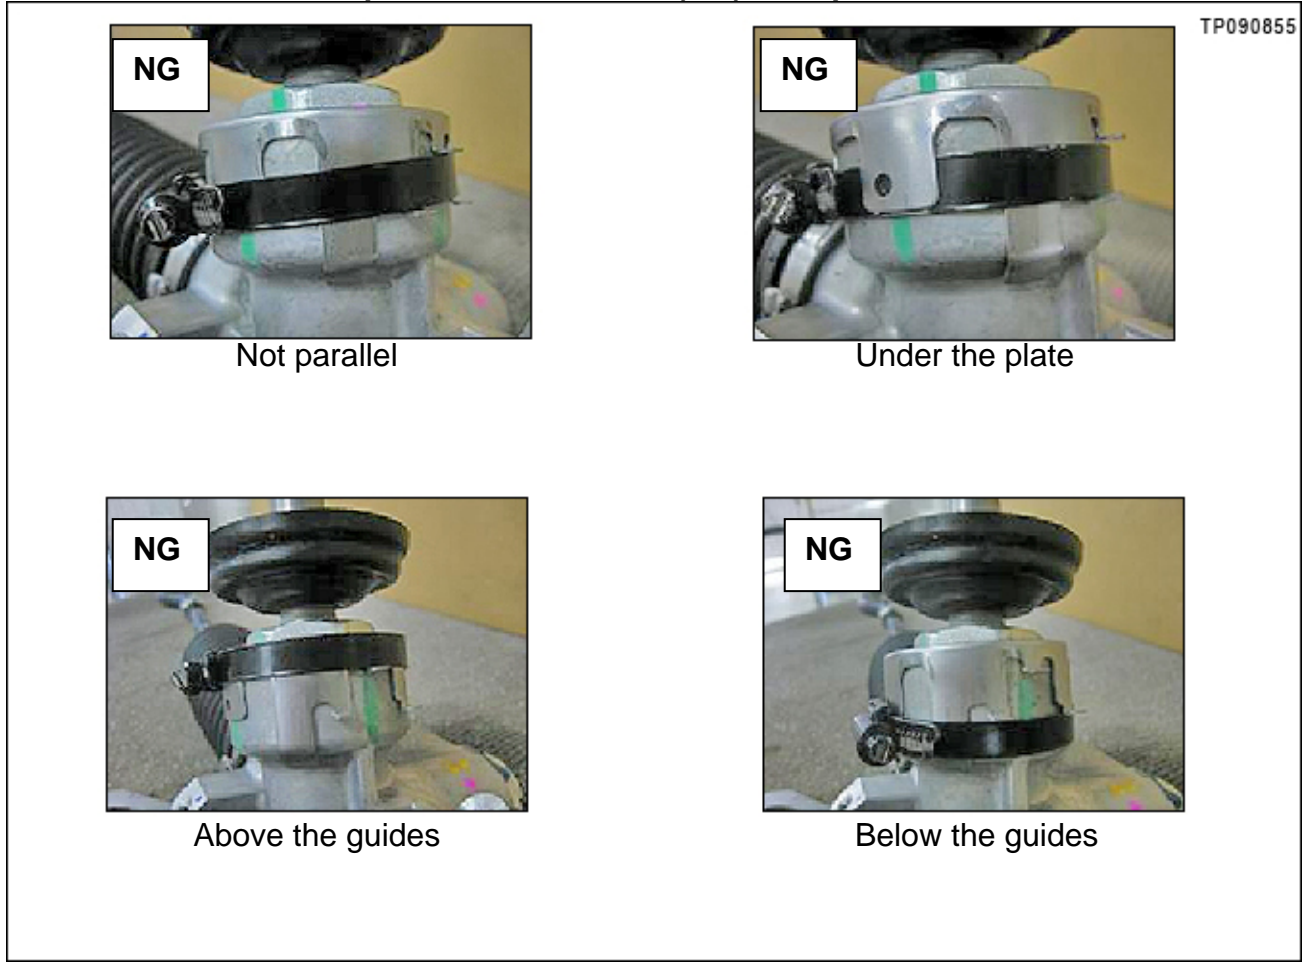
Figure 10

**Examples of INCORRECT (NG) Clamp Installation**
