TOYOTA CUSTOMER SERVICES

Volume: XVI
Number: TC10-015
Date: 03/08/2010
 Action
 Retain
 Information

Subject: Safety Recall (Special Service Campaign) – 90M
Certain 2000 – 2003 Model Year Toyota Tundra Vehicle in Severe Cold Climate States
Excessive Corrosion of the Rear Cross Member (Spare Tire Carrier)

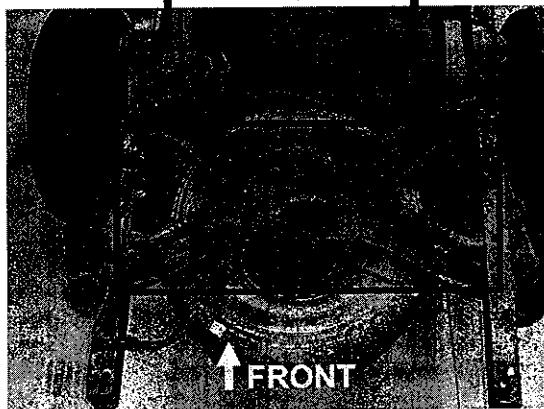
Case 3: More than 3 perforated spots.

For part number information, please reference Section V "PARTS INFORMATION"

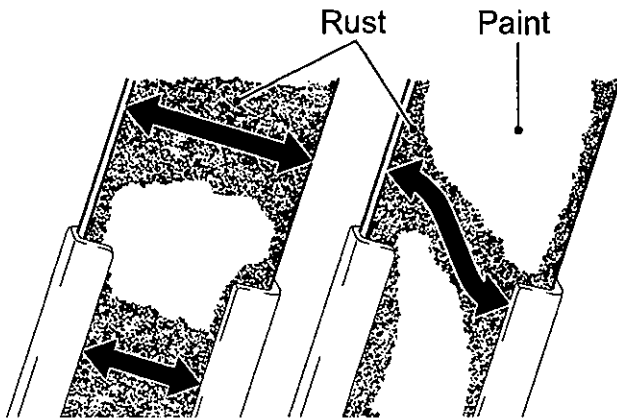
Rusting occurs continuously along the entire width of the strap.

Judgement Criteria	Action
NG	Replace the fuel tank strap(s) For part number information, please reference Section V "PARTS INFORMATION"
OK	Replacement not required

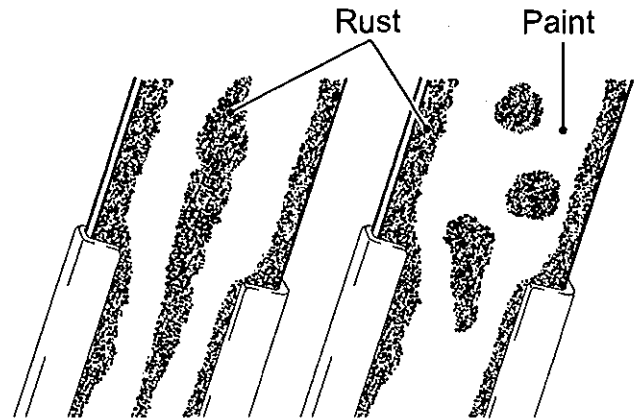
OK

Rusting does not occur continuously along the entire width of the strap.

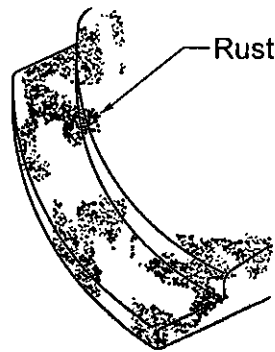
OK

Rust but no deterioration or holes present

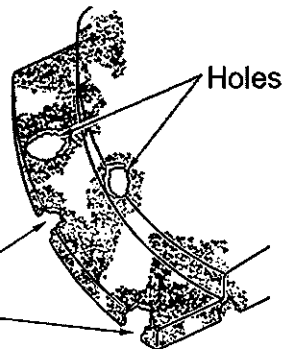
Deterioration or holes present

Judgement Criteria	Result	Action
Deterioration Found	NG	Replace the spare tire carrier For part number information, please reference Section V "PARTS INFORMATION"
No Deterioration	OK	Replacement not required
