Subject: Safety Recall (Special Service Campaign) – 90M
Certain 2000 – 2003 Model Year Toyota Tundra Vehicle in Severe Cold Climate States
Excessive Corrosion of the Rear Cross Member (Spare Tire Carrier)
Phase I – 20 Severe Cold Climate States

**SSC 90M – Certain 2000 through 2003 Tundra Vehicles
Severe Corrosion of the Rear Cross-Member
Safety Recall Notice (*Interim Notice*)**

2000-2003 MODEL YEAR TUNDRA

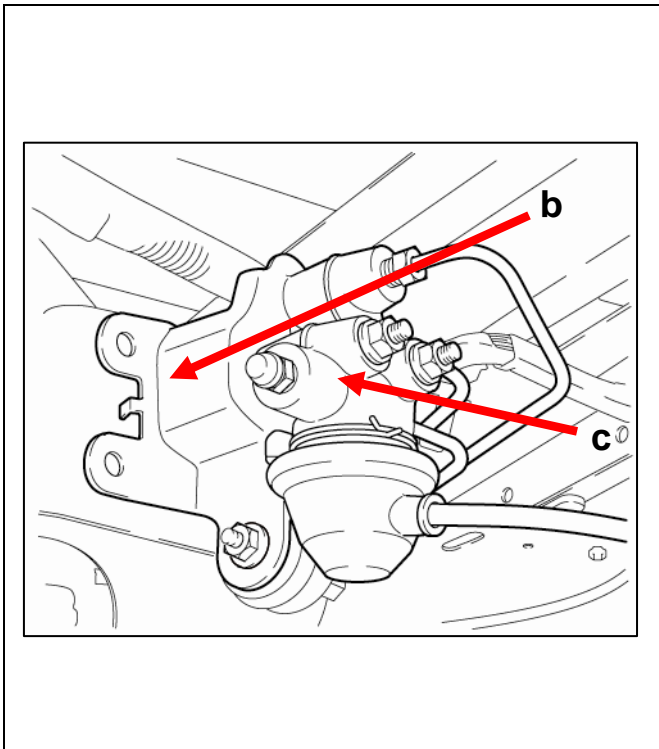
C. LOAD SENSING PROPORTIONING & BY-PASS VALVE AND ASSOCIATED BRAKE LINE INSPECTION

1. Inspect the Load Sensing Proportioning & By-Pass Valve (LSP & BV) for excessive rust, looseness & normal function.

- a) If there are signs of excessive rust and/or any sign of brake fluid leakage, note that the valve will require replacement and continue inspection.
- b) With one hand using minimal force, attempt to wiggle the **valve bracket (b)**.
 - i. If the LSP & BV bracket is loose, note that the LSP & BV and bracket will require replacement and continue inspection.
- c) With one hand using minimal force, attempt to wiggle the **valve body (c)**.
 - i. If the LSP & BV body and/or associated components are loose or show any signs of leakage, note that the LSP & BV and bracket will require replacement and continue inspection.

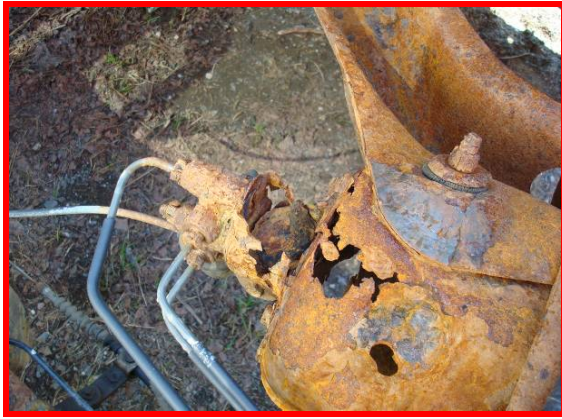
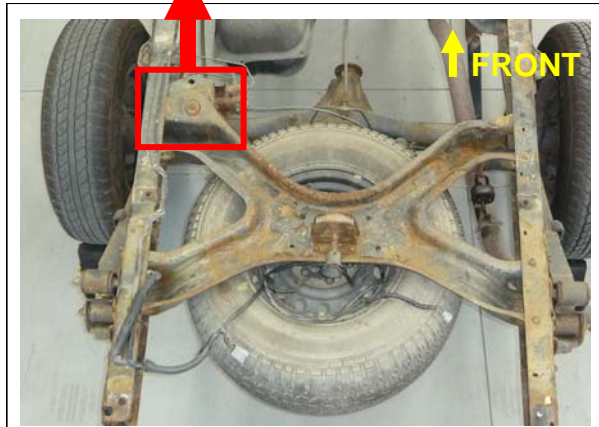
Example of NG Condition: Replace Rear Cross Member

Vehicle should not be driven without rear cross member replacement

- Rear LH Shock absorber mounting area
- LSP&BV Bracket installation area

Case 3 inspections fail. Inform customer that rear cross member will require replacement, and provide them with rental vehicle. Contact the customer when parts become available.

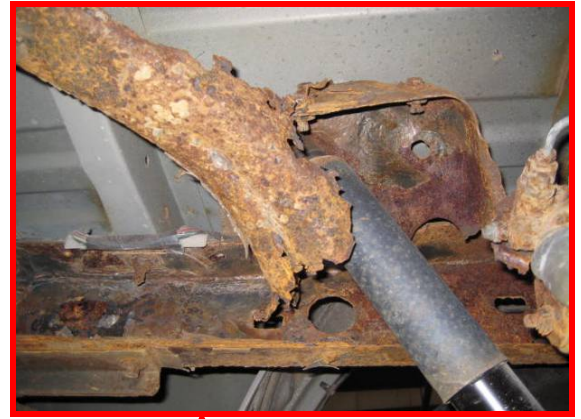
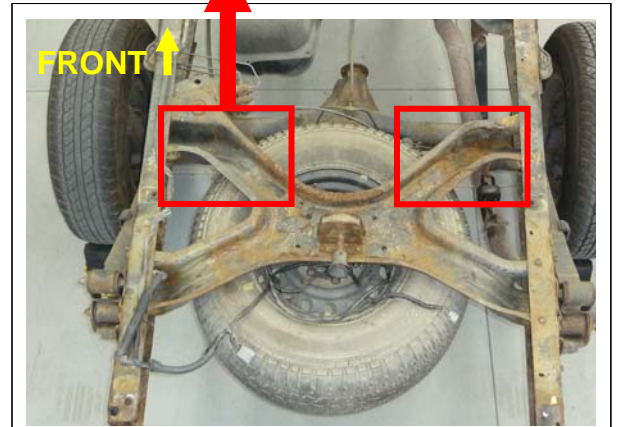
Rear Cross Member - Front Arm Areas

Guideline: The size of the perforation is more than 2/3 of the cross section length

Example of NG Condition: Replace Rear Cross Member

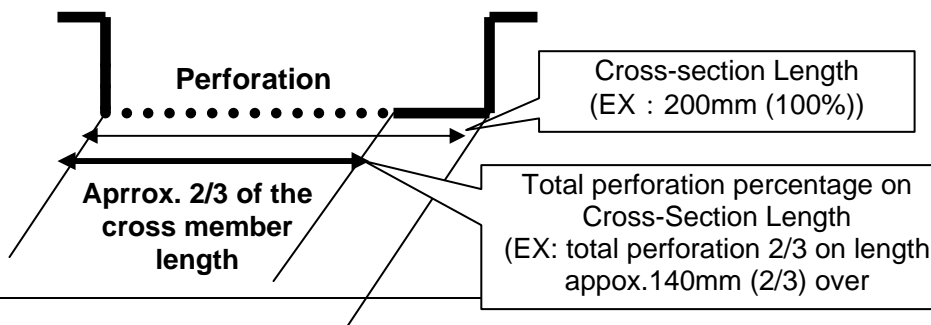
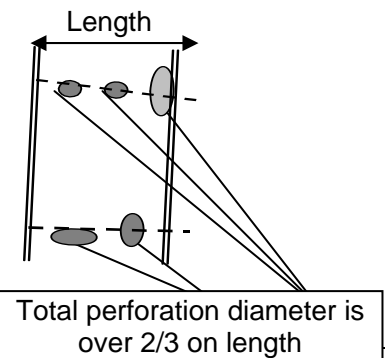
Rear Cross Member - Front Arm Cross Section

((NOTE)) Explanation of the meaning of

"The length of perforation is more than 2/3 of the cross section length"

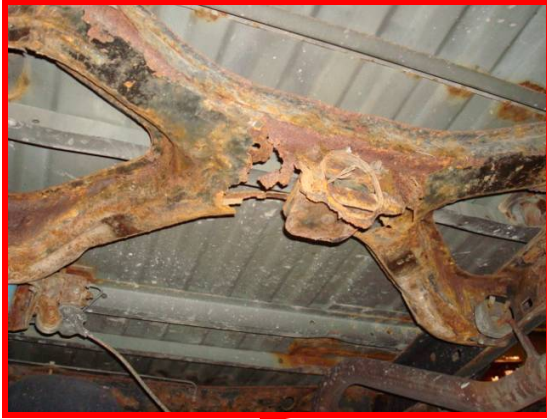
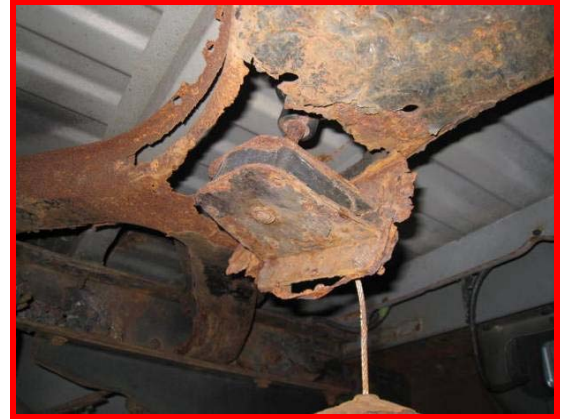
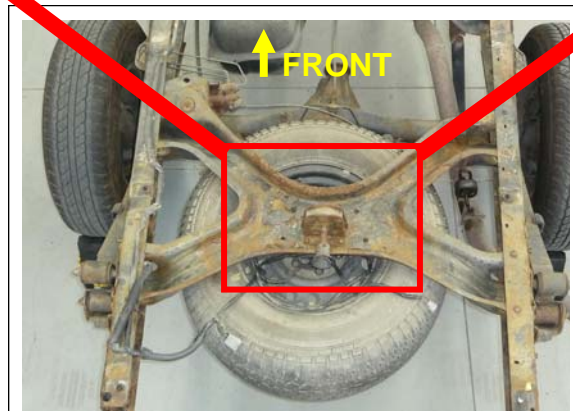
Vehicle should not be driven without rear cross member replacement

Guideline: The size of the perforation is more than 2/3 of the cross section length

Example of NG Condition: Replace Rear Cross Member

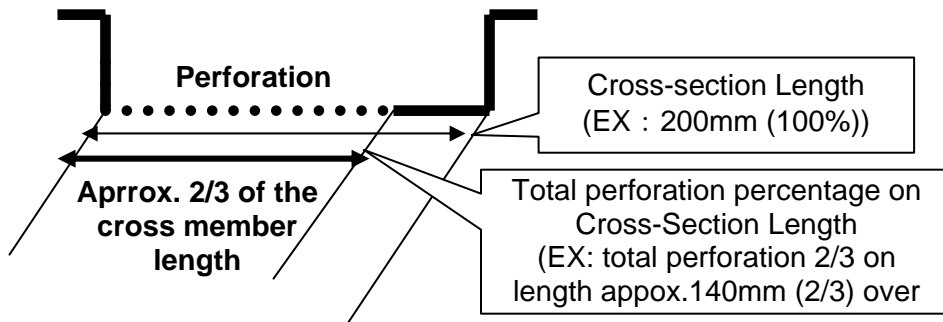
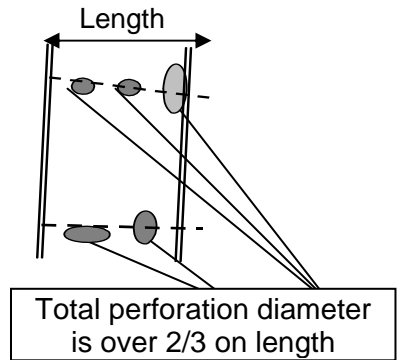
Rear Cross Member – Center Cross Section

((NOTE)) Explanation of the meaning of "The length of perforation is more than 2/3 of the cross-section length"

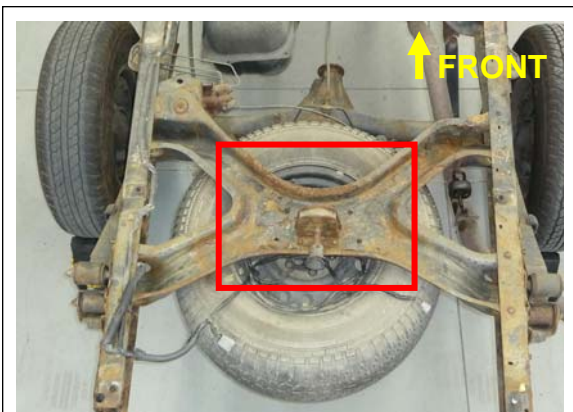
Example of NG Condition: Spare tire should be removed and secured in bed of truck.

NG Case 2: **more than 3 perforated spots in center portion of rear cross member**

Vehicle can be driven without rear cross member replacement however; spare tire must be removed from carrier and secured in truck bed.

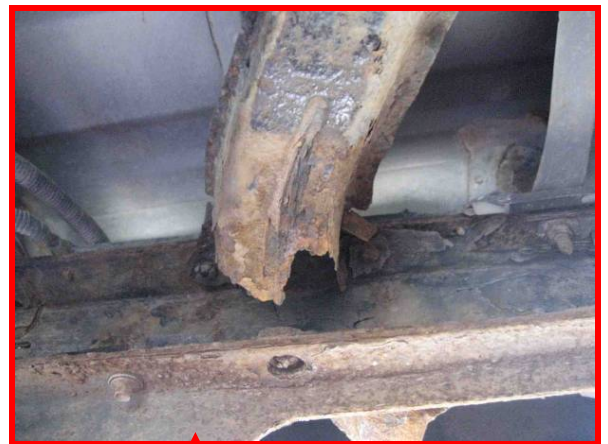
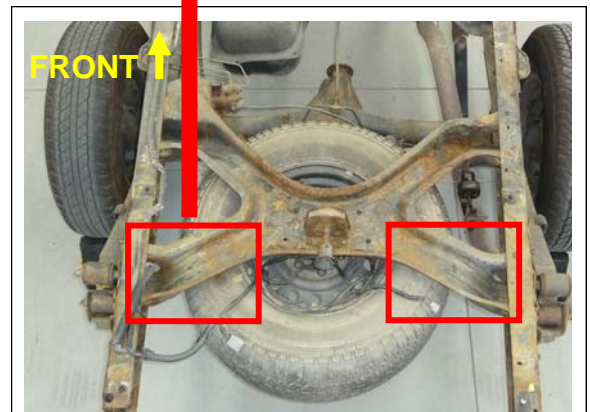
Rear Cross Member - Rear Arm Area

Guideline: if a **complete breakage/separation from side rail is observed in rear arm of the cross-member**, spare tire should be removed and secured in bed of truck.

Example of NG Condition: Necessary to replace Rear Cross Member
