# TOYOTA CUSTOMER SERVICES

Volume: XVI  
Number: TC09-041  
Date: 12/07/2009  
 Action  
 Retain  
 Information

Subject: Safety Recall (Special Service Campaign) – 90M  
Certain 2000 – 2003 Model Year Toyota Tundra Vehicle in Severe Cold Climate States  
Excessive Corrosion of the Rear Cross Member (Spare Tire Carrier)  
Phase I – 20 Severe Cold Climate States

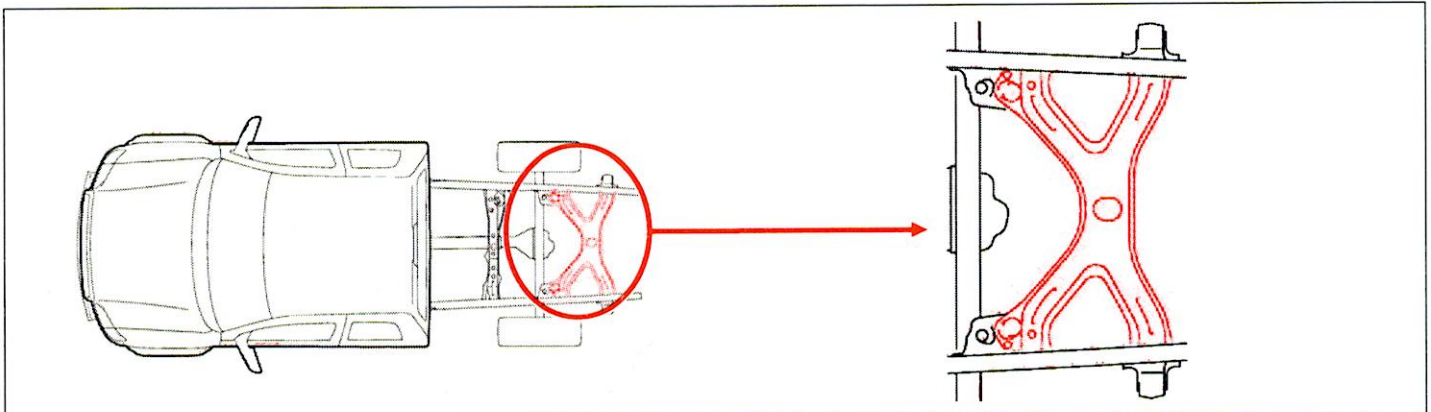
- On certain 2000 through 2003 model year Tundra vehicles operated in cold climate areas with high road salt use (*Severe Cold Climate States*) excessive corrosion may be exhibited on the rear cross-member. In the worst case, the spare tire stowed under the truck bed may become separated from the rear cross-member. Eventually, excessive corrosion of the rear cross-member may also affect the functionality of the rear brake line at the proportioning valve.
- Exposure to cold climate and high road salt usage conditions are primary contributors. This is unrelated to, and separate from, normal surface rust which is commonly found on metallic surfaces after some years of usage and/or exposure to the environment.

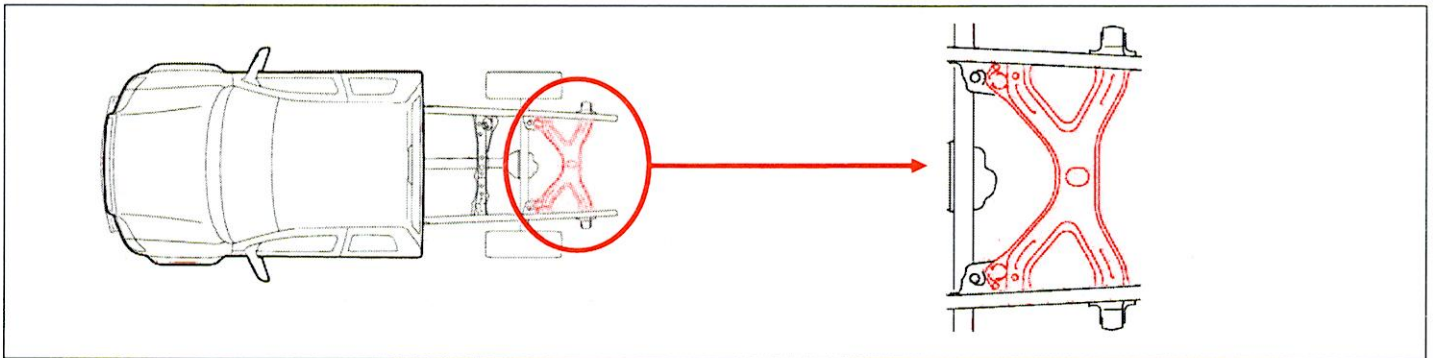
- On certain 2000 through 2003 model year Tundra vehicles operated in cold climate areas with high road salt use (*Severe Cold Climate States*) excessive corrosion may be exhibited on the rear cross-member. In the worst case, the spare tire stowed under the truck bed may become separated from the rear cross-member. Eventually, excessive corrosion of the rear cross-member may also affect the functionality of the rear brake line at the proportioning valve.
- Exposure to cold climate and high road salt usage conditions are primary contributors. This is unrelated to, and separate from, normal surface rust which is commonly found on metallic surfaces after some years of usage and/or exposure to the environment.
