TOYOTA

Subject: Safety Recall (Special Service Campaign) – 90M
Certain 2000 – 2003 Model Year Toyota Tundra Vehicle in Severe Cold Climate States
Excessive Corrosion of the Rear Cross Member (Spare Tire Carrier)

REAR FRAME CROSS MEMBER REPLACEMENT

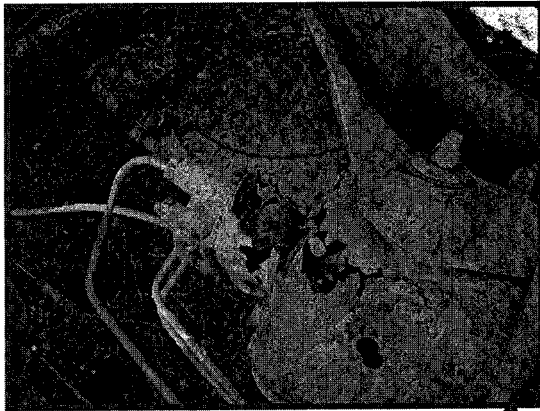
GUSSET AREA ONLY

NG Condition, Replacement Required:
Any perforation in gusset area where the LSPV is installed.

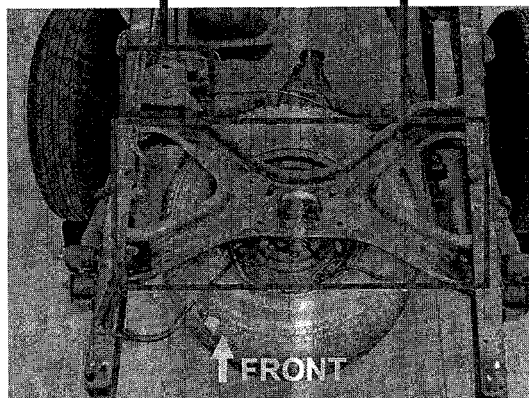
Case 3: More than 3 perforated spots.

For part number information, please reference Section V "PARTS INFORMATION"

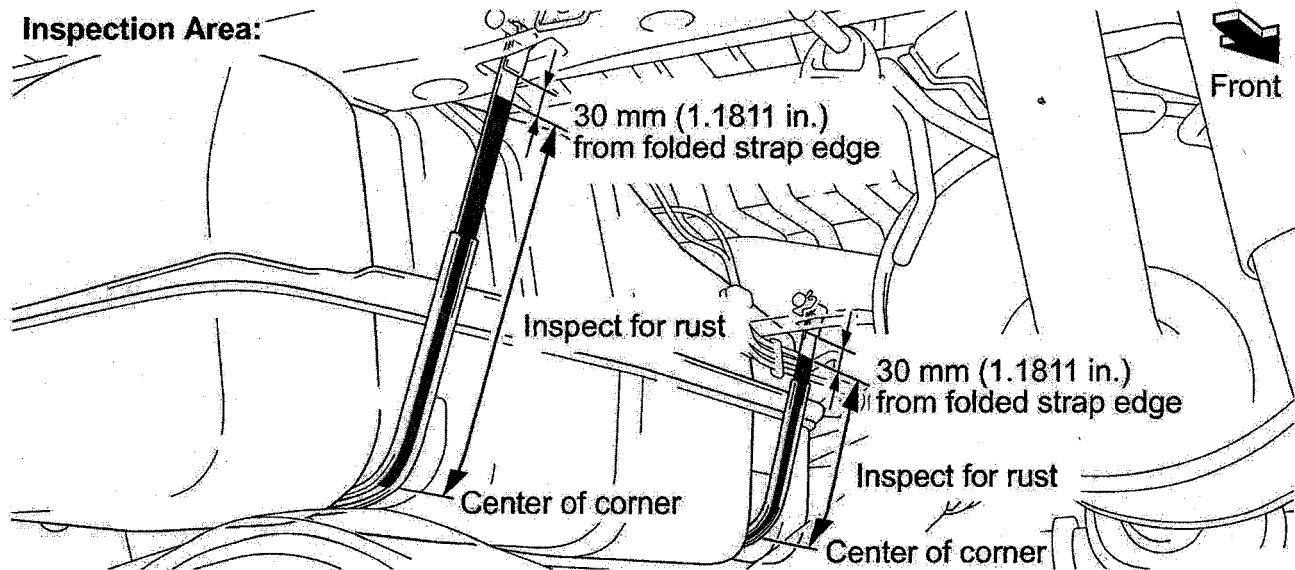
b) Inspect the outside surface of the fuel tank straps, does the rust span the width (front to rear) of either fuel tank strap as shown.

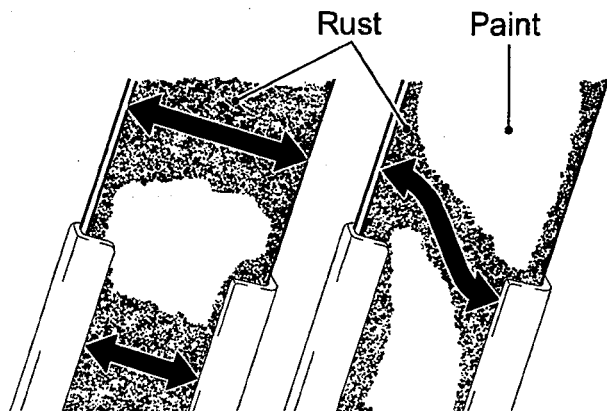
Rusting occurs continuously along the entire width of the strap.

Judgement Criteria	Action
NG	Replace the fuel tank strap(s) For part number information, please reference Section V "PARTS INFORMATION"
OK	Replacement not required

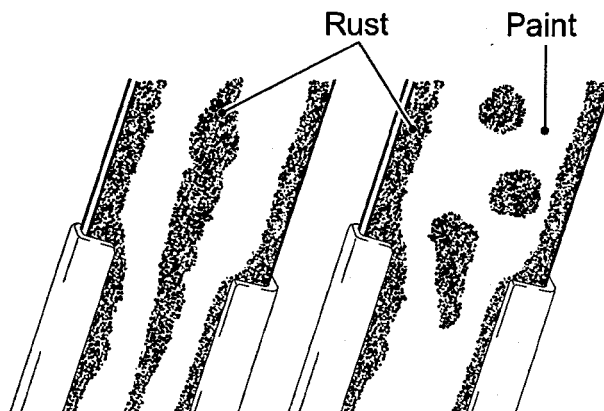
OK

Rusting does not occur continuously along the entire width of the strap.
