RE: Volvo Recall 218
Certain Model Year 2010 - XC60

VOLVO				TITLE:		GROUP:		NO:	
				Recall 218: Fuel Line Rail Cover Inspect / Reattach		23		218	
Service Manager Bulletin						Model Year 2010 - XC60		ISSUING DEPARTMENT:	
				Warranty					
Service Personnel: read and initial.				REFERENCE BULLETINS:		CARMARKET:			
						United States, Canada			
SERVICE MANAGER		SERVICE WRITER		WARRANTY ADMINISTRATOR		DATE:			
						YEAR MONTH DAY			
						2009 12 17			
						Page 1 of 2

Retailer Technical Journal 22278

"Fuel Line Rail Cover Inspect / Reattach"

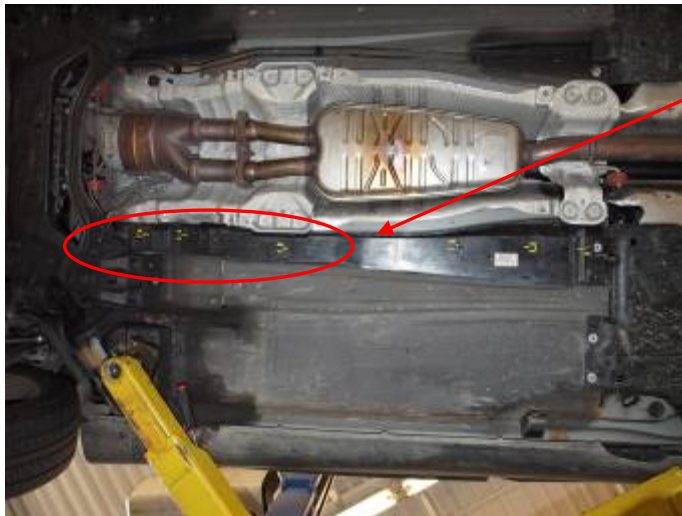
DESCRIPTION: VCNA has identified that the fuel line rail retainer panel, protecting the fuel lines underneath the vehicle, may not be properly attached. If not properly attached, the fuel line rail may come loose exposing the fuel lines to damage.

Inspect clips on front of fuel rail cover.

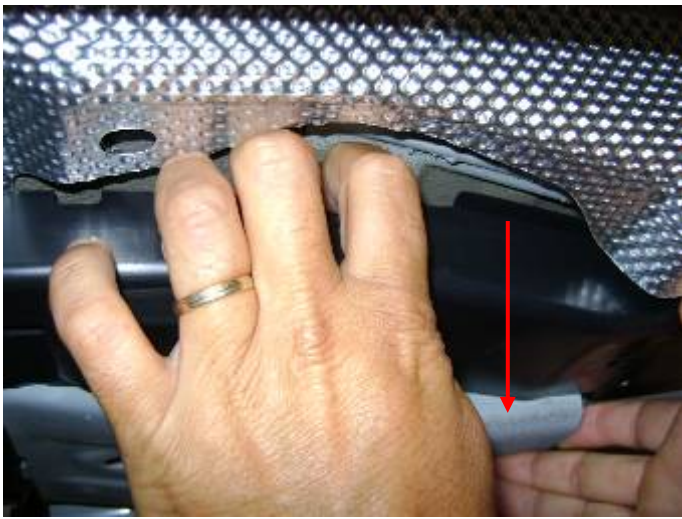
Check for loose clips by gently pulling down.

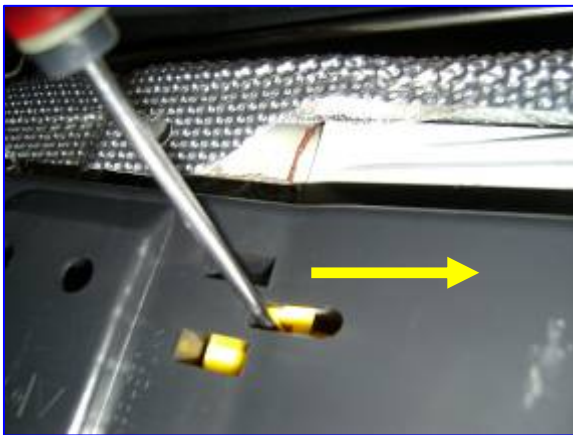
Repositioning clip 2.

If clip 2 is not secure slide clip (not cover) backwards to align over body stud.(see pic.below)
