Audi of America, Inc.

SAFETY RECALL CAMPAIGN ANNOUNCEMENT

Subject: **Voluntary Safety Recall Campaign 70D4/J6
2009 Audi Q5 vehicles
Replace Middle Clip of A –Pillar Cover**

Safety Recall Circular

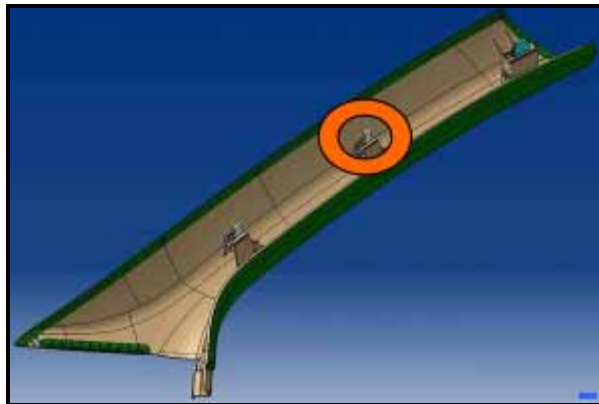
Tip: If center trim clamp -circle- remains in the body mounting, remove and discard trim clamp

- ⇐ Remove center retaining clip -circle- and install new retaining clip part number (8Z0 867 276)

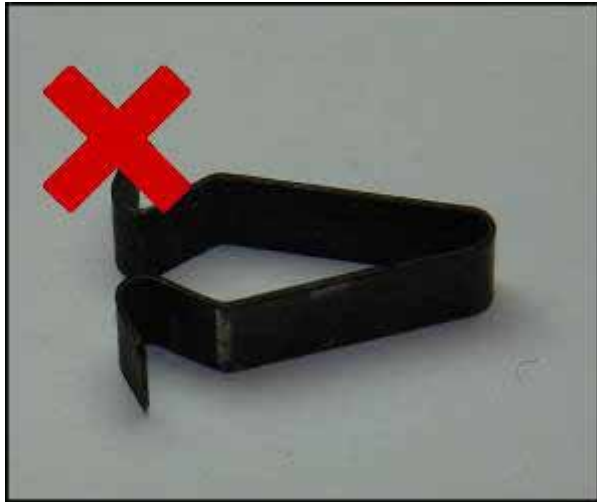
Tip: Old retaining clip (must be removed)
