CONTROL ARM DEFECT OWNER NOTIFICATION LETTER - RECALL 09E-056

Qualis Automotive, LLC 3150 Livernois Rd, Ste 103 Troy, MI 48083

November 9, 2009

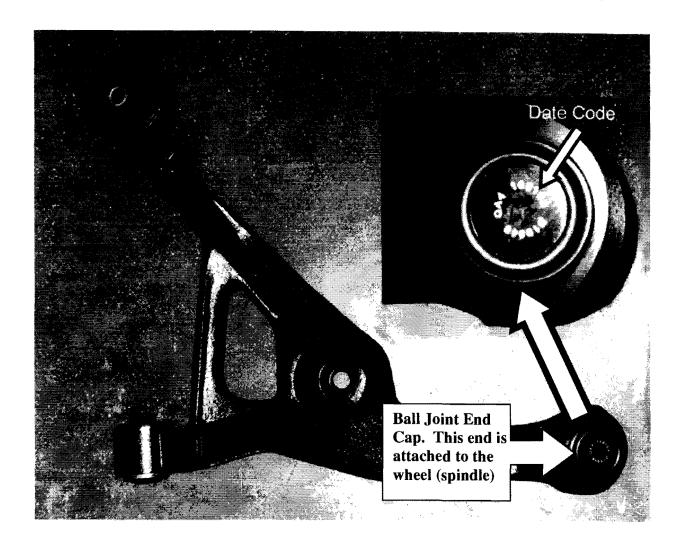
EXHIBIT A

Qualis Automotive, LLC has decided that a defect which relates to motor vehicle safety exists in certain control arms with the date codes outlined in TABLE A. The affected control arm part numbers are 10945 and 10946. Under severe loads, the ball joint housing in the control arm may crack and the control arm may separate from the spindle. This may cause a loss of vehicle steering, possibly resulting in a crash.

Go to a service bay and verify the date code on the ball joint end cap is one of the codes in TABLE A. Please have the technician refer to Exhibit A to find the location of the date code on the part. If the part is verified as having a code in TABLE A call 1-800-522-0833 to get a box with pre-paid shipping sent to your address. Please have a technician replace the part and give you the affected control arm so you can ship back. You will not get reimbursed unless the part is sent back. Please fill out the form provided in the pre-paid box and include a copy of the repair

Qualis Automotive, LLC will reimburse each owner reasonable charges if the part is already installed on the vehicle. The reimbursement charges will cover the cost of the new control arm plus labor for installation. The reimbursement will be in the form of a check mailed to the owner's address.
