**SAFETY RECALL NOTICE**

**VOLUNTARY SAFETY RECALL CAMPAIGN # 09V-111**

B-091

## 1125R, XB12R AND XB12Scg BRAKE LINE RECALL

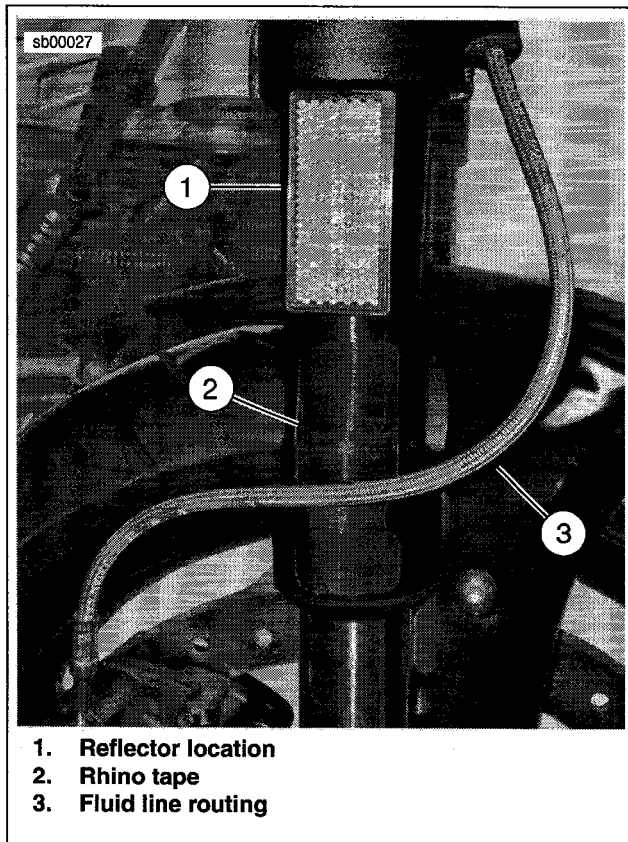
Figure 1. Reflector/Rhino Tape Location (XB12Scg)

These motorcycles have a front brake line which may contact the front tire. The condition could cause a hole to develop in the front brake line, allowing brake fluid to leak.

- Remove the reflectors on the outer fork tubes and install **new** reflectors pressed up against the lower triple clamp.
- Fit the rhino tape against the lower edge of the outer fork tube and press into place.

1. **XB12R/XB12Scg:** See Figure 1. Remove the reflectors on the outer fork tubes and install **new** reflectors pressed up against the lower triple clamp.

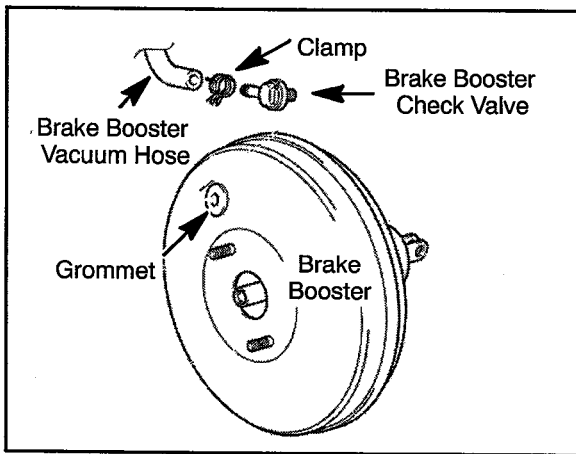
On some affected vehicles equipped with automatic transmissions (including CVT), the brake booster check valve may stick closed when the engine is shut off. Under certain conditions (very slow vehicle maneuvers after a restart) there may be insufficient initial brake assist, which may temporarily increase the stopping distance of the vehicle and therefore increase the risk of a crash.

5. Locate the brake booster.
6. Using pliers, compress the clamp securing the brake booster hose to the brake booster check valve and slide the clamp away from the valve.
7. Remove the hose from the check valve.
8. Take note of the direction the check valve is facing.
9. Remove the check valve from the brake booster.
10. Insure that the grommet is in position and flush to the booster surface prior to installing the new check valve.

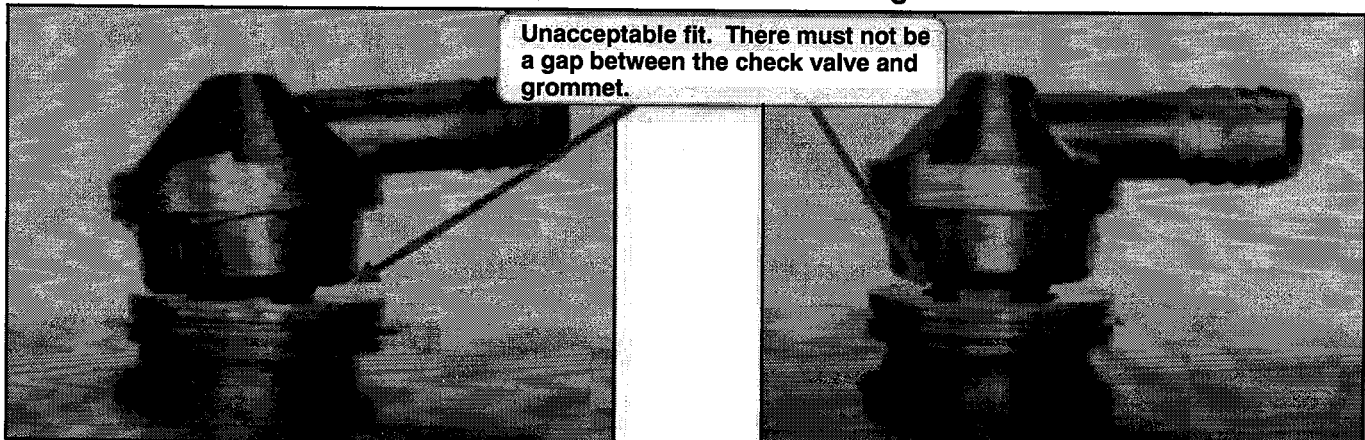
Insure the check valve fits flush to the grommet. There must not be a gap between the base of the check valve and the grommet.

11. Install a new brake booster check valve **facing the same direction as the one you removed**. Insure that the check valve is completely inserted and that no gap exists between the valve and the grommet (see following photos).
