# **Daimler Buses Recall Bulletin**

Orion VII N.G. Models

## **1.0 WINDOW DELAMINATION RECALL NOTICE**

**SAFETY DEFECT - Hehr Window Delamination.**

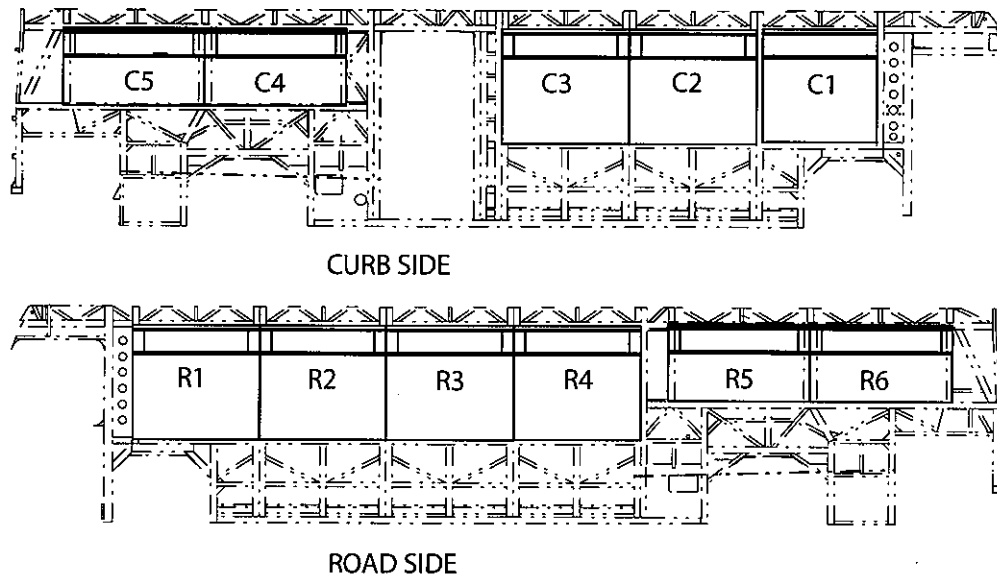
FIGURE 1-2 WINDOW NUMBERING

1. In the bus to be tested, number the windows from the front of the bus to back starting with #C1 (#C2, #C3, #C4, etc.) on the "Curb" side and #R1 from front to rear on the "Road" side. (See Figure 1-2)

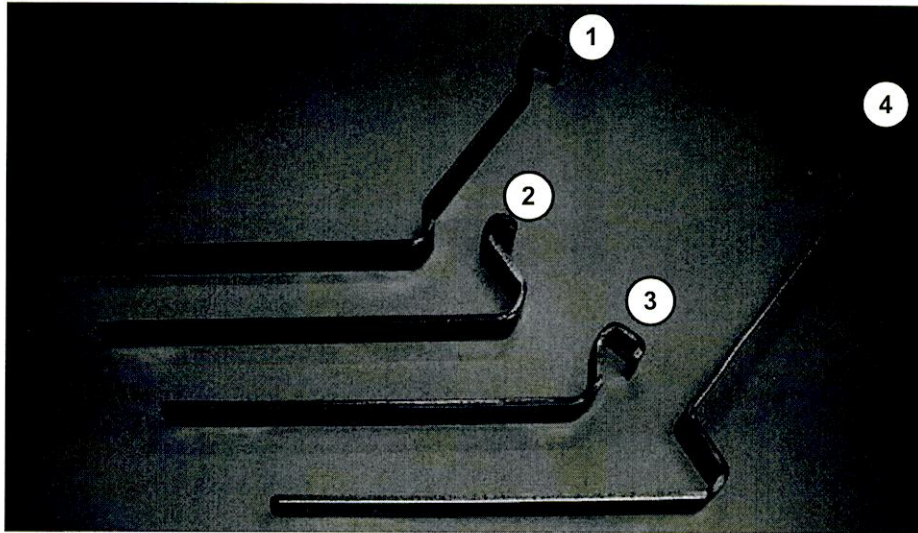
FIGURE 1-3 WINDOW TESTING TOOLS

The window testing tool number corresponds to the number of holes in the base of the tool.

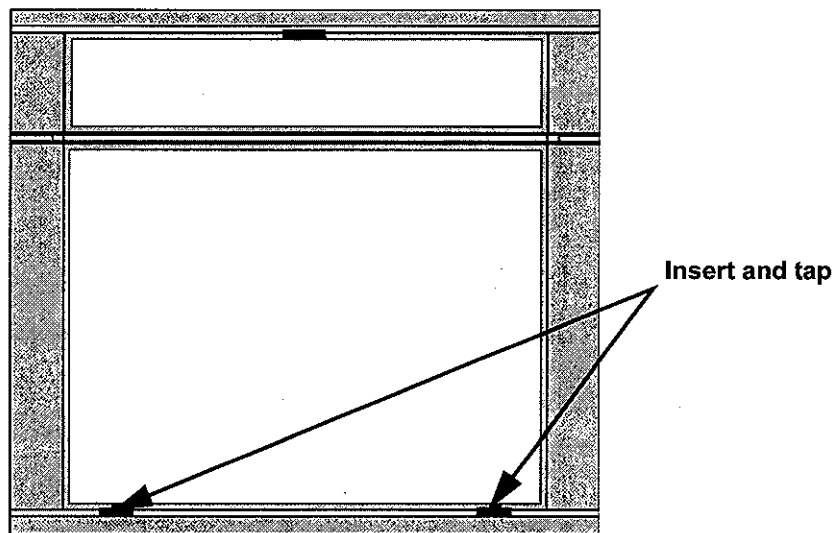
**FIGURE 1-5 NON-EGRESS WINDOW**

- b. **Non-Egress Window** (without black or red pull-handle) - Open window by inserting screwdriver or similar flat-bladed implement between the base of the window and window frame in the locations shown in **Figure 1-5** and pushing in, then down, until a click is heard and the catch is released.

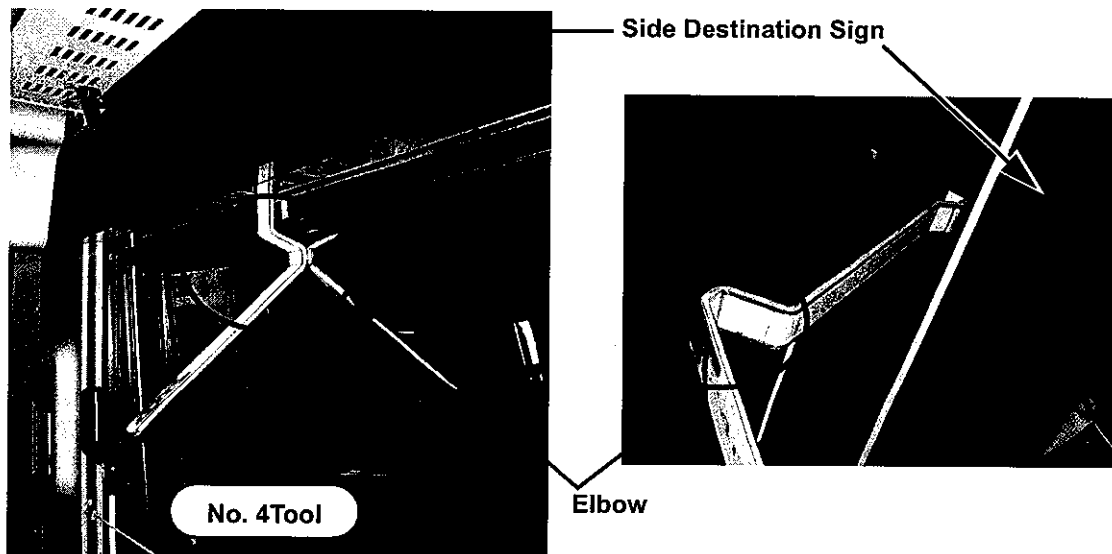
**FIGURE 1-6 TOOL# 4 USED ON DESTINATION SIGN WINDOW**

- c. **Destination Sign (R1) Window** (if equipped) - Open the top-hinged side destination sign window and, from outside the bus, secure the No. 4 testing tool to the top edge of the window as shown in **Figure 1-6**.

Use the No. 4 tool to test the four points labeled "X4" on the lower vent window as indicated in "**Window Load Test Points - Top-Hinged Windows**" on page 9.
