R09PL

# Headlining Rivets

# RECALL

**MODELS AFFECTED:** 2010 D3FE All American School Buses manufactured at Fort Valley, Georgia from January 19, 2009 through May 13, 2009.

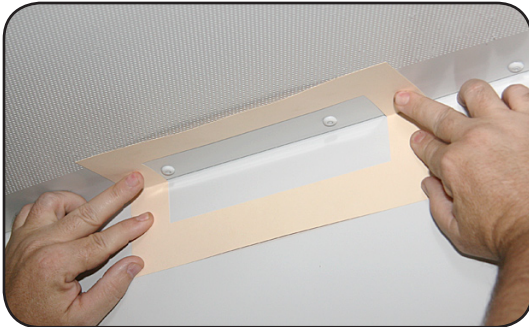
On some units, the rivet spacing may be incorrect in some segments of the rear headlining and rear upper inner panel joint, resulting in noncompliance with FMVSS 221, School Bus Body Joint Strength.

- 1** Park vehicle on level surface, apply parking brake, remove ignition key and chock wheels.
- 2** Inspect rivet spacing at rear headlining and rear upper inner panel joint. Joint must have a minimum of four rivets in an eight inch segment.
  - 2.1 Place the template over the joint and parallel to the edge of the headlining panel, allowing roof rivets to be exposed through the opening in the template as shown.
