# ***Latch Handle Disable Alternate Method - Final***

**National Traffic and Motor Vehicle Safety Number (NHTSA):** NHTSA recall number: 09V-318, Transport Canada number 09-240

This notice is sent to you in accordance with the requirements of the National Traffic and Motor Vehicle Safety Act. This notice is also sent in accordance with the Canadian Motor Vehicle Safety Act. Daimler Buses of North America (DNA) has decided that a defect, which relates to motor vehicle safety, exists in certain model year 2006 through 2009 Orion VII transit buses manufactured between August 2007 and June 2009.

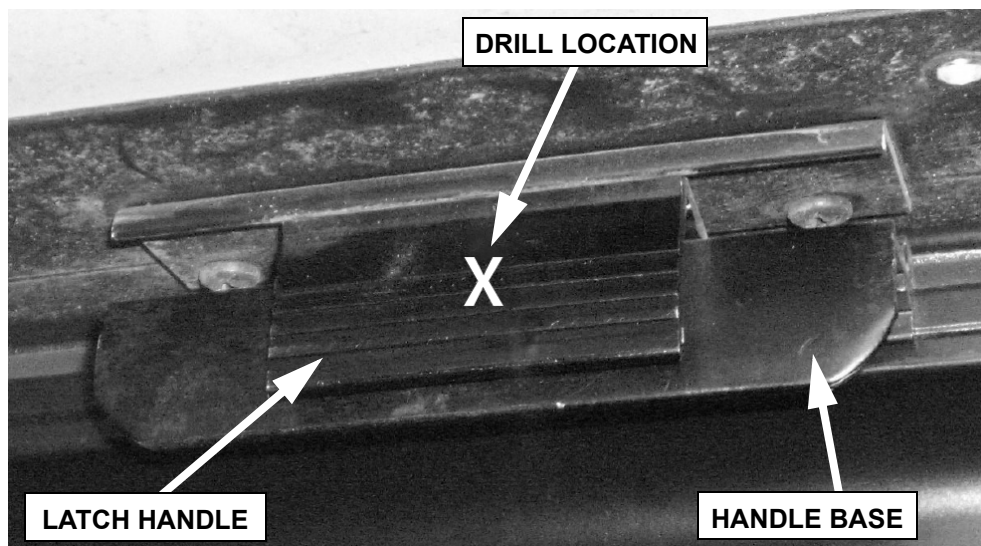
**Figure 1-1 Transom Window Latch (Closed Position)**

The passenger windows have a tip-in transom window which is attached by shocks and screws. These screws and shocks may loosen or fail and the window may dislodge and fall into the bus.

1. Ensure that the transom window is closed. See [Figure 1-1](#).
2. Drill a 9/64" hole through the center of the latch handle and handle base. See [Figure 1-1](#).
