Latch Handle Disable

National Traffic and Motor Vehicle Safety Number (NHTSA): NHTSA recall number: 09V-318, Transport Canada number 09-240

APPLICATION
ORION NG

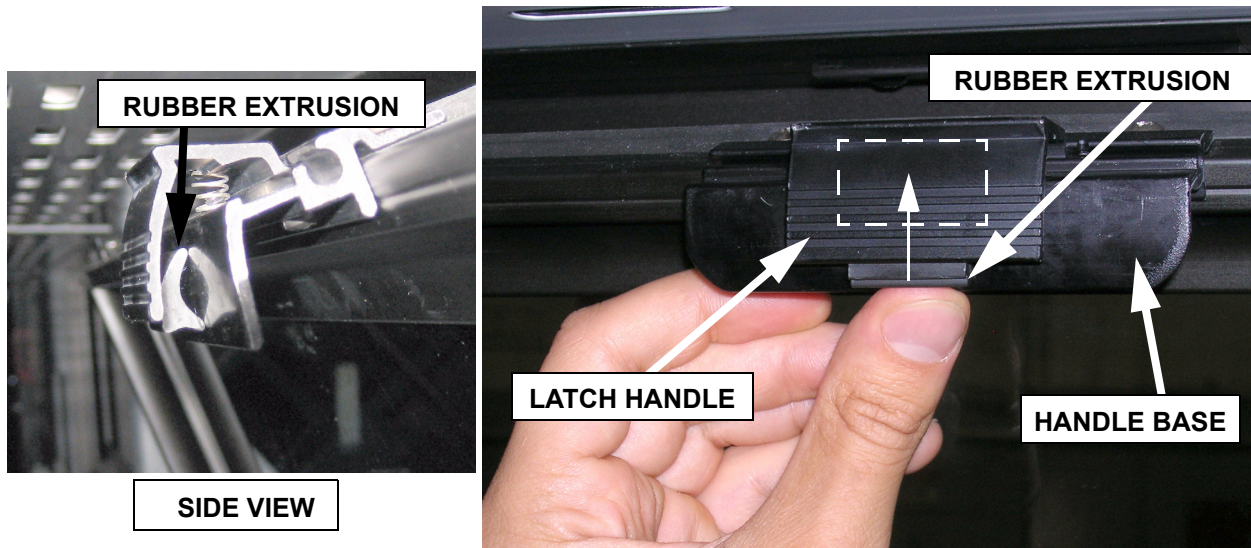
Figure 1-1 Transom Window

The passenger windows have a tip-in transom window which is attached by shocks and screws. These screws and shocks may loosen or fail and the window may dislodge and fall into the bus.

1. Open the transom window. See [Figure 1-1](#)
2. Place rubber extrusion between the latch handle and handle base. See [Figure 1-1](#)
3. Slide rubber extrusion upward. See [Figure 1-1](#)
