# Recall Campaign

Daimler Trucks  
North America LLC

February 2010  
FL557AB  
NHTSA #09V-357

### Subject: Rack and Pinion Steering Inner Tie Rod Ends

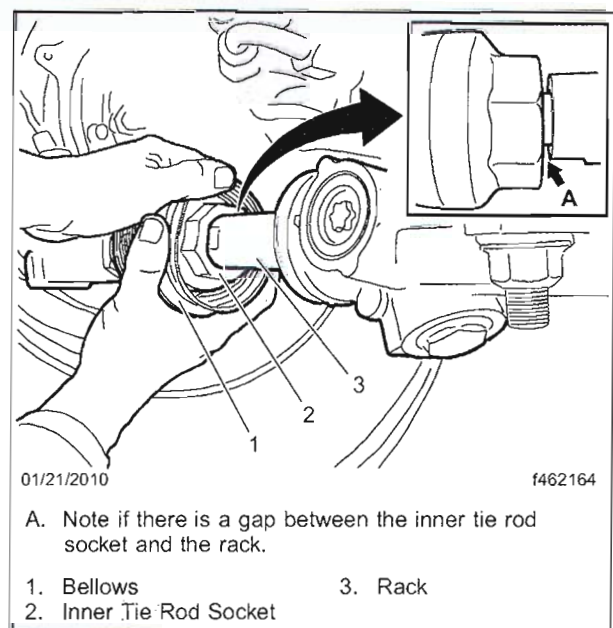
Fig. 2, Inner Tie Rod Inspection

9. Visually inspect the connection between the rack and the inner tie rod. Note if there is a gap present between the inner tie rod socket and the rack ( Fig. 2, Items 2, 3, and A). This information will be used in step 32.
10. Place a jack under the left side of the front axle and jack up the driver-side steer tire, making sure the passenger-side tire remains firmly on the ground. Support the vehicle with a jack stand.
11. Remove the cotter pin and castellated nut and disconnect the driver-side outer tie rod from the tie rod arm.
12. Install the holding fixture as follows.

32. If a gap was found between the inner tie rod socket and the rack in step 9, adjust each tie rod length to obtain the specified toe-in dimension, as follows. Use a toe bar or tape measure to complete the following steps. If no gap was found, go to step 33.
  - 32.1 Loosen the driver-side tie rod jam nut. If necessary, hold the inner tie rod in place with a backup wrench on the inner tie rod flat ( **Fig. 11**, Item 3).
  - 32.2 With the gear on-center, place a wrench on the driver-side inner tie rod flat and align the left tire by rotating the inner tie rod.
