**OWNER'S NOTIFICATION LETTER**

**Re: NHTSA Safety Recall, Program- Luminator LED Destination Sign  
Campaign number 09E - 054  
Van Hool Campaign number 09V - 397  
Van Hool Buses models A300L - AG300**

### Important Safety Recall

Safety Defect and Noncompliance Report Guide for Equipment  
**PART 573 Defect and Noncompliance Report<sup>1</sup>**

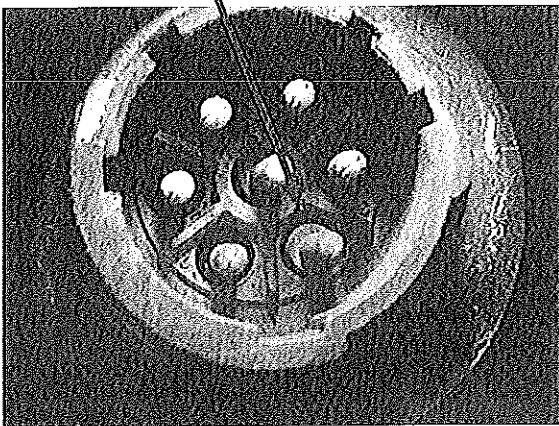
**Corrosion on Open Connector**

The corrosion is caused by an accumulation of moisture under the connector. None of the connectors which have a cable attached to them show any sign of corrosion. The base of the connector is too close to the board to effectively coat the solder connections with conformal coating (a corrosion preventative). This corrosion creates the conductive path between battery voltage and ground pins. Certain cleaning practices, (i.e. spraying water and cleaning agents) used at the Transit Authorities facilities introduces more moisture into the connector and increases the likelihood of the corrosion.

On all buses built in 2007 or older the connector board will be replaced with a newly designed board. The new board eliminates the possibility of arcing by putting the ground and battery voltage on separate layers of the board. The traces have also been moved to allow the maximum spacing. In addition conformal coating has been applied below the connector and a cap is installed on all open connectors to prevent the incursion of moisture and debris which would allow corrosion to develop

On all buses built since 2008, there has been no evidence of corrosion. By cleaning the connector with a moisture displacing corrosion inhibitor and subsequently capping the open connector with a vinyl cap, the conditions that allow the moisture to ingress and produce the corrosion will be eliminated.

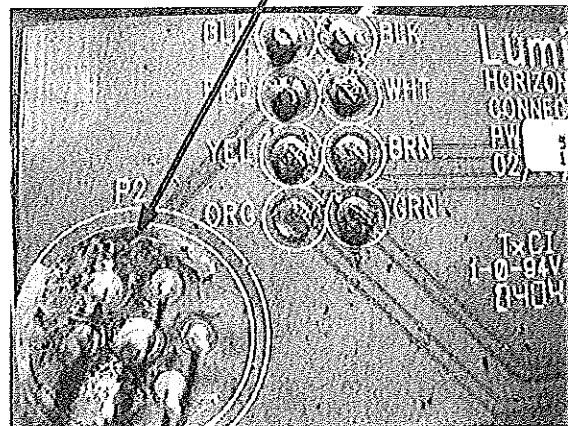
**Corrosion on board under connector**

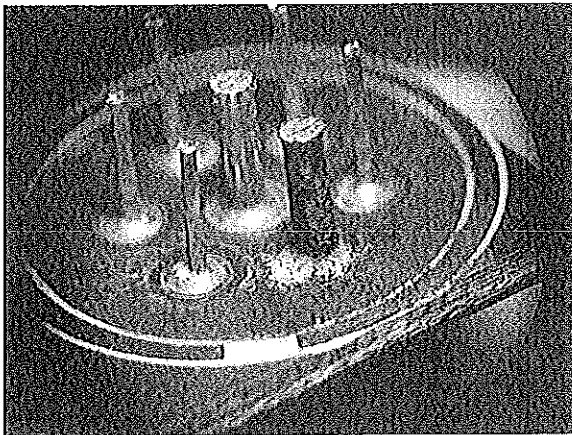
The signs listed above are equipped with the 506746 connector board that is used to "daisy chain" the Side Destination sign to other signs in the sign system. When there is no rear sign, or there are multiple side signs, one connector is left uncovered by the missing cable. This creates an open connector condition that allows debris to collect inside the connector and provides a path for moisture to ingress along the pins of the connector down to the PWA board itself causing corrosion on the solder connection between the open connector and PWA board. The corrosion allows for a conductive path between battery voltage and ground. This corrosion will allow a potential short and the sign will fail. In rare instances, this corrosion will cause the sign to smoke and possibly flame.

**Corrosion Starting on Battery Voltage Pin**

This corrosion will allow a potential short and the sign will fail. In rare instances, this corrosion will cause the sign to smoke and possibly flame.

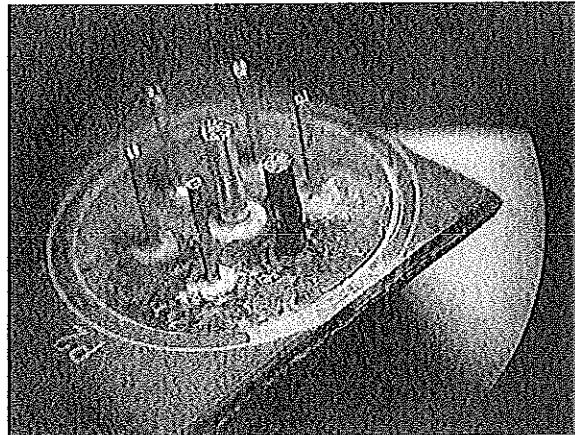
**Corrosion advanced to a conductive condition**
