# SAFETY RECALL NOTICE

## **Re: Ignition Switch Connector and Ignition Switch Harness Routing**

Campaign no.: 2010-0002

December 18, 2009 Subject: **Ignition Switch Connector and Ignition Switch Harness Routing**No. **2010-2**

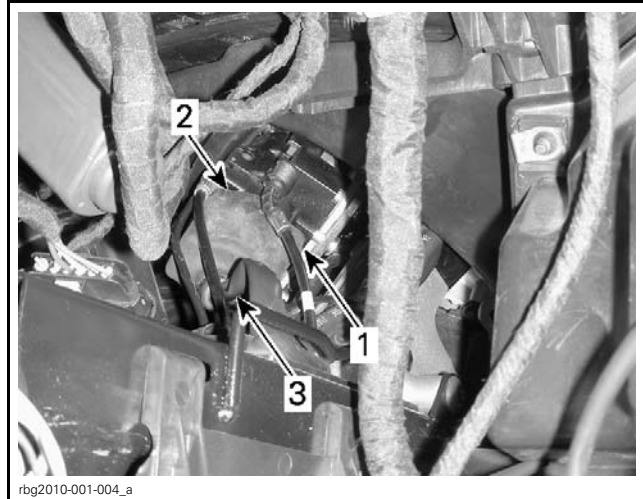
1. Ignition switch connector  
2. Rubber boot  
3. Ignition switch harness

- 2.2 Using both hands, ensure connector is well engaged in its housing and locked by locking tabs.

- 2.3 Reinstall rubber boot

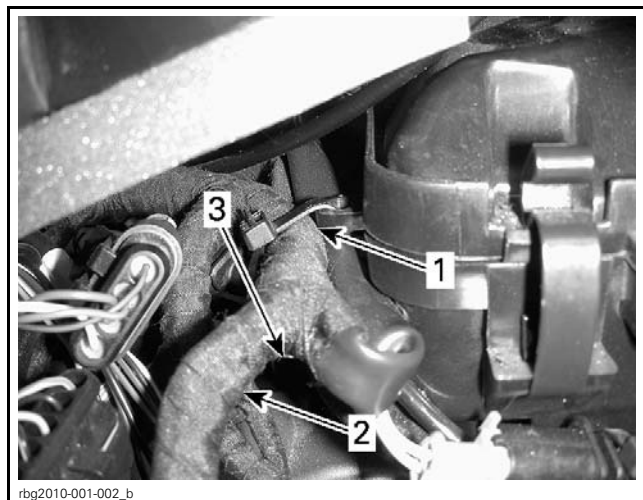
- 3.1 Locking tie should attach harness to air box before the branching point.

1. Wrong locking tie location on harness  
2. Correct locking tie location on harness  
3. Branching point

- 3.2 If locking tie position is incorrect, proceed with the repair procedure.

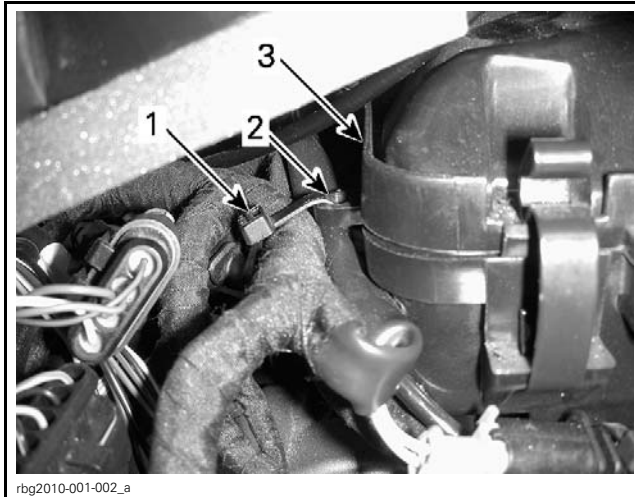
1. Tie rap
2. Attachment point on air box
3. Air box

1. Cut locking tie located on vehicle harness in front of air box.
