**Re: Defect Information Report – Supplemental Report No. 6
09V-011, FL-544, Transmission Vehicle Interface Module**

Product Recall

Subject: RECALL 09V-011 – Transmission Vehicle Interface Module Replacement

MODEL: HDX, 3000 SERIES TRANSMISSION
SUBJECT: TRANSMISSION VEHICLE INTERFACE MODULE (VIM) REPLACEMENT
DATE: OCTOBER 7, 2009
PAGE: 1 OF 3

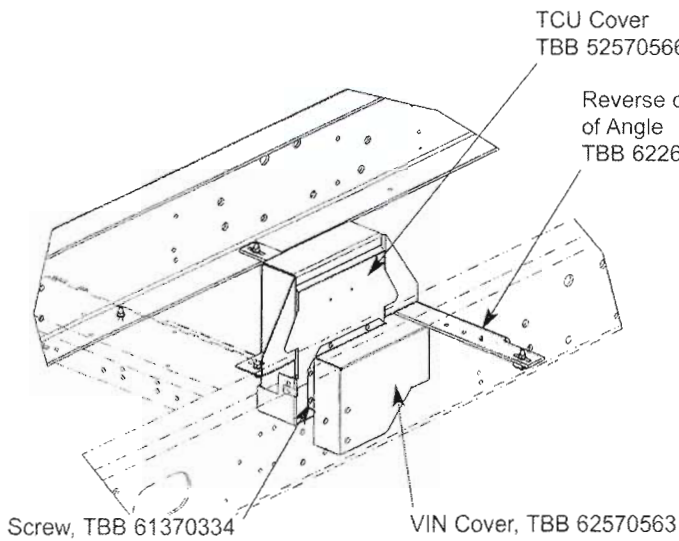
Figure 2 - Original TCU mounting until 5/21/03

NOTE: If your unit does not have the TCM Cover, refer to PSB Index 33, Bulletin 8R which is not warrantable. Also, if the Cover is not installed as manufacturing and/or the PSB provides, the warranty on the TCU and VIM electrical will be denied on future repairs. See Figures 2 & 3 on page 3 for early configurations.

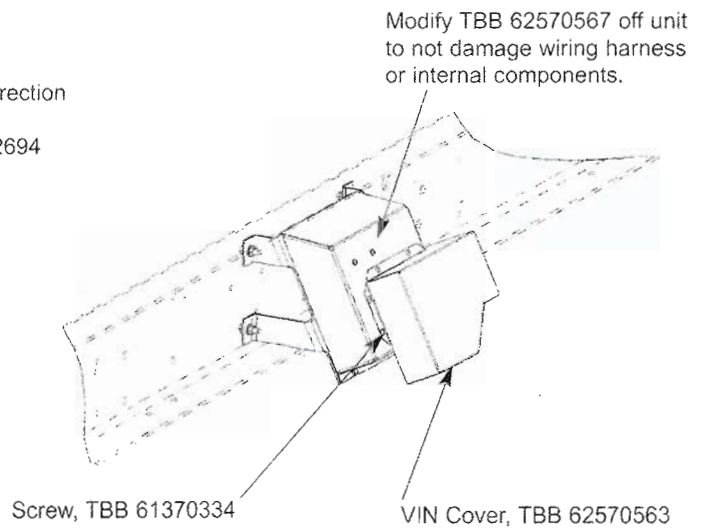
Figure 3 - Angled TCU mounting installation implemented on Chassis Yard #68197 on 5/21/03
