**Re: Defect Information Report – Supplemental Report No. 2  
09V-287, FL-555, Emergency Exit Window Binding**

Subject: RECALL 09V-287 – Emergency Exit Windows Binding

**RECALL #09V-287**  
**EGRESS TO NON-EGRESS**

## RECALL #09V-287 EGRESS REPAIR

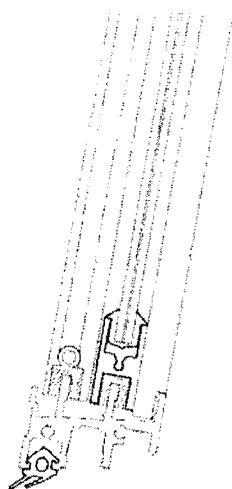
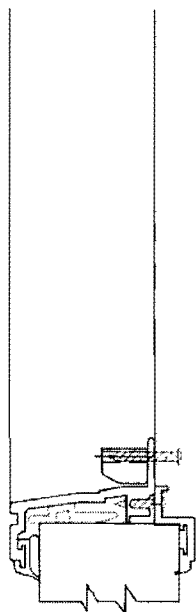
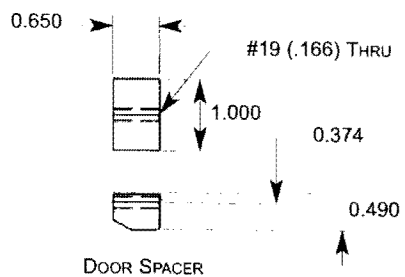
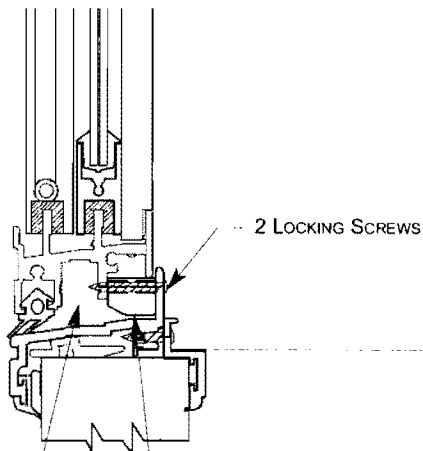
NO LATCH MECHANISM

PLASTIC SPACER &  
SCREWS TO SECURE  
CLOSED

**Step 9-** Open the window, remove the tape and re-place the plastic blocks on the Back Frame with #8 x 1-1/4 Pan Head Sheet Metal Screws inserted into the plastic spacers. The screws will hold the spacers in place. Carefully close the window, and drive the screws into the 1/8" hole drilled in the Inner Frame. The window is now secured closed.

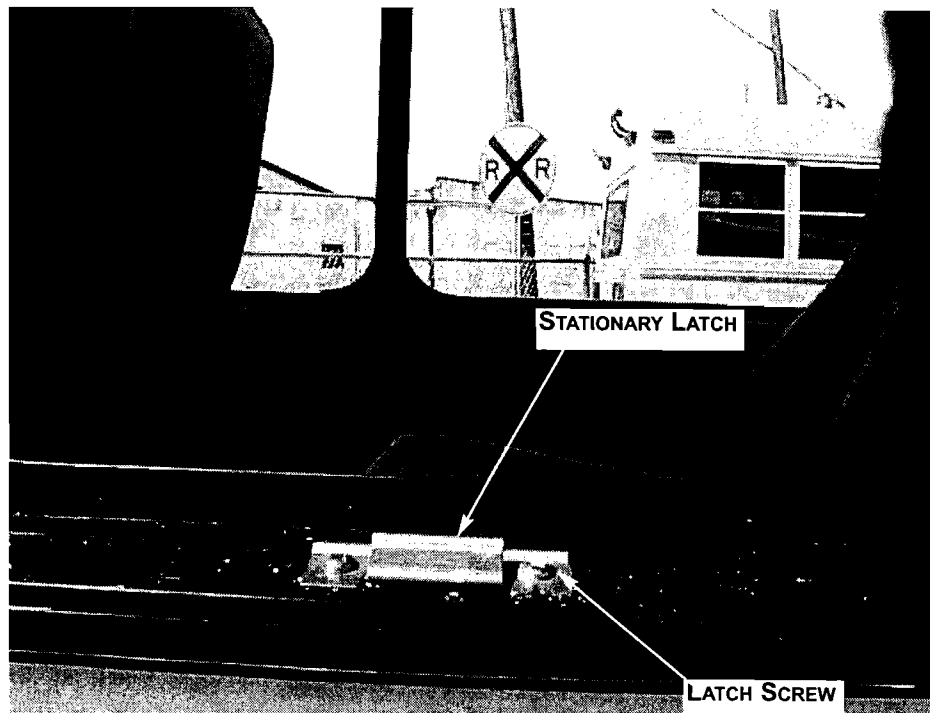
FIGURE 3

If handle requires large force to move (exceeds 18 ft/lbs.) the stationary latch may be bent up or broken. Once you get the window open, inspect the latches. If one or more are bent up further than they should be, bend them down slightly and re-check for proper engagement. If there is still an issue, you may need to repeat this process until you have proper engagement. **Figure 3** SRT Code for the repair = 90-95.

If the window comes closed but does not fully engage, loosen one or more of the stationary latches (**Figure 3**) and re-position them so they are in line with the moving latch points on the cable. **Figure 2** Once this adjustment is made, the window should latch. SRT Code for this repair = 90-94.

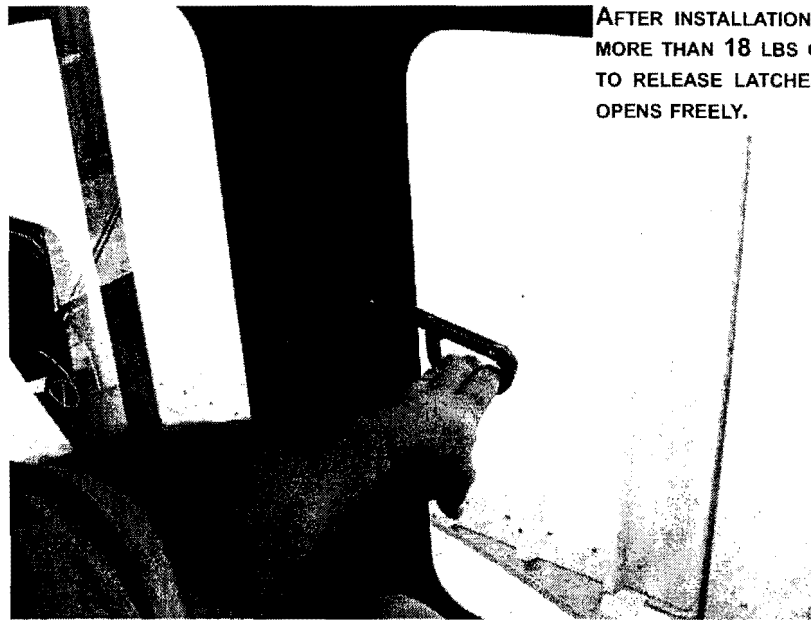
FIGURE 4

The release handle could be bent or broken. Upon inspection, if the handle is found to be damaged, replace with the appropriate handle. **Figure 4** SRT Code for the repair = 90-96.

AFTER INSTALLATION, MAKE SURE THAT NO MORE THAN 18 LBS OF FORCE IS REQUIRED TO RELEASE LATCHES AND THAT WINDOW OPENS FREELY.

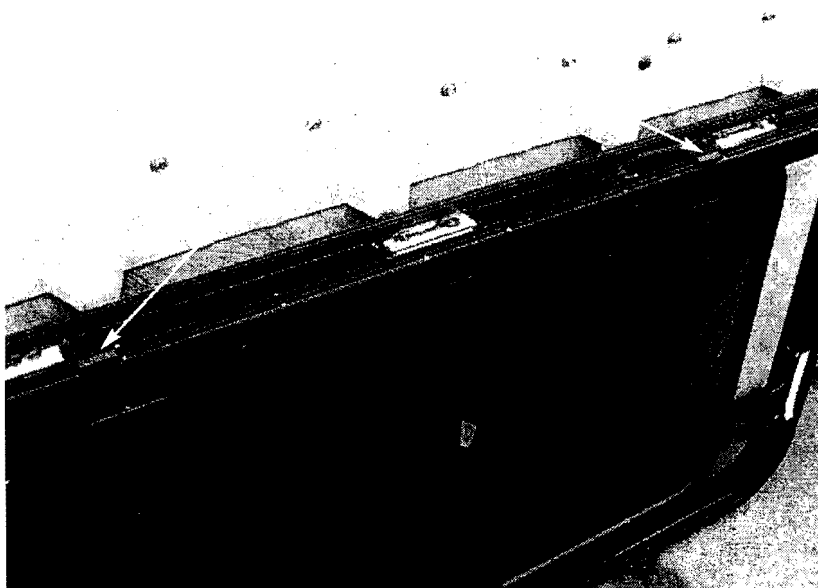
FIGURE 7

Spacers (2)

6. Confirm the spacers (#11) are installed at the bottom of the window. If none are found, Install the spacers positioned adjacent to the outer latch striker backing plates and toward the center of the window. **Figure 7**
