# SAFETY RECALL NOTICE

# SERVICE BULLETIN

Number: 09-002

## EC Series Electrical System Mandatory Product Improvement

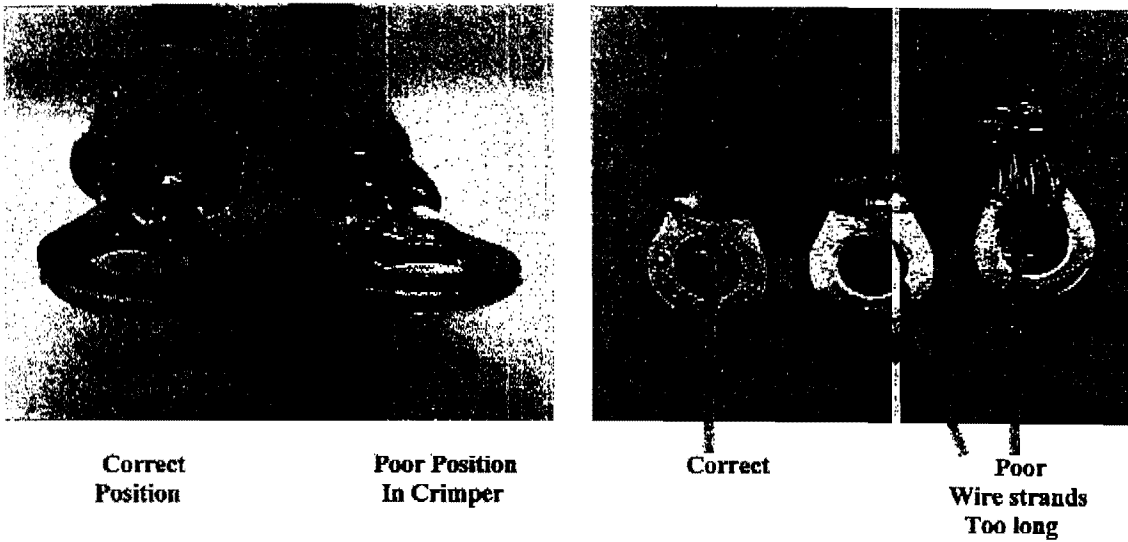
Fig 1

1. Crimps on the wires going to the terminal strip of the relay board should be uniform and tight. There should be no bare wire visible between the wire insulation and the terminal, and strands flush with terminal barrel. (Fig 1 & Fig 2)

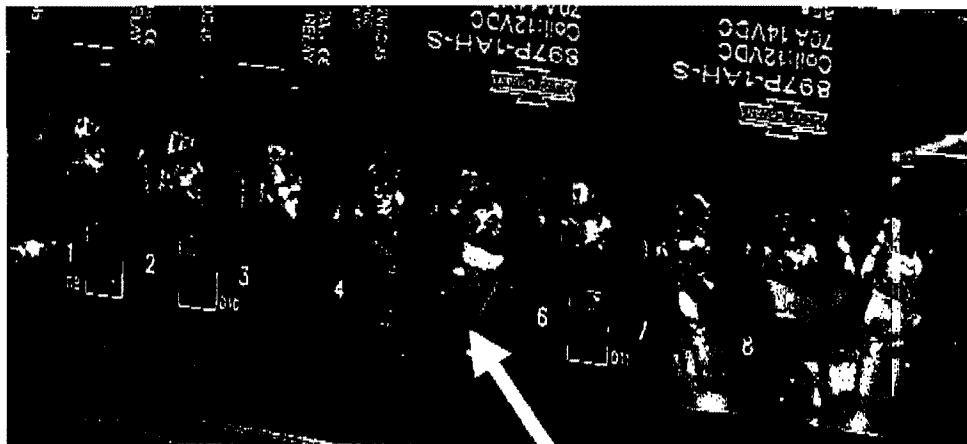
Fig 4

Heat discoloration of a poor (loose) crimp
