Reference: NHTSA Identification Number 09E-001

Revised May 2009

Safety Recall H46 - Mopar Steering Linkage

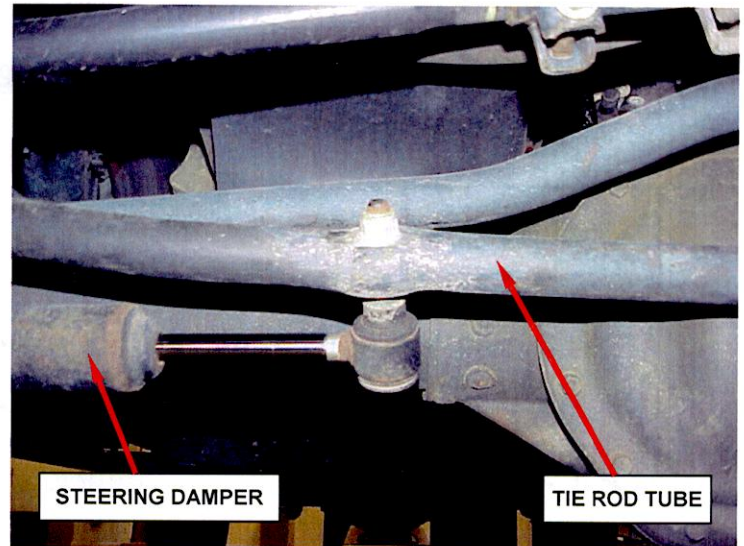
Figure 1 – Steering Linkage

- If the steering damper mounts to the tie rod tube as shown in Figure 1, the steering linkage is good. Return the vehicle to the customer. No further action is required.

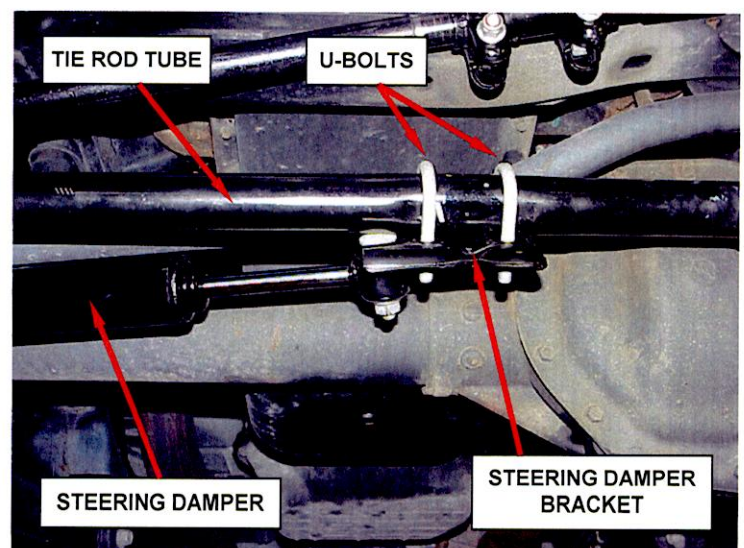
Figure 2 – Steering Linkage

- If the steering damper mounts to the tie rod tube as shown in Figure 2, the vehicle will require further inspection and/or repair by a technician. The vehicle should be assigned to a technician and the technician should continue with Step 2 of this procedure.

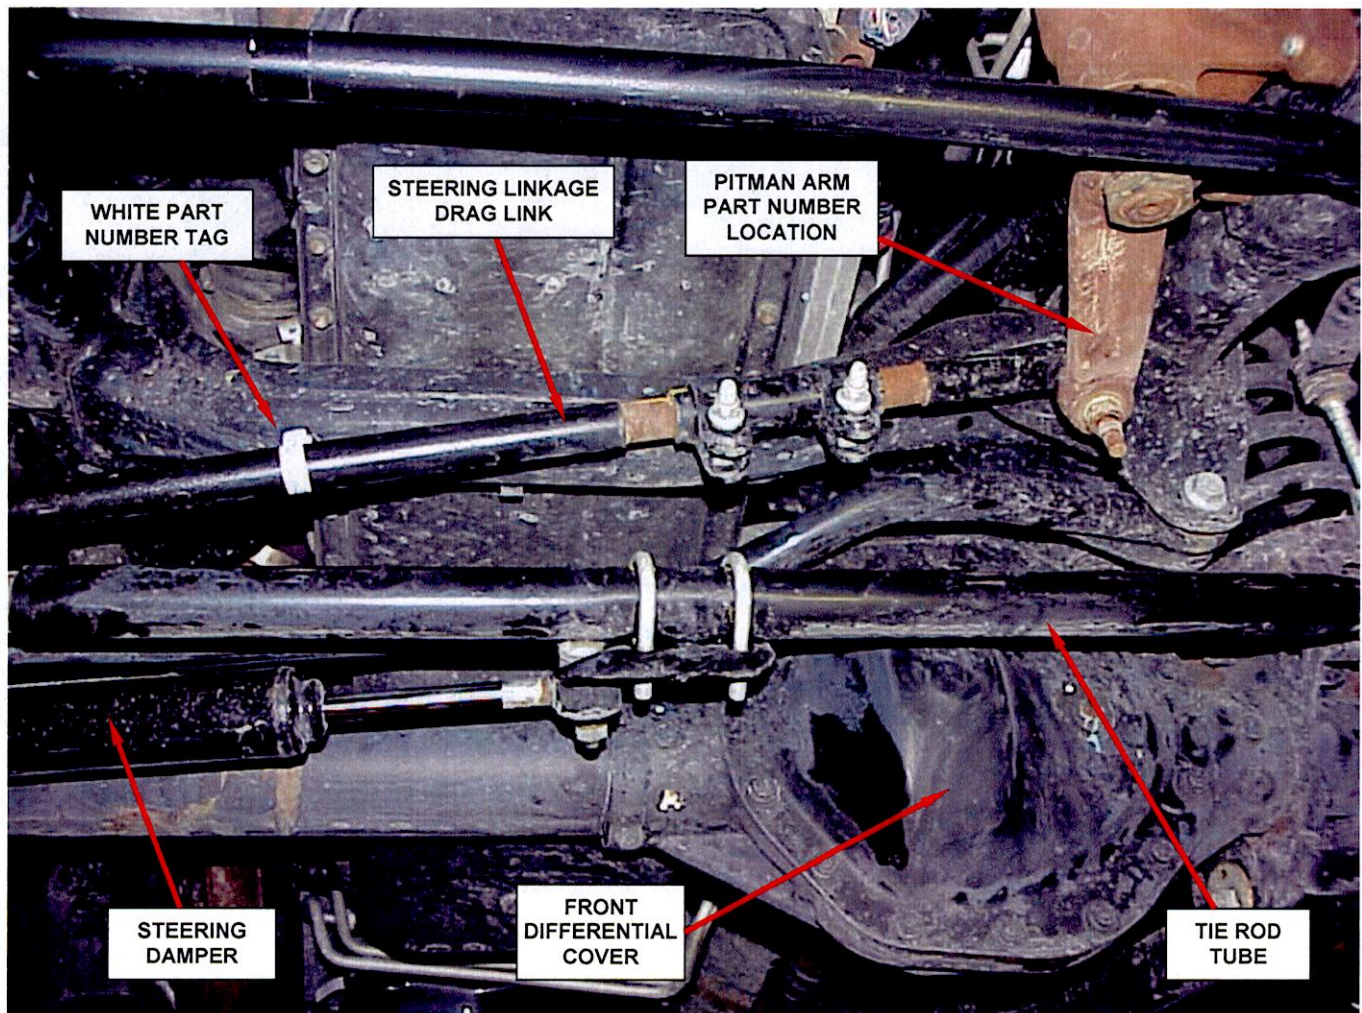
Figure 3 – Inspect for White Part Number Tag

2. Lift the vehicle on a hoist and inspect the steering linkage drag link for a white part number tag (Figure 3):
 - If the steering linkage drag link does not have a white part number tag, continue with Step 3 of this procedure.
 - If the steering linkage drag link has a white part number tag:
 - For 2009 model year trucks, continue with Step 9 of this procedure.
 - For 2003 through 2008 model year trucks, continue with Step 5 of this procedure.

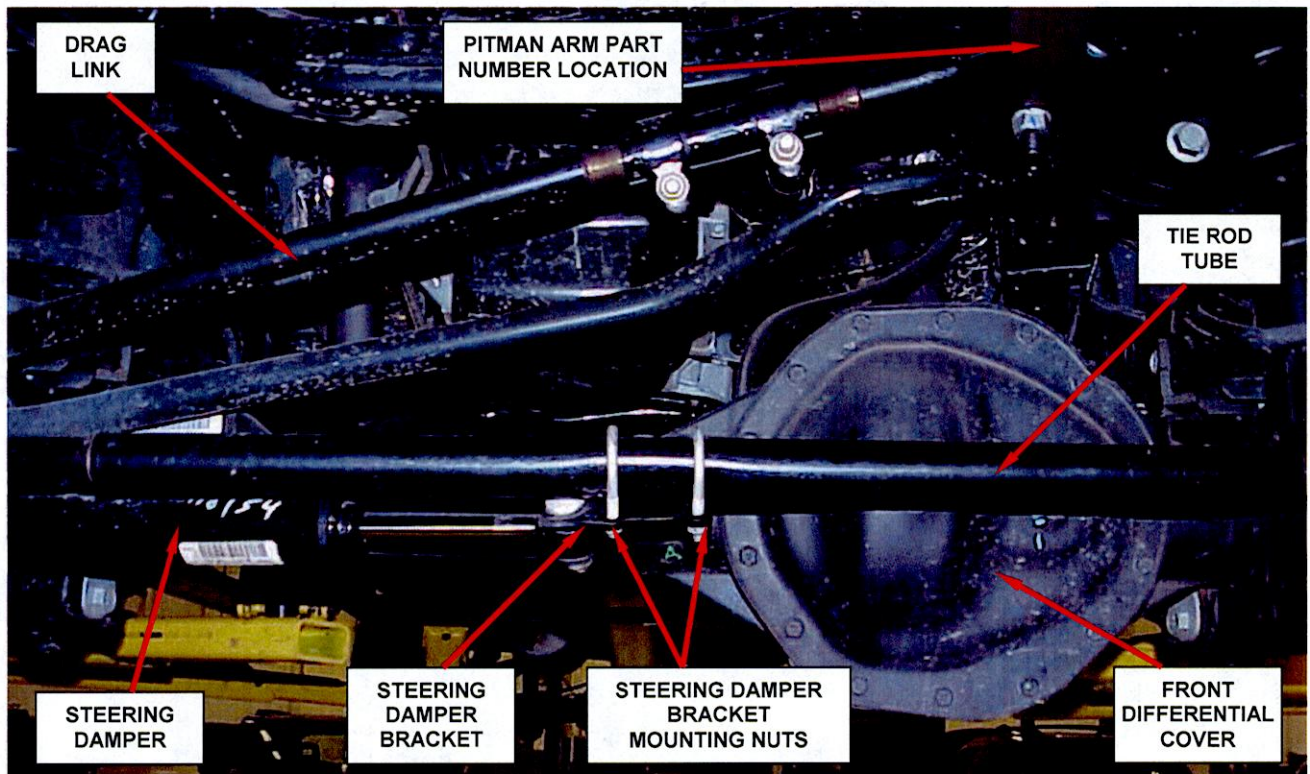
**Figure 4 – Damper Bracket Inspection**

3. Inspect the steering damper bracket to tie rod tube mounting u-bolt nuts by putting a 13 mm box-end wrench onto the nut (Figure 4):
 - If a **13 mm wrench fits** the steering damper bracket mounting u-bolt nuts, the bracket and fasteners **must be replaced**. Continue with Step 4 of this procedure.
 - If a **13 mm wrench does not fit** the steering damper bracket mounting u-bolt nuts, the bracket **does not require replacement**. Continue with Step 5 of this procedure.

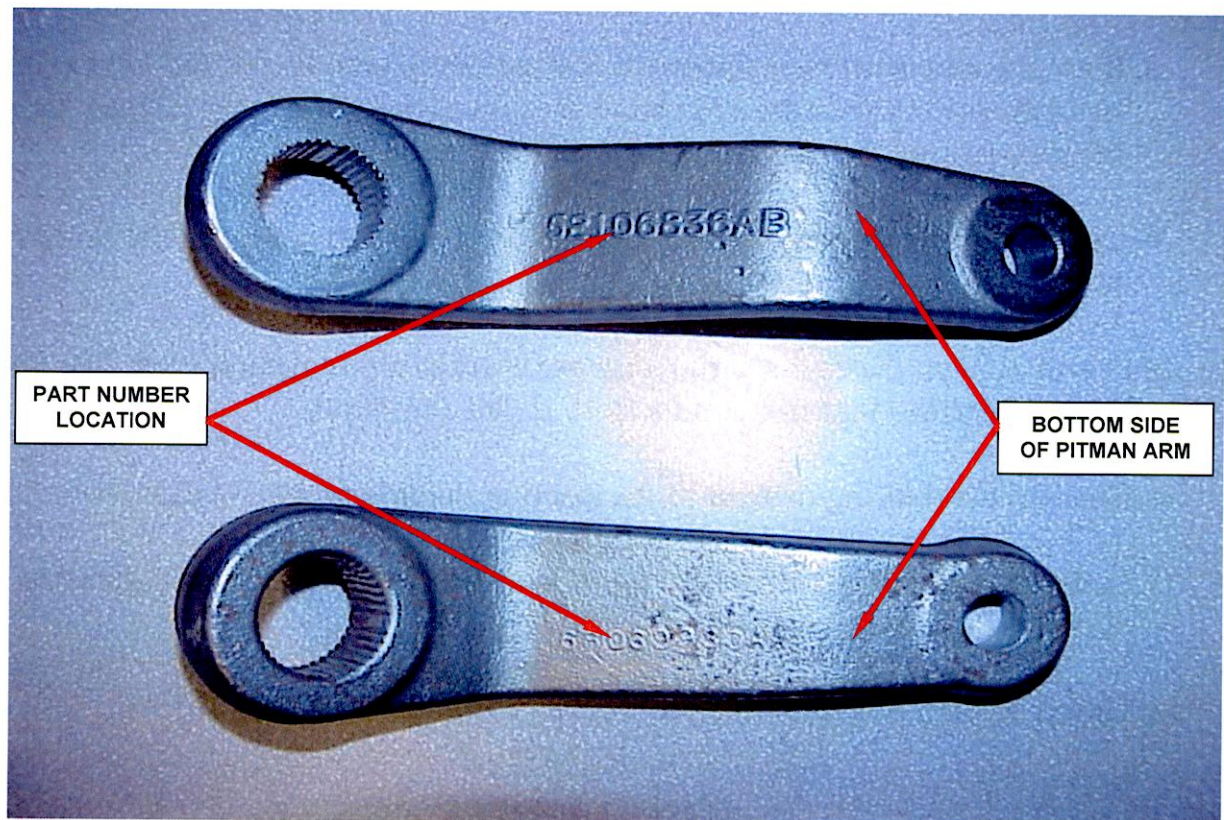
**Figure 6 – Pitman Arm Identification**

5. **For 2009 model year trucks**, continue with Step 6 of this procedure. **For 2003 through 2008 model year trucks**, inspect the pitman arm part number (Figure 6):
- If the part number cast into the bottom side of the pitman arm is 68039930AA the pitman arm does not require replacement.
 - Steering linkage **with** a white part number tag, continue with Step 9 of this procedure.
 - Linkage **without** a white part number tag, **replace the inner drag link joint**. Continue with Step 6 of this procedure.
 - If the part number cast into the bottom side of the pitman arm is 52106836AB, or is not legible:
 - Steering linkage **without** a white part number tag, **replace the inner drag link joint and pitman arm**. Continue with Step 7 of this procedure.
 - Steering linkage **with** a white part number tag, **replace the pitman arm**. Continue with Step 8 of this procedure.

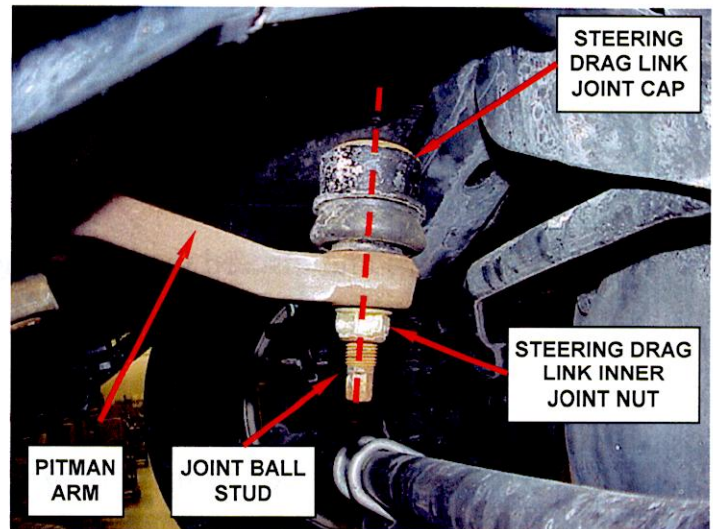
Figure 9 – Drag Link Joint Cap Alignment

CAUTION: Failure to center the drag link inner and outer joint caps over the joint ball studs before tightening the drag link adjuster sleeve clamps could cause joint failure.

- h. With the wheels in the straight ahead position, make sure that **both inner and outer steering drag link joint caps** are centered over the joint ball stud (Figure 9).

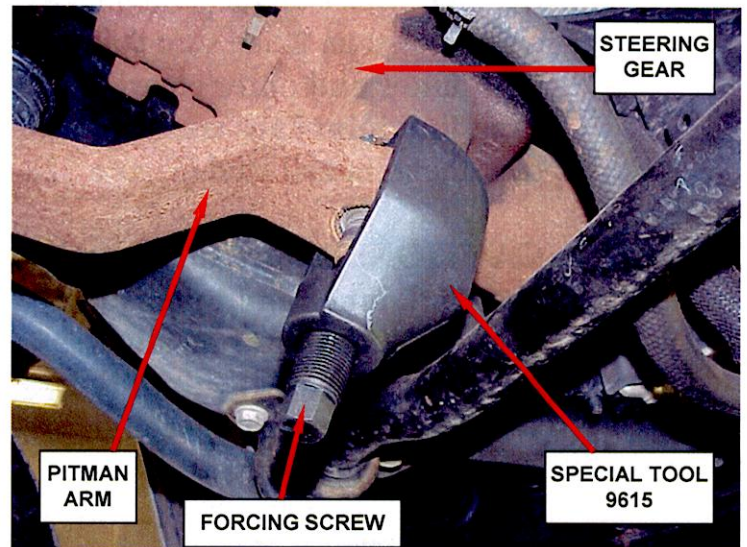
**Figure 11 - Special Tool 9615**

CAUTION: Failure to use the correct pitman arm puller could cause damage to the steering gear.

7. Replace the inner drag link joint and pitman arm using the following procedure:
 - a. Loosen both drag link adjuster sleeve clamp nuts (Figure 7).
 - b. Remove and save the pitman arm retaining nut located on the steering gear output shaft.
 - c. Install pitman arm puller (Special Tool 9615) onto the steering gear output shaft (Figure 11).

- d. Tighten the pitman arm puller forcing screw until the pitman arm separates from the steering gear output shaft (Figure 11).
- e. While counting the number of turns, unscrew the steering inner drag link joint (with pitman arm still attached) from the drag link adjuster sleeve (right handed threads) and discard the pitman arm and inner drag link joint.

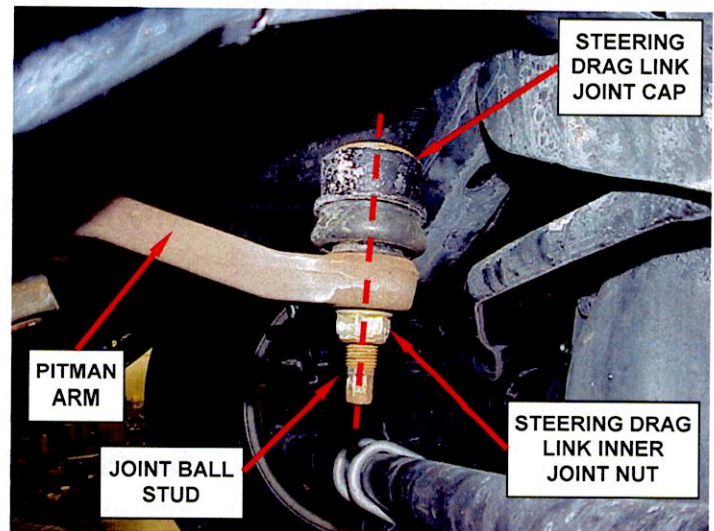
Figure 12 – Drag Link Joint Cap Alignment

CAUTION: Failure to center the drag link inner and outer joint caps over the joint ball studs before tightening the drag link adjuster sleeve clamps could cause joint failure.

- j. With the wheels in the straight ahead position, make sure that **both inner and outer steering drag link joint caps** are centered over the joint ball stud (Figure 12).

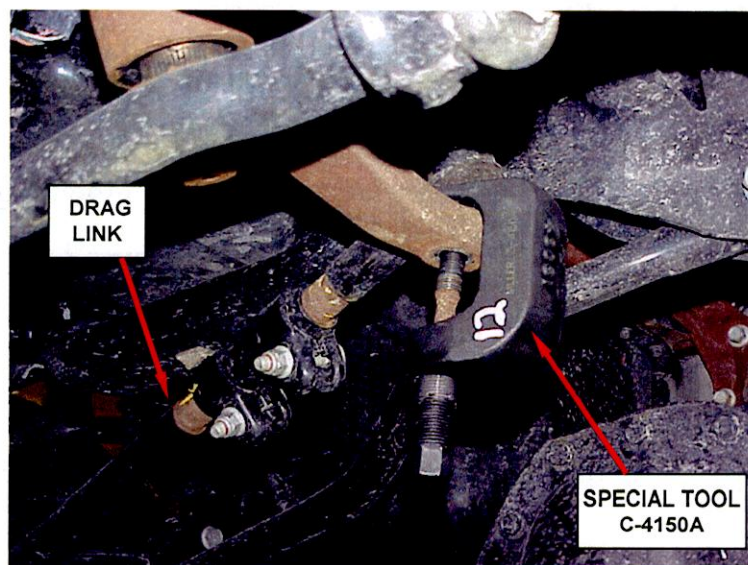
**Figure 14 – Special Tool C-4150A**

CAUTION: Use extreme care not to tear, nick or damage the inner drag link joint rubber boot.

- Use Special Tool C-4150A to separate the steering inner drag link joint from the pitman arm (Figure 14).

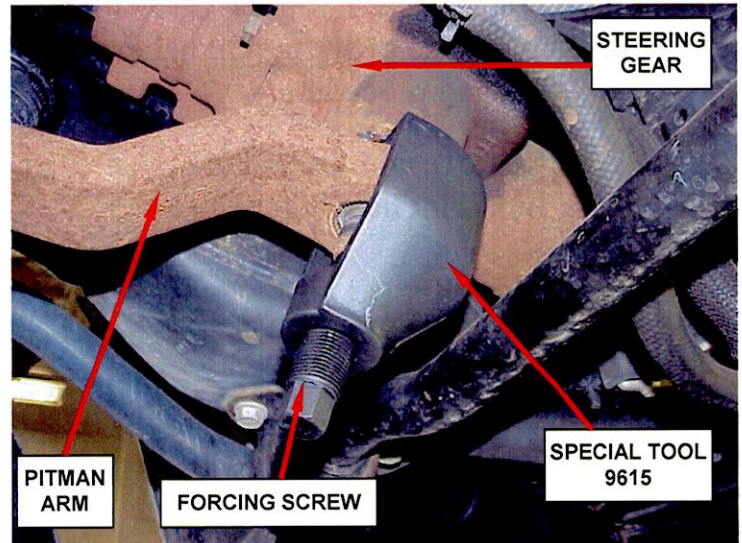
Figure 15 - Special Tool 9615

CAUTION: Failure to use the correct pitman arm puller could cause damage to the steering gear.

- d. Install pitman arm puller (Special Tool 9615) onto the steering gear output shaft (Figure 15).

- e. Tighten the pitman arm puller forcing screw until the pitman arm separates from the steering gear output shaft (Figure 15).

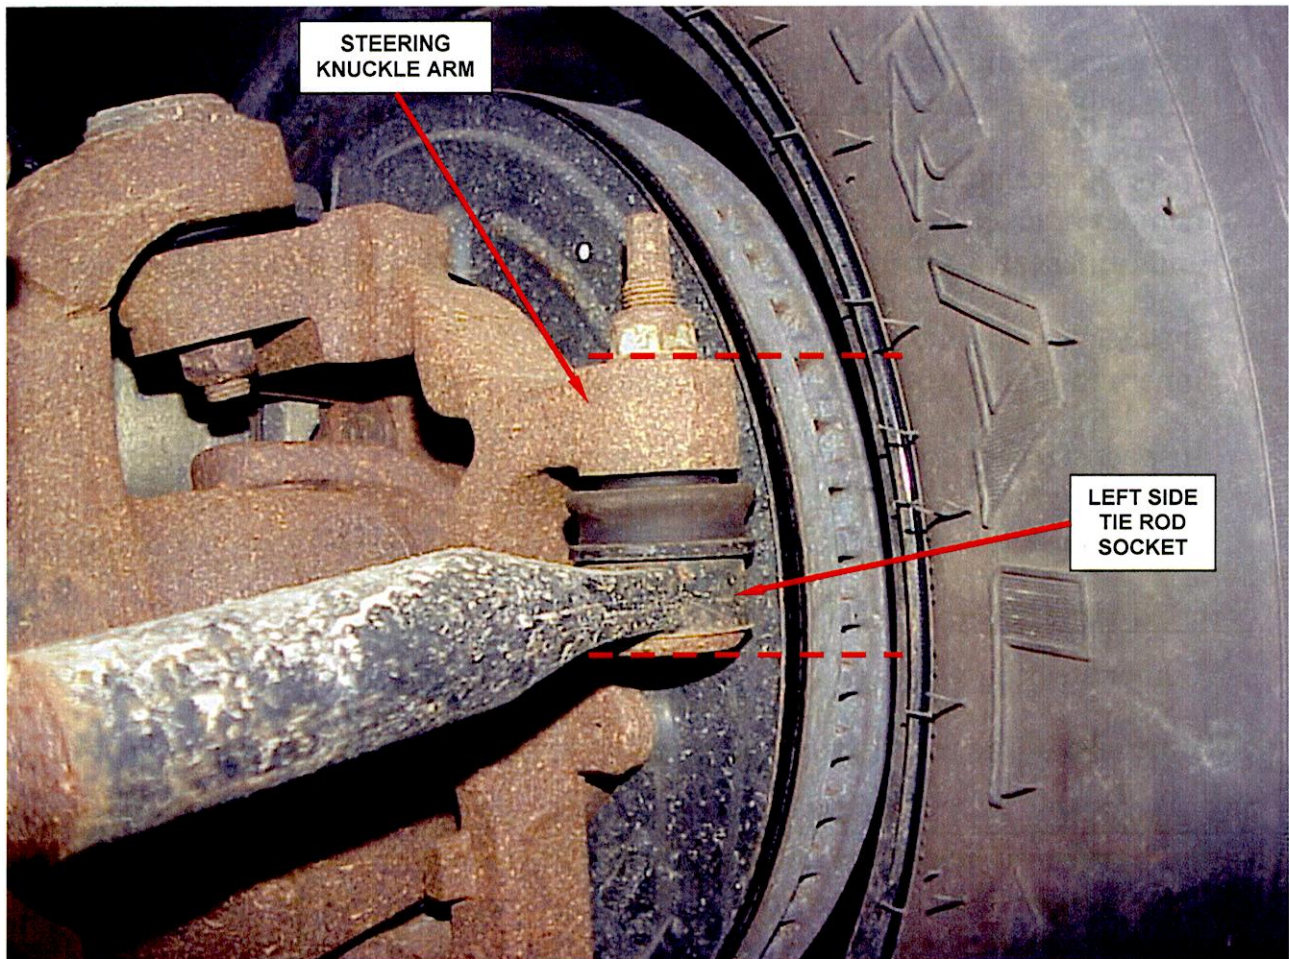
Figure 16 – Align Left Tie Rod Socket Parallel to Left Steering Knuckle

CAUTION: Failure to align the left tie rod end parallel to the steering knuckle could cause tie rod end damage.

9. Verify the lower surface of the left outer tie rod socket is parallel to the upper surface of the left knuckle attaching arm using the following procedure:
 - a. Loosen the tie rod tube adjuster sleeve clamps.
 - b. Rotate the left tie rod until the bottom of the tie rod socket is parallel to the top of the left steering knuckle arm (Figure 16).
 - c. Tighten the tie rod adjuster sleeve clamp nuts to 45 ft. lbs. (61 N·m).
