Reference: NHTSA Identification Number 09E-001

April 2009

Dealer Service Instructions for:

## **Safety Recall H46 - Mopar Steering Linkage**

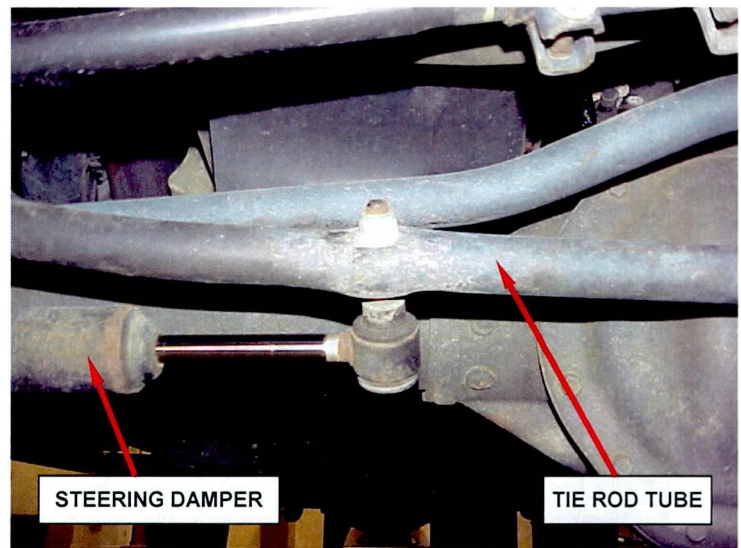
**Figure 1 – Original Style Steering Linkage**

1. Look under the front of the vehicle and inspect the steering linkage at the steering damper mounting point:
  - If the steering damper mounts to the tie rod tube as shown in Figure 1, the steering linkage is original style steering linkage. Return the vehicle to the customer. No further action is required

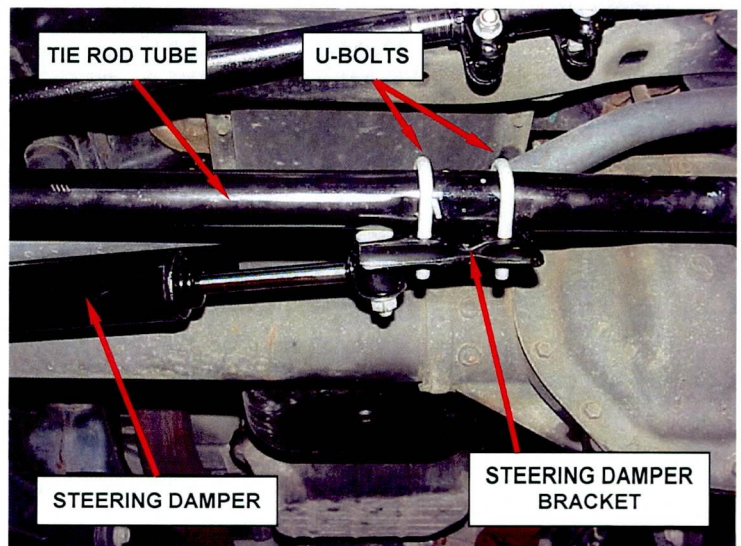
**Figure 2 – Replacement Style Steering Linkage**

- If the steering damper mounts to the tie rod tube as shown in Figure 2, the vehicle will require further inspection and/or repair by a technician. The vehicle should be assigned to a technician and the technician should continue with Step 2 of this procedure.

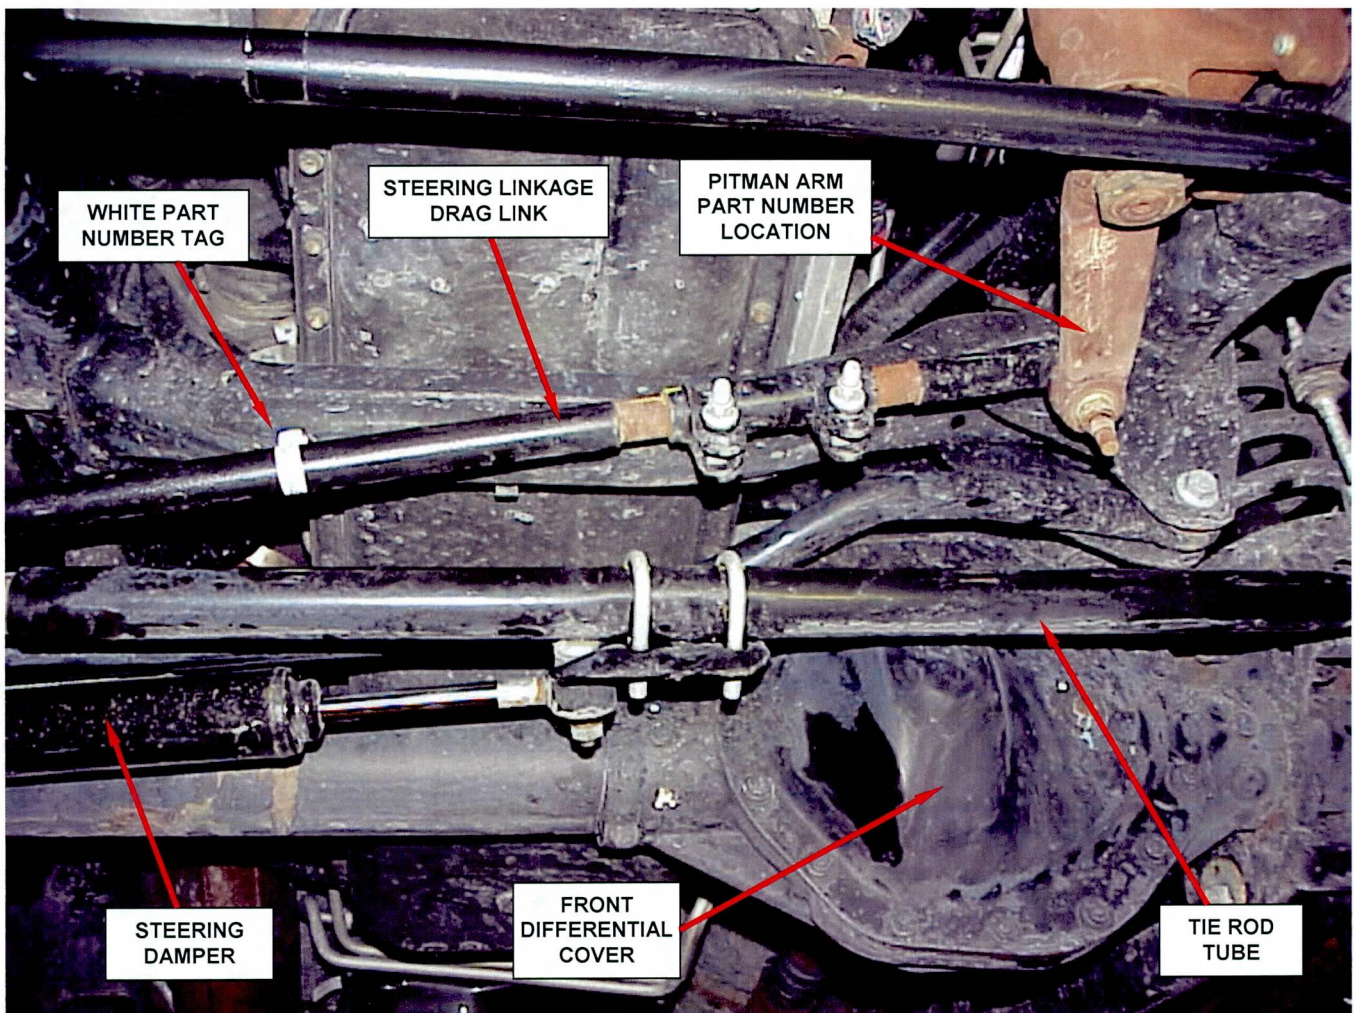
Figure 3 – Inspect for White Part Number Tag

2. Lift the vehicle on a hoist and inspect the steering linkage drag link for a white part number tag (Figure 3):
  - If the steering linkage drag link **does not have** a white part number tag, continue with Step 3 of this procedure.
  - If the steering linkage drag link **has** a white part number tag, continue with Step 6 of this procedure.

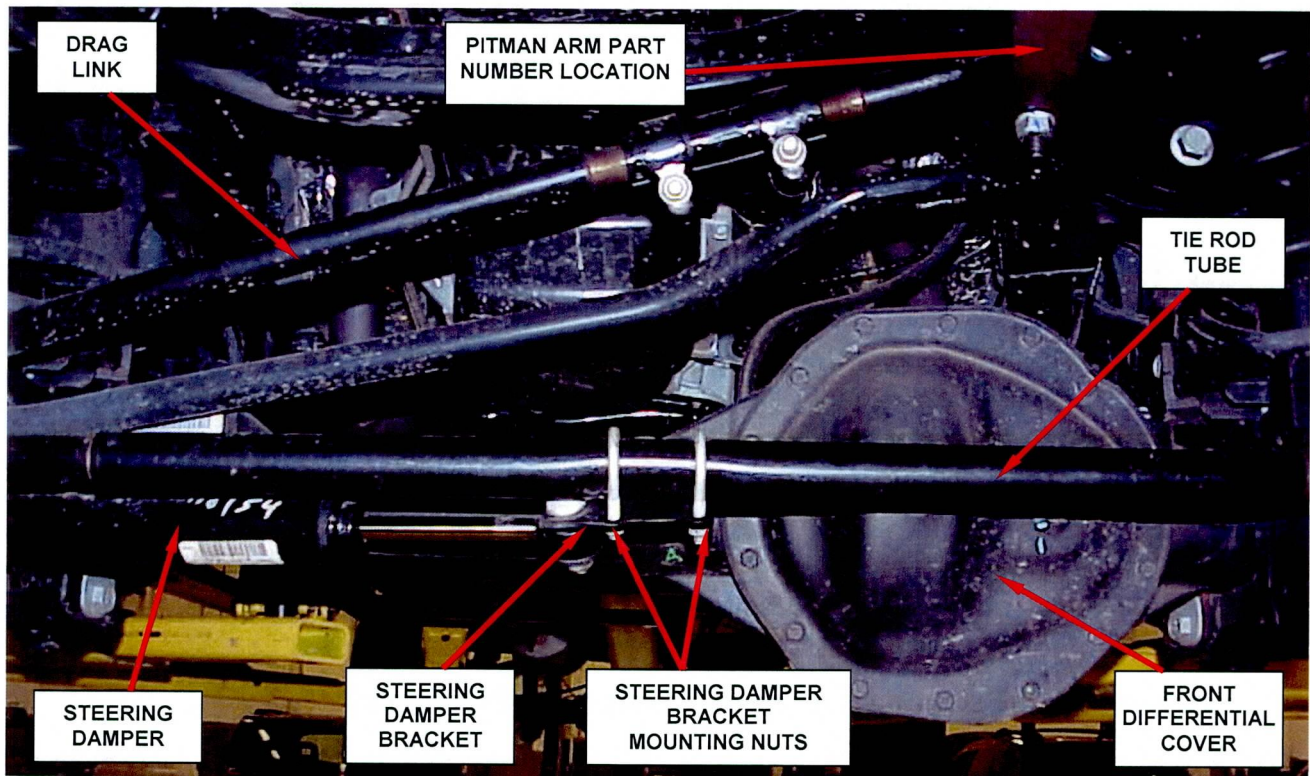
**Figure 4 – Damper Bracket Inspection**

Also, the steering damper bracket at the tie rod tube may loosen. This could allow the bracket to slide on the tube and may cause increased vehicle turning radius.

3. Inspect the steering damper bracket to tie rod tube mounting u-bolt nuts by putting a 13 mm box-end wrench onto the nut (Figure 4):
  - If a **13 mm wrench fits** the steering damper bracket mounting u-bolt nuts, the bracket and fasteners **must be replaced**. Continue with Step 4 of this procedure.
  - If a **13 mm wrench does not fit** the steering damper bracket mounting u-bolt nuts, the bracket **does not require replacement**. Continue with Step 5 of this procedure.

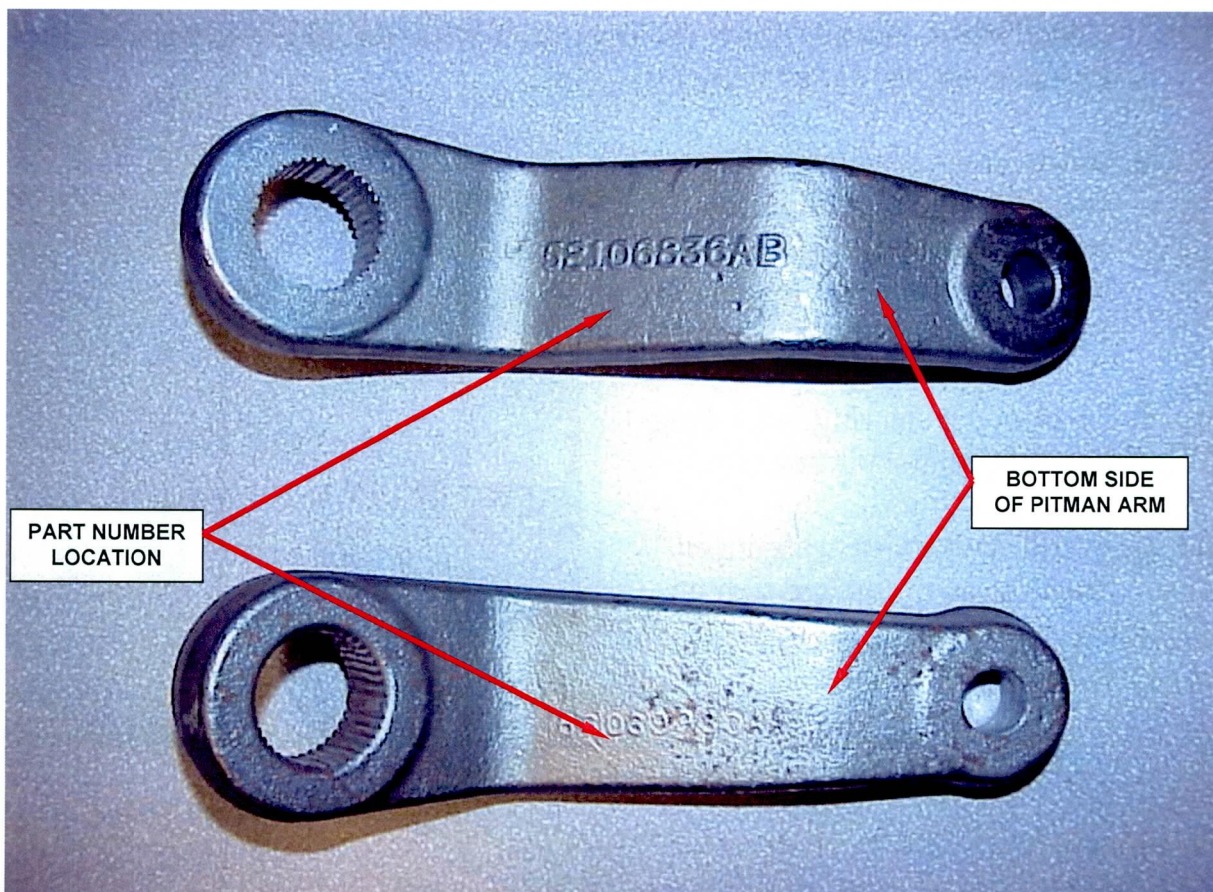
**Figure 6 – Pitman Arm Identification**

5. Inspect the pitman arm part number (Figure 6):
- If the part number cast into the bottom side of the pitman arm is 68039930AA the pitman arm is good.
    - Steering linkage **with** a white part number tag require no further action. Return the vehicle to the customer.
    - Linkage **without** a white part number tag, **replace the inner drag link joint**. Continue with Step 6 of this procedure.
  - If the part number cast into the bottom side of the pitman arm is 52106836AB, or is not legible:
    - Steering linkage **without** a white part number tag, **replace the inner drag link joint and pitman arm**. Continue with Step 7 of this procedure.
    - Steering linkage **with** a white part number tag, **replace the pitman arm**. Continue with Step 8 of this procedure.

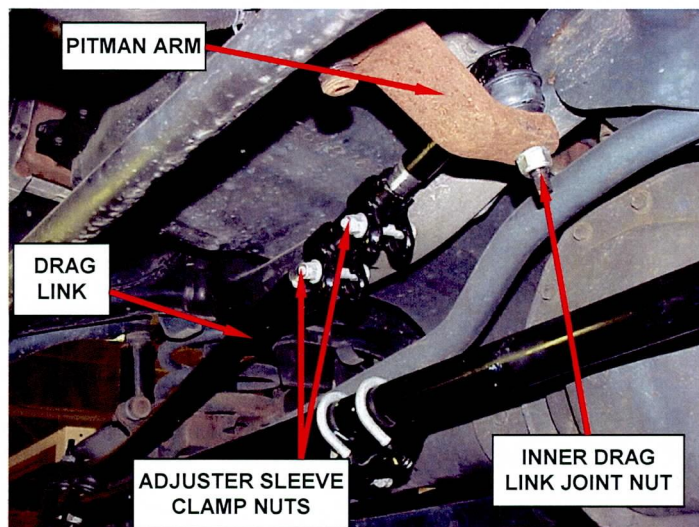
**Figure 7 - Inner Drag Link Joint Nut**

During a prior service appointment, a Mopar service parts steering linkage was installed on about 19,400 of the above vehicles. The drag link inner joint may fracture under certain driving conditions. This could result in a loss of steering control and cause a crash without warning.

6. Replace the inner drag link joint using the following procedure:
  - a. Loosen both drag link adjuster sleeve clamp nuts (Figure 7).
  - b. Remove and discard the inner drag link joint to pitman arm nut (Figure 7).
  - c. Use Special Tool C-4150A to separate the steering inner drag link joint from the pitman arm (Figure 8).

- e. Screw in the new inner drag link joint into the drag link adjuster sleeve the same number of turns counted in step 6d. of this procedure.
  - f. Connect the steering inner drag link joint to the pitman arm.
  - g. Install the new steering inner drag link joint nut and tighten the nut to 100 ft. lbs. (135 N·m).

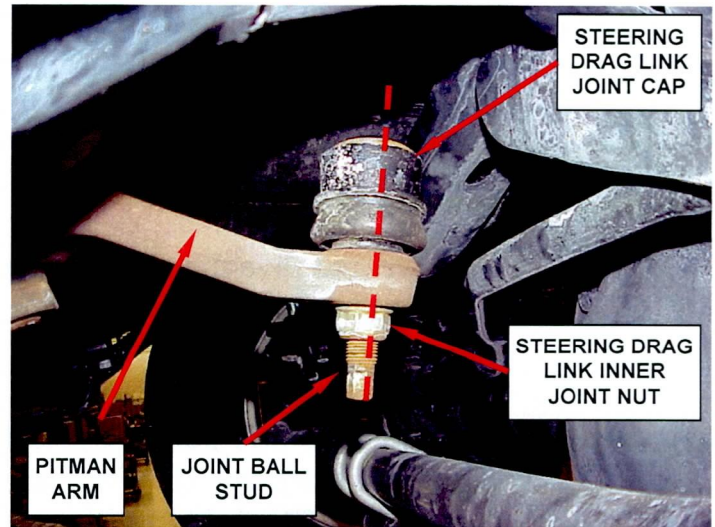
**Figure 9 – Drag Link Joint Cap Alignment**

**CAUTION:** Failure to center the drag link inner and outer joint caps over the joint ball studs before tightening the drag link adjuster sleeve clamps could cause joint failure.

- h. With the wheels in the straight ahead position, make sure that both inner and outer steering drag link joint caps are centered over the joint ball stud (Figure 9).

- i. Tighten both drag link adjuster sleeve clamp nuts to 45 ft. lbs. (61 N·m).

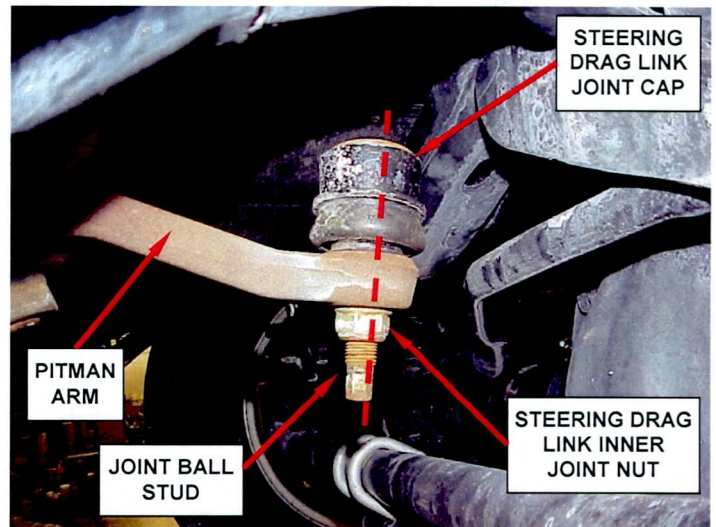
**Figure 11 – Drag Link Joint Cap Alignment**

**CAUTION:** Failure to center the drag link inner and outer joint caps over the joint ball studs before tightening the drag link adjuster sleeve clamps could cause joint failure.

- j. With the wheels in the straight ahead position, make sure that both inner and outer steering drag link joint caps are centered over the joint ball stud (Figure 11).

- k. Tighten the drag link adjuster sleeve clamp nuts to 45 ft. lbs. (61 N·m).
