Subject: Special Service Campaign (SSC) – 90B
Early 2004 Sienna Driver's Side Center Console Trim Panel (Floor Carpet Cover)

**Early 2004 Sienna - Floor Carpet Cover and Retaining Clip
Safety Recall Campaign 90B**

Special Service Campaign 90B - Q&A

DRIVER'S SIDE CENTER CONSOLE TRIM PANEL
(FLOOR CARPET COVER)

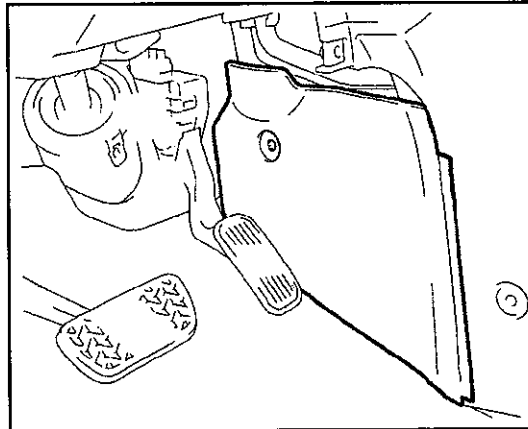
Toyota has received reports that the Retaining Clip for the Driver's-side Center Console Trim Panel (Floor Carpet Cover) was missing in a handful of vehicles. If this Retaining Clip is missing, the Floor Carpet Cover may become loose. If this condition is not repaired and the accelerator pedal is depressed to nearly full throttle, a loose floor carpet cover may interfere with the accelerator pedal.

Toyota will initiate a Special Service Campaign to replace the Driver Side Center Console Trim Panel (Floor Carpet Cover) and retaining clip on certain early 2004 model year Sienna vehicles.

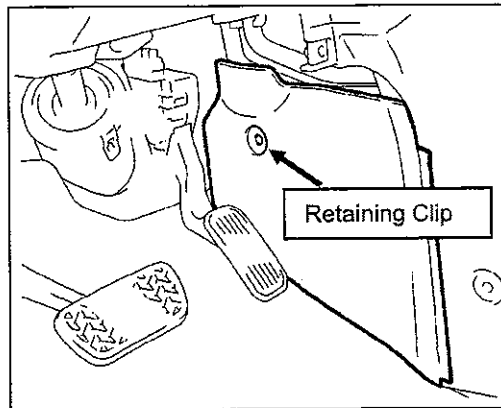
Until this repair is completed on your vehicle, you may verify the Retaining Clip is installed on your vehicle by inspecting for it as indicated below. If the clip is missing, please call your local Toyota dealership.

Any Toyota dealer will replace the Retaining Clip and Floor Carpet Cover with a newly designed one at **NO CHARGE** to you.

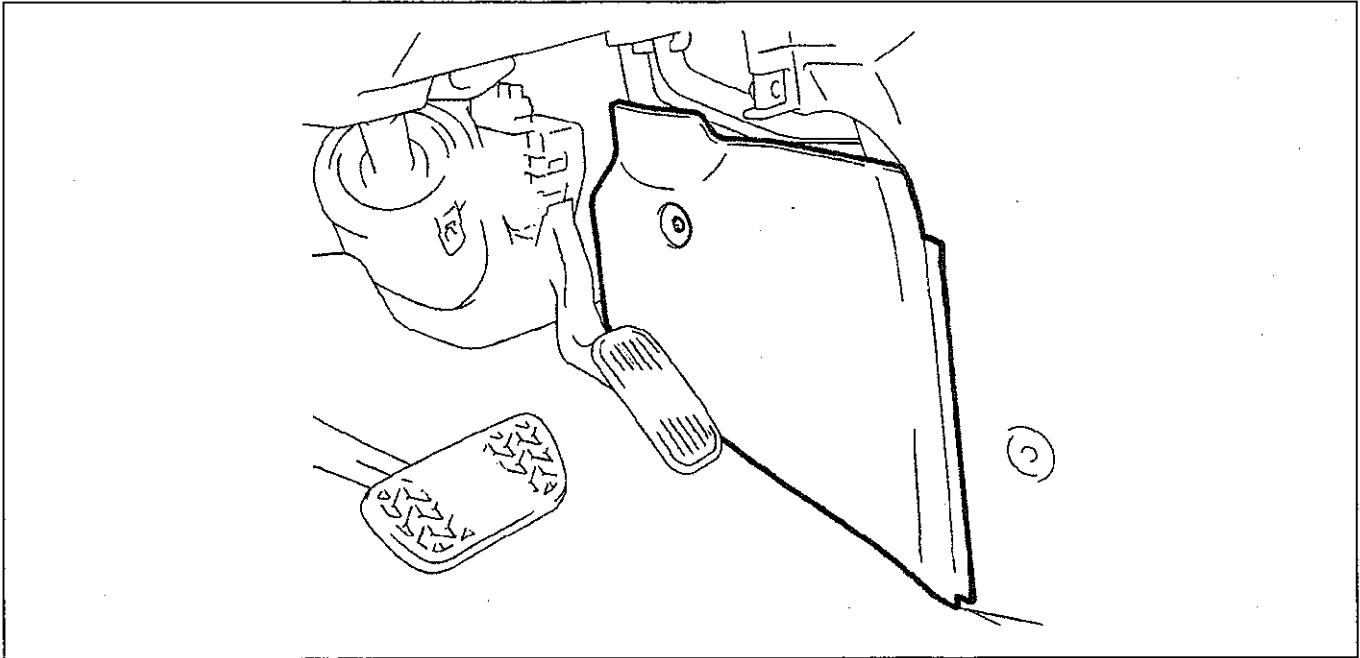
Driver's Side Center Console Trim Panel (Floor Carpet Cover)

Toyota has received reports that the Retaining Clip for the Driver's side Center Console Trim Panel (Floor Carpet Cover) was missing in a handful of vehicles. If this Retaining Clip is missing, the Floor Carpet Cover may become loose. If this condition is not repaired and the accelerator pedal is depressed to nearly full throttle, a loose floor carpet cover may interfere with the accelerator pedal.
