Campaign Service BULLETIN

BULLETIN NUMBER:
CB09-F-001

GROUP:
DRIVELINE/AXLE

PROPELLER SHAFT SAFETY RECALL CAMPAIGN NO. 09V-042

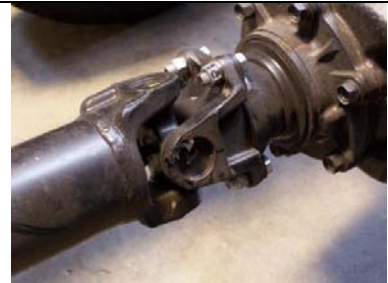
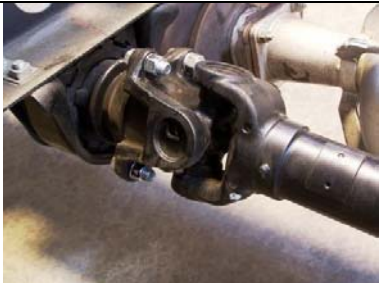
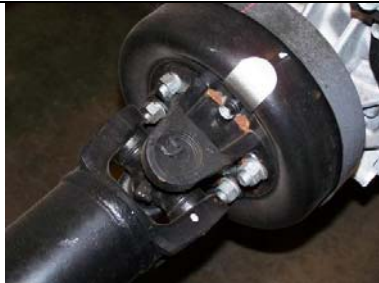
Pinion Flange Yoke	Center Bearing Yoke	Transmission Yoke <i>(109" Wheel base)</i>
(109 in WB)

(132.5 in, 150 and 176 in WB)

1. Front Mount (Transmission Yoke) 2. Prop Shaft 3. Rear Mount (Pinion Flange Yoke)	1. Front Mount (Center Bearing Yoke) 2. Prop Shaft 3. Rear mount (Pinion Flange Yoke)

1. Remove the rear propeller shaft mounting hardware, (4) nuts, (4) washers and (4) bolts, at pinion flange yoke.
2. Remove the front propeller shaft mounting hardware, (4) nuts, (4) washers and (4) bolts, at center bearing yoke. (For 109" wheel base remove the front propeller shaft mounting hardware, (4) nuts and (4) washers, at the transmission yoke – transmission yoke studs do not need to be removed.)

3. Remove the propeller shaft assembly.
4. Discard (scrap) the removed propeller shaft assembly and mounting hardware.

5. Install the new propeller shaft assembly.
6. Install the front propeller shaft new mounting hardware, (4) nuts, (4) washers and (4) bolts, at the center bearing yoke. (For 109" wheel base, install new (4) nuts and (4) washers at the transmission yoke.)
7. Install the rear propeller shaft new mounting hardware (4) nuts, (4) washers and (4) bolts at pinion flange.
8. Tighten the nuts at the pinion flange yoke and center bearing yoke (for 109" wheel base at the pinion flange yoke and transmission yoke) to 103 N-m (76 lb ft)
