Attached you will find documents related to campaign 5209A – 2009 Mazda6 Outer Door Handle Voluntary Safety Recall.

SUBJECT: 2009 MAZDA6 Outer Door Handle Voluntary Safety Recall 5209A

2009 MAZDA6 - Outer Handle Recall Campaign [5209A]**A. VEHICLE INSPECTION PROCEDURE**

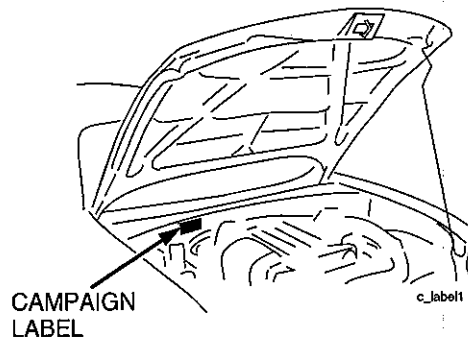
1. Verify that the vehicle is within the following range:
 - 2009 Mazda6 vehicles built from April 8, 2008 through November 7, 2008
 - VIN Range: 1YVHP8***95 M00057 - M36656
 - If the vehicle is within the above ranges, proceed to Step 2.
 - If the vehicle is not within the above ranges, return the vehicle to the customer or inventory.
2. Perform a Warranty Vehicle Inquiry using your eMDCS System and inspect vehicle for a Campaign Label **RECALL 5209A** attached to the vehicle's bulkhead. Refer to eMDCS System - Warranty Vehicle Inquiry Results table below.

1. Fill out a blue "Campaign Label" (9999-95-065A-05) with Campaign No: "5209A", your dealer code, today's date, and affix it to the vehicle's bulkhead as shown in "A. VEHICLE INSPECTION PROCEDURE".

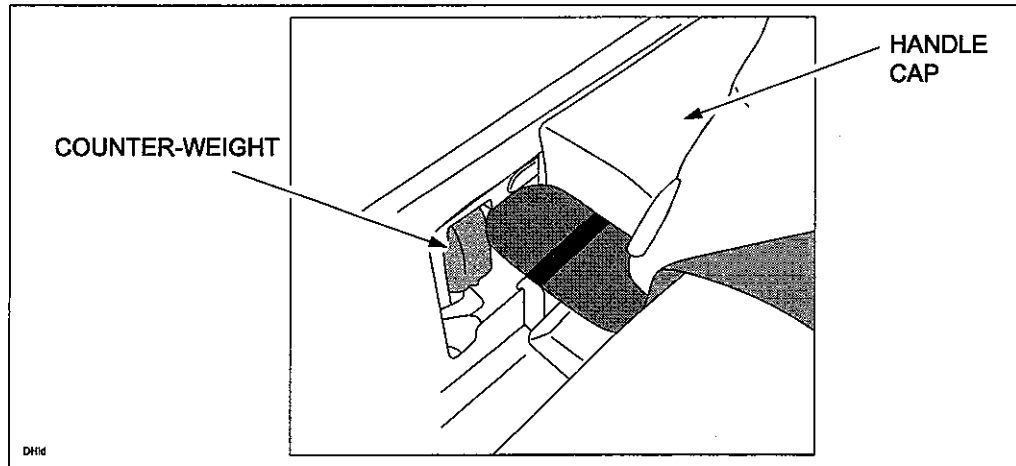
5. Position thickness gauge (0.05mm) at lever sliding area as indicated below.

NOTE: Tip of gauge touches counter weight (metal part - gray) and side is parallel to handle cap.

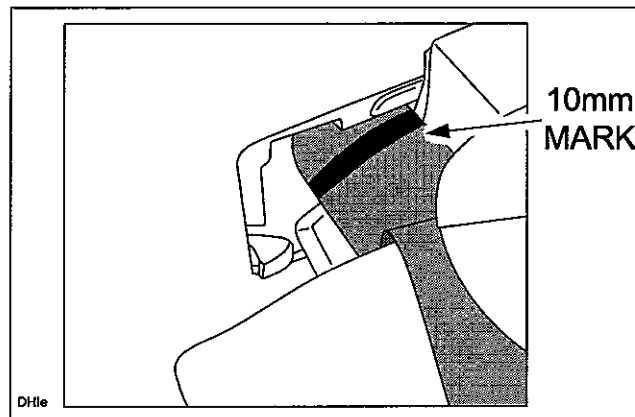
6. Slowly return driver's outer handle to 10mm mark.

7. Check if thickness gauge can be moved freely.
 - If gauge is stuck and force is required to remove it, outer handle is "Suspect", document outer handle type (Standard Keyless Entry or Advanced Keyless Entry) on Repair Order. Proceed to Step 8.

- If gauge is not stuck, outer handle is "Good". Proceed to Step 8.
8. Remove thickness gauge and slowly return outer handle.
9. Pull outer handle to full open position again and return with fingers firmly on outer handle. Ensure there is no sticking feeling.

- **If driver's outer handle does stick,** remove outer handle according to Workshop Manual (section 09-14 FRONT OUTER HANDLE REMOVAL/INSTALLATION). After driver's outer handle removal, proceed to "C. OUTER HANDLE REMOVAL" to remove the other three (3) outer handles.

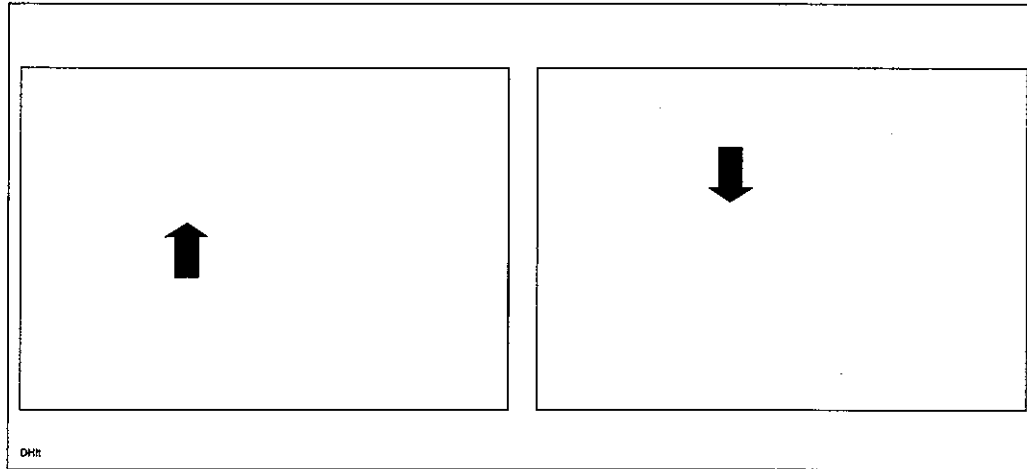
2. Slide the SST across the narrow area of the outer handle.
3. Slide the SST end-to-end (full stroke) over the entire surface of the outer handle.
 - If the outer handle does not fit into the SST, it fails the inspection.
 - If it takes excessive effort to slide the outer handle through the SST (SST should move freely with some resistance), it fails the inspection.

- If outer handle fails inspection, document outer handle type (Standard Keyless Entry or Advanced Keyless Entry) and location (LF, RF, LR, RR) on Repair Order. Proceed to "E. REPAIR PROCEDURE".
- If outer handle passes inspection, proceed to "**Handle Bracket Inspection**" to check handle bracket with male end of SST.

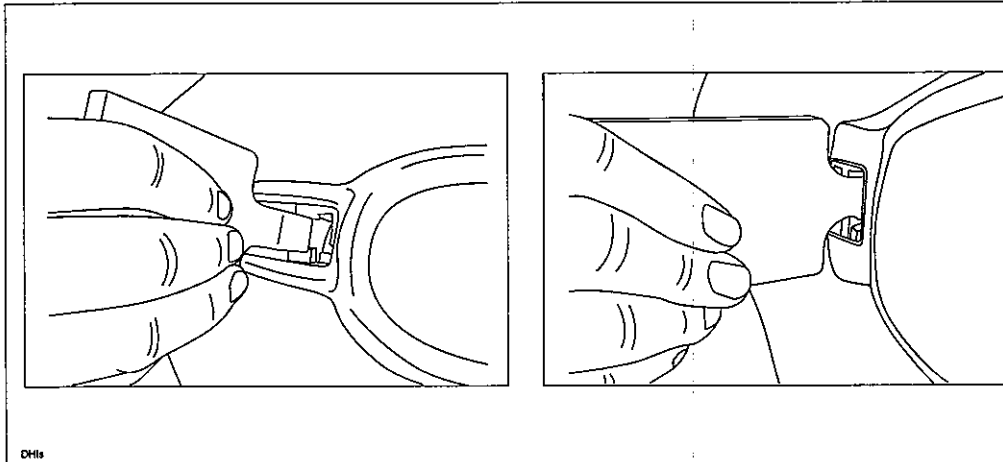
4. Using **SST SSTE-RC-001**, check the handle bracket mating surface. Insert the male end of the SST into handle bracket at the position shown below.
- If the SST does not fit into the handle bracket, it fails the inspection.
 - If the SST does not slide fully into the handle bracket (minimal resistance is okay), it fails the inspection.

- If handle bracket fails inspection, document outer handle type (Standard Keyless Entry or Advanced Keyless Entry) and location (LF, RF, LR, RR) on Repair Order. Proceed to "E. REPAIR PROCEDURE".
- If handle bracket passes inspection, reinstall original outer handle. Proceed to "F. CAMPAIGN LABEL INSTALLATION".
