# Recall Bulletin

## F/CMVSS NONCOMPLIANCE RECALL

**SUBJECT:** Shift Lever Indicator May Not Display Correct Gear

**MODELS:** 2009 Chevrolet Malibu  
 2009 Pontiac G6  
 2009 Saturn AURA  
 Equipped with 4-Speed Transmission (RPO ME7/MN5)

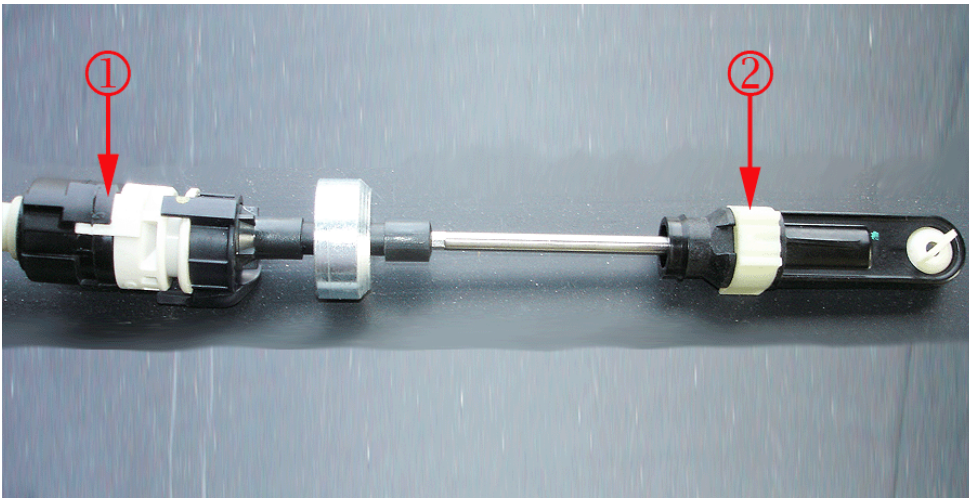
- (1) Shift Cable Locking Tabs
- (2) Shift Cable Adjuster Locking Clip

1. Open the hood and locate the transmission shift cable.
2. Determine if the transmission shift cable locking tabs are fractured and separated.

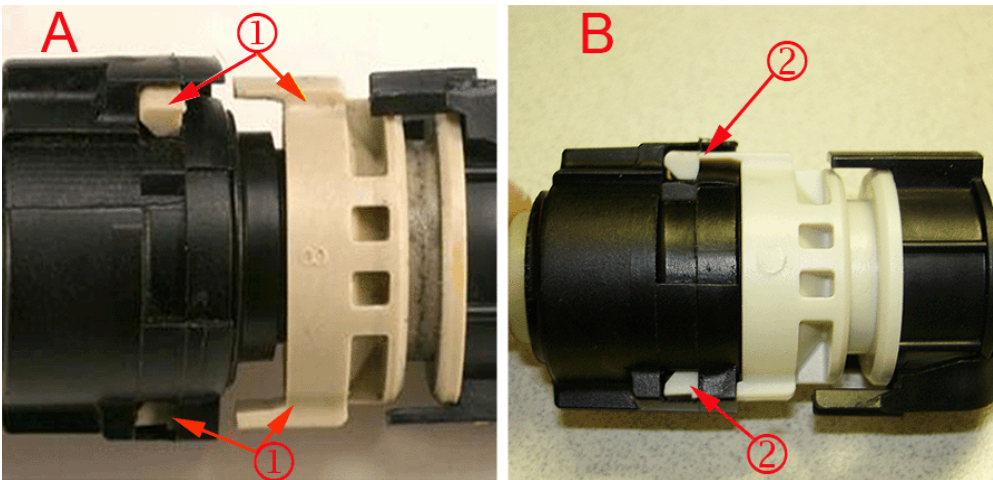
- If the transmission shift cable locking tabs (1) are fractured and separated (A), remove the transmission shift cable and replace it with a new one. Refer to *Floor Shift Control Cable Replacement* or *Range Selector Lever Cable Replacement* in SI. No further action is required after replacing the transmission shift cable. DO NOT install a transmission shift cable kit.
- If the transmission shift cable locking tabs (2) are NOT fractured and separated (B), install the transmission shift cable kit. Proceed to Step 3.

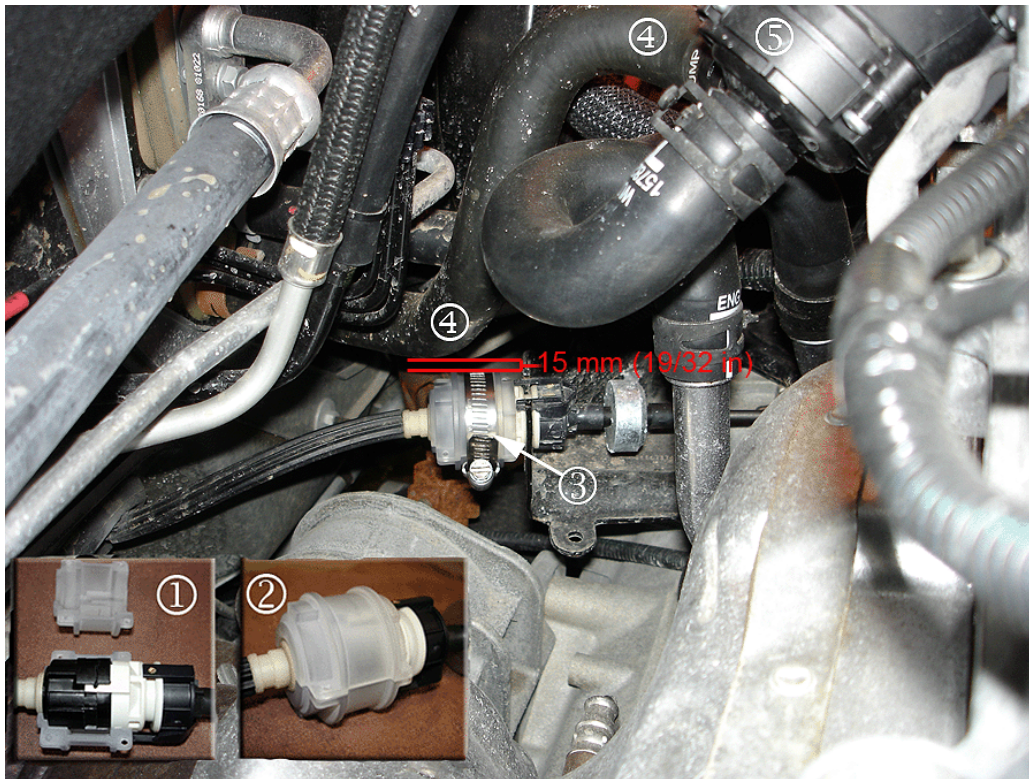
Hybrid vehicle shown. Combustion engine vehicle is similar.

- (1) Clam Shell in Two Pieces
- (2) Clam Shell Around Shift Cable Locking Tabs
- (3) Clamp on Clam Shell
- (4) Inlet Coolant Hose and
- (5) Heater Cooler Pump.

3. Install the clam shell (1) (2) over the shifter cable locking tabs.
4. Install the service clamp over the clam shell (3). Position the clamp fastener head away from the inlet coolant hose (4). **Tighten the clamp to 4 Nm (35 lb-in).**
5. Ensure that there is 15 mm (19/32 in) of clearance between the inlet coolant hose (4) and the clam shell (3). On hybrid equipped vehicles, it may be necessary to reposition the inlet coolant hose (4) to achieve the required 15 mm (19/32 in) of clearance. **To reposition the inlet coolant hose (4) on hybrid equipped vehicles, locate the heater cooler pump (5) and perform Steps 5.1-5.4.**

**Caution:** Do not kink or damage the inlet coolant hose (4) when repositioning the hose to obtain the 15 mm (19/32 in) clearance. To avoid damaging the hose clamp, use J-38185 or equivalent hose clamp pliers to loosen the hose clamp.

- 5.1. Using J-38185 or equivalent hose clamp pliers, loosen the inlet coolant hose (4) connected to the heater cooler pump (5). Note the location of the clamp on the inlet coolant hose (4).
- 5.2. Rotate the inlet coolant hose (4) clockwise until 15 mm (19/32 in) of clearance between the inlet coolant hose (4) and clam shell (3) is achieved.
- 5.3. Ensure that the inlet coolant hose clamp is secure on the inlet coolant hose (4) in the production location.
- 5.4. Install the generator control module cover. Refer to *Generator Control Module Cover Replacement* in SI.
