File In Section: Product Recalls  
Bulletin No.: 09041A  
Date: June 2009

# Recall Bulletin

## F/CMVSS NONCOMPLIANCE RECALL

**SUBJECT:** Shift Lever Indicator May Not Display Correct Gear

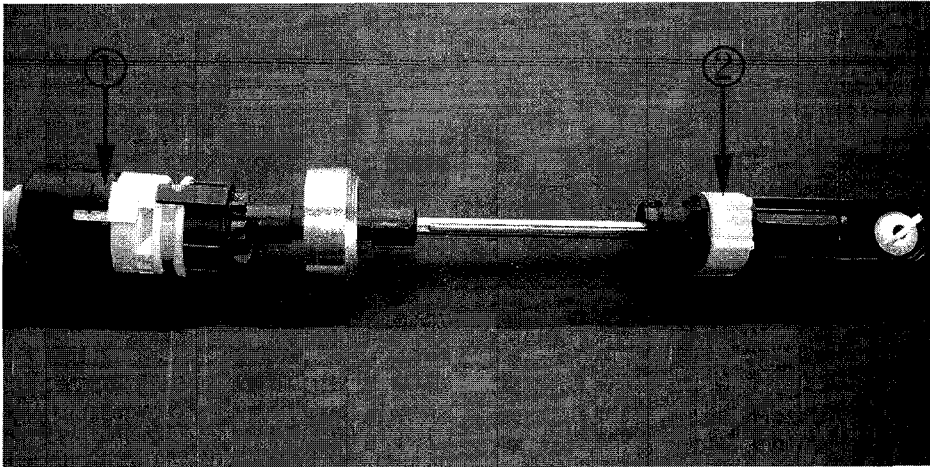
2269489

- (1) Shift Cable Locking Tabs
- (2) Shift Cable Adjuster Locking Clip

1. Open the hood and locate the transmission shift cable.
2. Determine if the transmission shift cable locking tabs are fractured and separated.

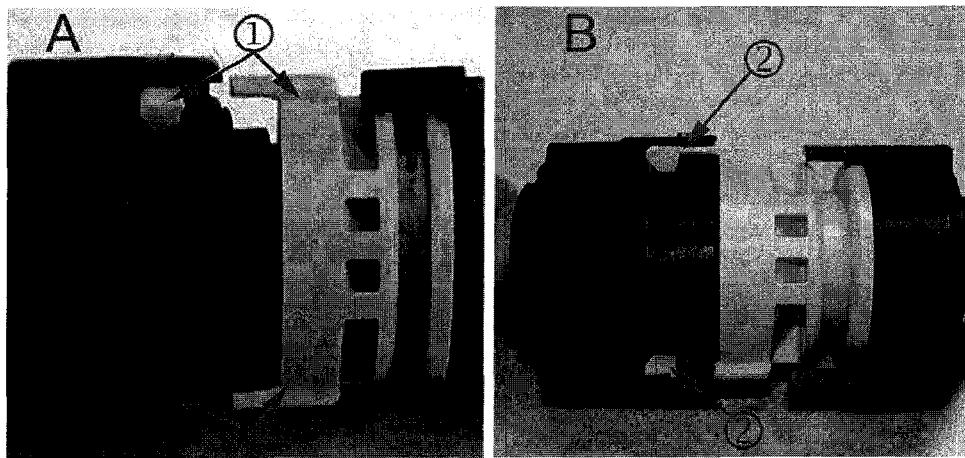
2269486

- If the transmission shift cable locking tabs (1) are fractured and separated (A), remove the transmission shift cable and replace it with a new one. Refer to *Floor Shift Control Cable Replacement* or *Range Selector Lever Cable Replacement* in SI. No further repairs are required after replacing the transmission shift cable. Submit warranty claim.
- If the transmission shift-cable locking tabs (2) are NOT fractured and separated (B), install the transmission shift cable kit. Proceed to Step 3.

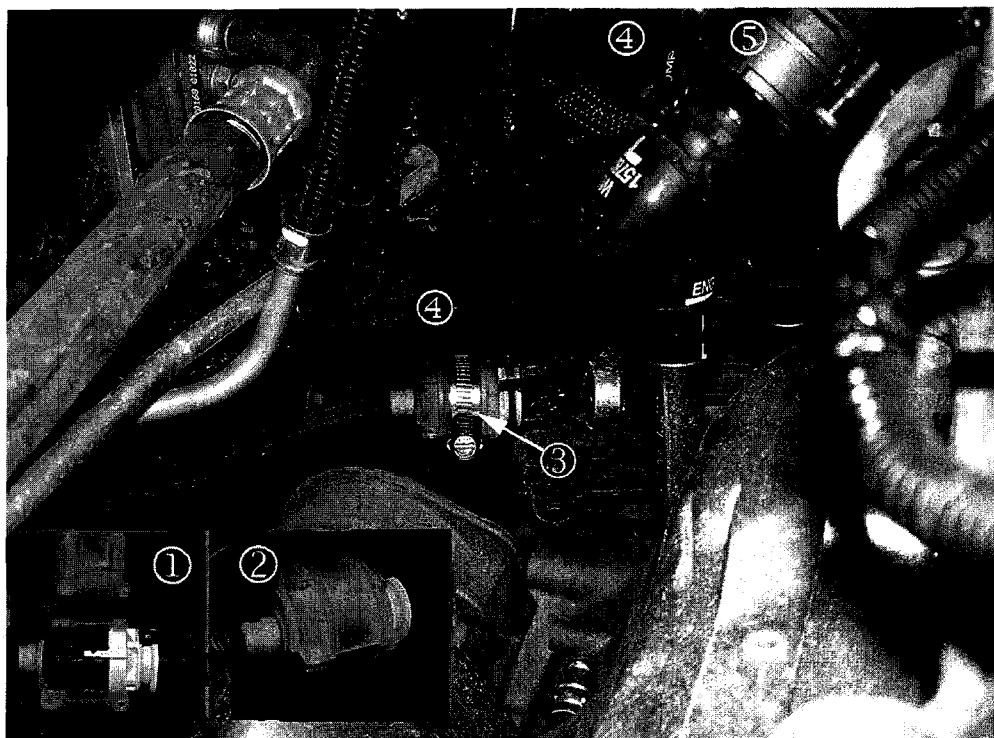
2269484

- (1) Clam Shell in Two Pieces
- (2) Clam Shell Around Shift Cable Locking Tabs
- (3) Clamp on Clam Shell
- (4) Inlet Coolant Hose and
- (5) Heater Cooler Pump.

3. Install the clam shell (1) (2) over the shifter cable locking tabs.

4. Install the service clamp over the clam shell (3). Position the clamp fastener head away from the inlet coolant hose (4). **Tighten the clamp to 4 Nm (35 lb-in).**
5. Ensure that there is 15 mm (19/32 in) of clearance between the inlet coolant hose (4) and the clam shell (3). On hybrid equipped vehicles, it may be necessary to reposition the inlet coolant hose (4) to achieve the required 15 mm (19/32 in) of clearance. **To reposition the inlet coolant hose (4) on hybrid equipped vehicles, locate the heater cooler pump (5) and perform Steps 5.1-5.4.**

**Caution:** Do not kink or damage the inlet coolant hose (4) when repositioning the hose to obtain the 15 mm (19/32 in) clearance. To avoid damaging the hose clamp, use J-38185 or equivalent hose clamp pliers to loosen the hose clamp.

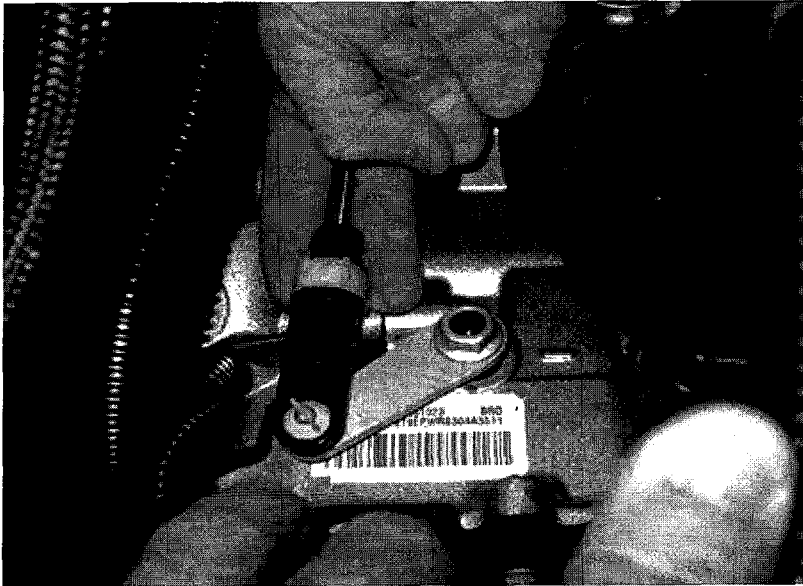
2239304

**Warning:** In the extremely rare event that the adjuster lock becomes disengaged, replace the shift cable. Refer to *Floor Shift Control Cable Replacement* (Cobalt, G5, HHR, Malibu) or *Range Selector Lever Replacement* (Acadia, Aura, Enclave, G6, Outlook, Traverse) in SI.

5. Apply a **LIGHT** vertical (upward) force with 2 fingers to the sides of the adjuster locking clip engagement legs. Refer to illustration. Push the shift cable adjuster lock down fully one more time to ensure complete lock engagement.
6. Move the shifter back and forth from PARK to N or L 3 times.
7. Verify that the vehicle shift system operates correctly.
