File In Section: Product Recalls
 Bulletin No.: 09041
 Date: March 2009

Recall Bulletin

F/CMVSS NONCOMPLIANCE RECALL

SUBJECT: Shift Lever Indicator May Not Display Correct Gear

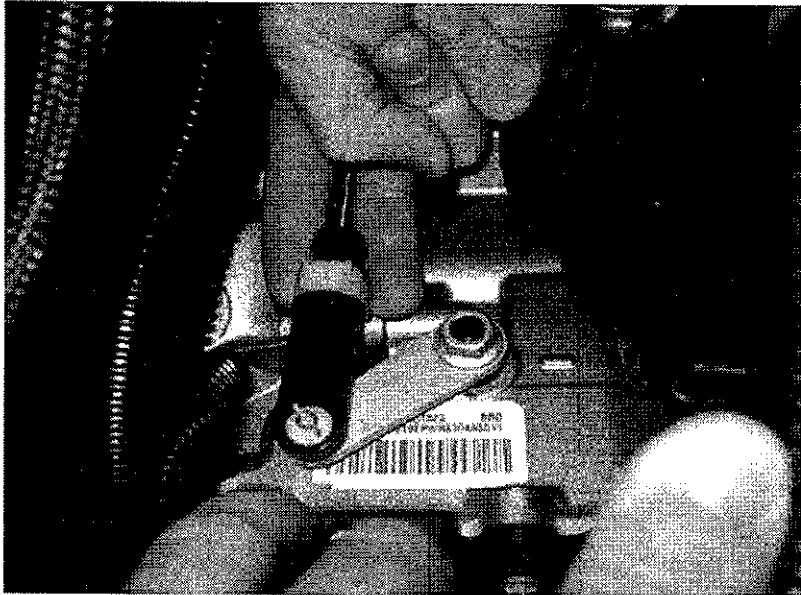
2239304

General Motors has decided that certain 2009 model year Buick Enclave; Chevrolet Cobalt, HHR, Malibu, Traverse; GMC Acadia; Pontiac G5, G6; and Saturn AURA and OUTLOOK vehicles fail to conform to Federal/Canada Motor Vehicle Safety Standard 102 , "Transmission Shift Position Sequence, Starter Interlock, and Transmission Braking Effect", and Standard 114, "Theft Protection and Rollaway Prevention". On some of these vehicles, the transmission shift cable adjustment clip may not be fully engaged. If the clip is not fully engaged, the shift lever and the actual position of the transmission gear may not match. With this condition, the driver could move the shifter to PARK and remove the ignition key, but the transmission gear may not be in PARK. The driver may not be able to restart the vehicle and the vehicle could roll away after the driver has exited the vehicle, resulting in a possible crash without prior warning.

1. Park the vehicle on a flat secure surface with the shifter in the PARK position.
2. Disengage the shift cable adjuster lock.
3. Turn the transmission side manual shaft lever counterclockwise and then release the lever to ensure that the transmission manual shaft is in the PARK position fully.
4. Push the shift cable adjuster lock down to fully engage the adjuster lock.

Warning: In the extremely rare event that the adjuster lock becomes disengaged, replace the shift cable. Refer to *Floor Shift Control Cable Replacement* (Cobalt, G5, HHR, Malibu) or *Range Selector Lever Replacement* (Acadia, Aura, Enclave, G6, Outlook, Traverse) in SI.

5. Apply a **LIGHT** vertical (upward) force with 2 fingers to the sides of the adjuster locking clip engagement legs. Refer to illustration. Push the shift cable adjuster lock down fully one more time to ensure complete lock engagement.
6. Move the shifter back and forth from PARK to N or L 3 times.
7. Verify that the vehicle shift system operates correctly.
