From: Technical Services Department
Sent: Thursday, April 23, 2009 3:48 PM
Subject: Upcoming 2010 Mazda3 Emission Harness Voluntary Safety Recall 5409D
Attachments: eFC-I-09-00034b.pdf

Mazda Motor Corporation has decided that a defect which relates to motor vehicle safety exists in certain 2010 Mazda3 vehicles equipped with LF or L5 engine and produced from October 7, 2008 through April 10, 2009.

On certain 2010 Mazda3 vehicles, the clearance between the emission harness and the housing of the starter motor may be insufficient. Due to this, the covering of the harness may be damaged from vibration during operation, resulting in a short-circuit between the harness wires and the starter housing. This condition could cause an engine control malfunction and/or poor shift quality. In the worst case, the main fuse may blow out, causing the engine to stall and an inability to restart, increasing the risk of a crash.

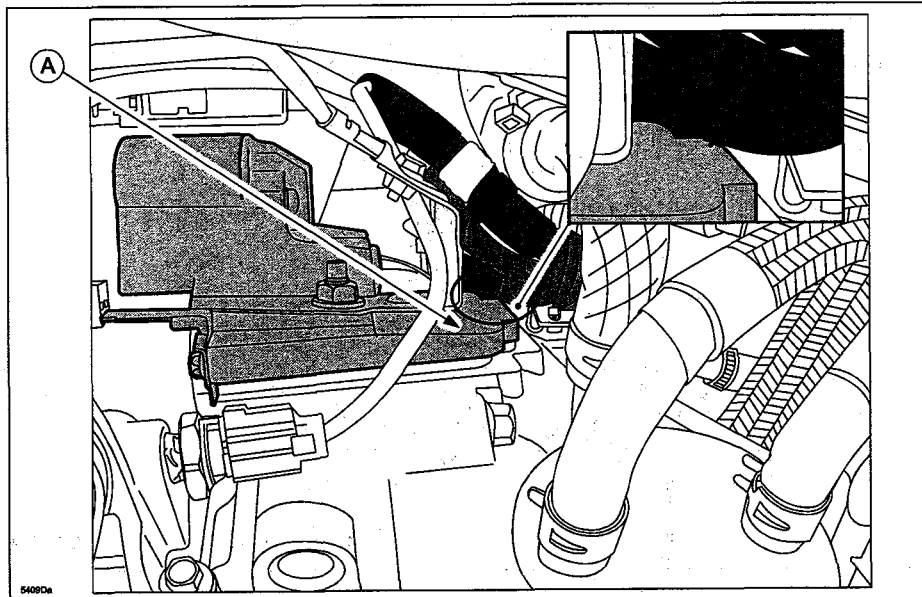
VIEWED FROM UNDERNEATH THE VEHICLE (LOOKING UP) WITH UNDERCOVER REMOVED

The emission harness may contact the engine starter housing (A) causing damage to the harness, and in some rare cases, the damage may cause the emission harness wiring to short to ground. This shorting to ground will cause the MIL to illuminate and / or driveability concerns.

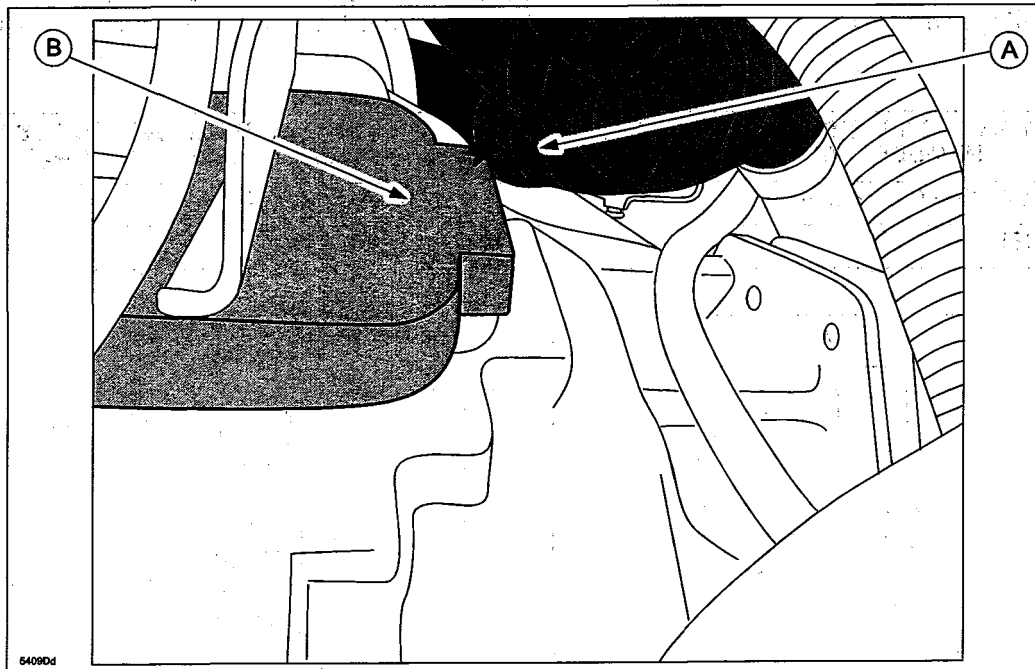
3. Carefully inspect the harness (A) in the area closest to the engine starter housing (B).
DOES THE HARNESS TOUCH THE ENGINE STARTER HOUSING?
- YES – Go to next step.
 - NO – Go to PROCEDURE "B".

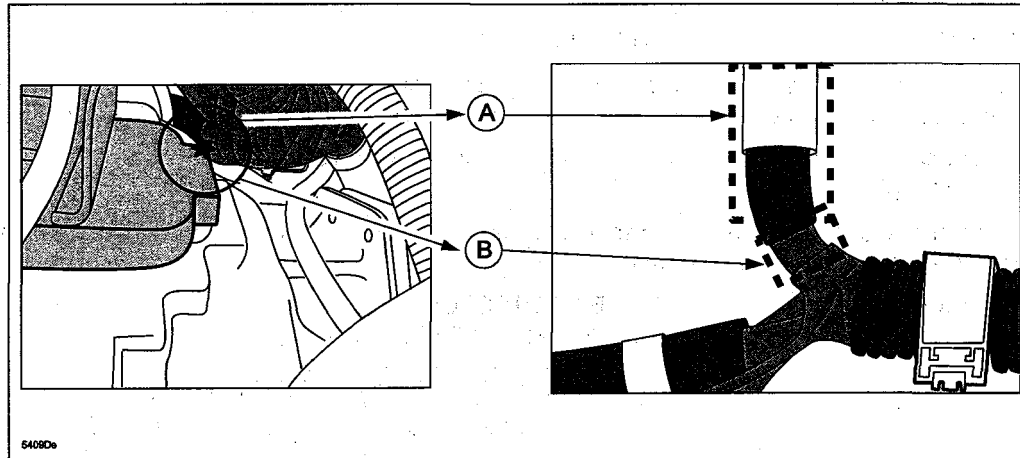
4. Inspect the vehicle's harness and compare to the illustration below to determine procedure.
- Starter contacts area of corrugated sheath (A) – Go to PROCEDURE "B".
 - Starter contacts area of tape (B) with no corrugated sheath – Go to PROCEDURE "C".

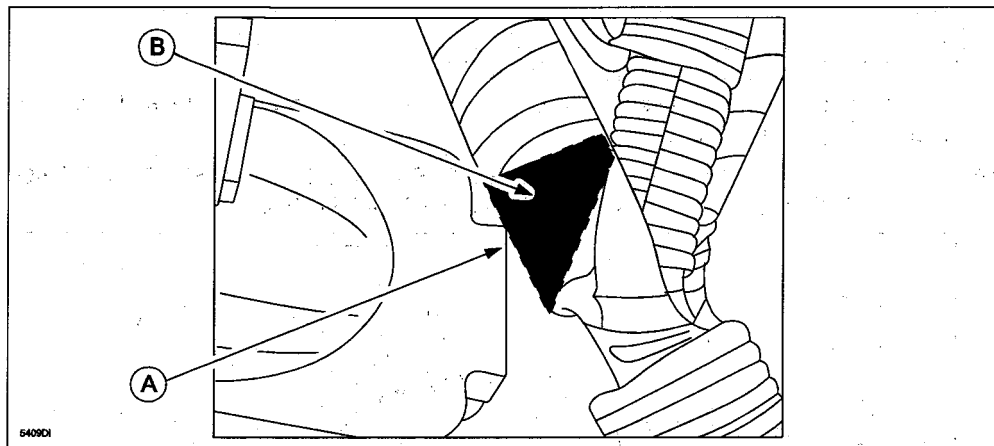
NOTE: This procedure prevents water entry if harness tape was damaged by engine starter housing contact.

IMPORTANT: IF VEHICLE IS EXPERIENCING MILS, BLOWN FUSES OR DRIVEABILITY CONCERNS THE EMISSION HARNESS WIRING MAY BE WORN THROUGH TO BARE COPPER CONDUCTOR WIRE AND TOUCHING THE ENGINE STARTER HOUSING.

1. Note the area of harness at the engine starter housing contact point (A) to be waterproofed as shown (B).

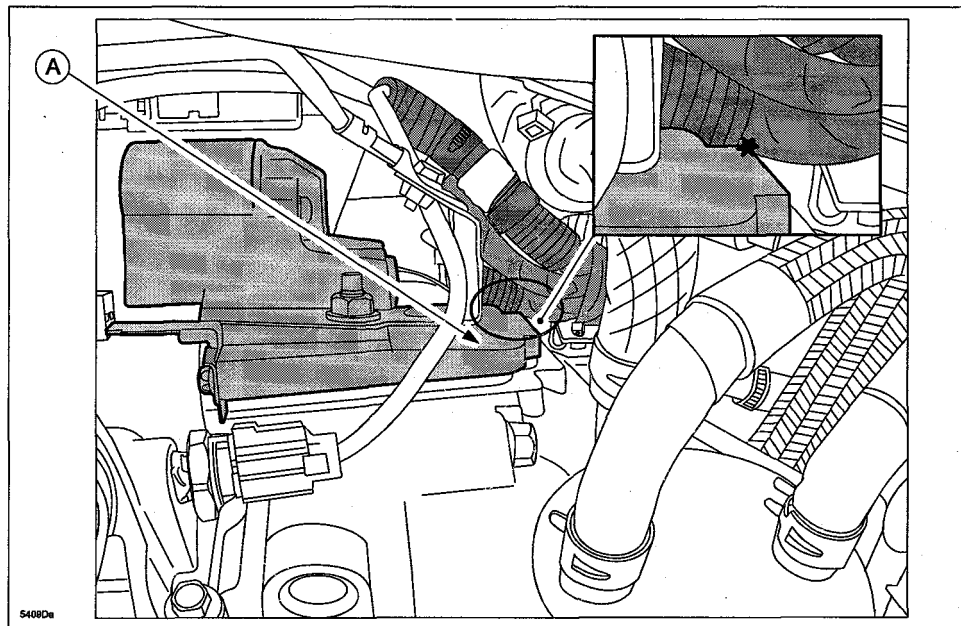
VIEWED FROM UNDERNEATH THE VEHICLE (LOOKING UP) WITH UNDERCOVER REMOVED

The emission harness may contact the engine starter housing (A) causing damage to the harness, and in some rare cases, the damage may cause the emission harness wiring to short to ground. This shorting to ground will cause the MIL to illuminate and / or driveability concerns.

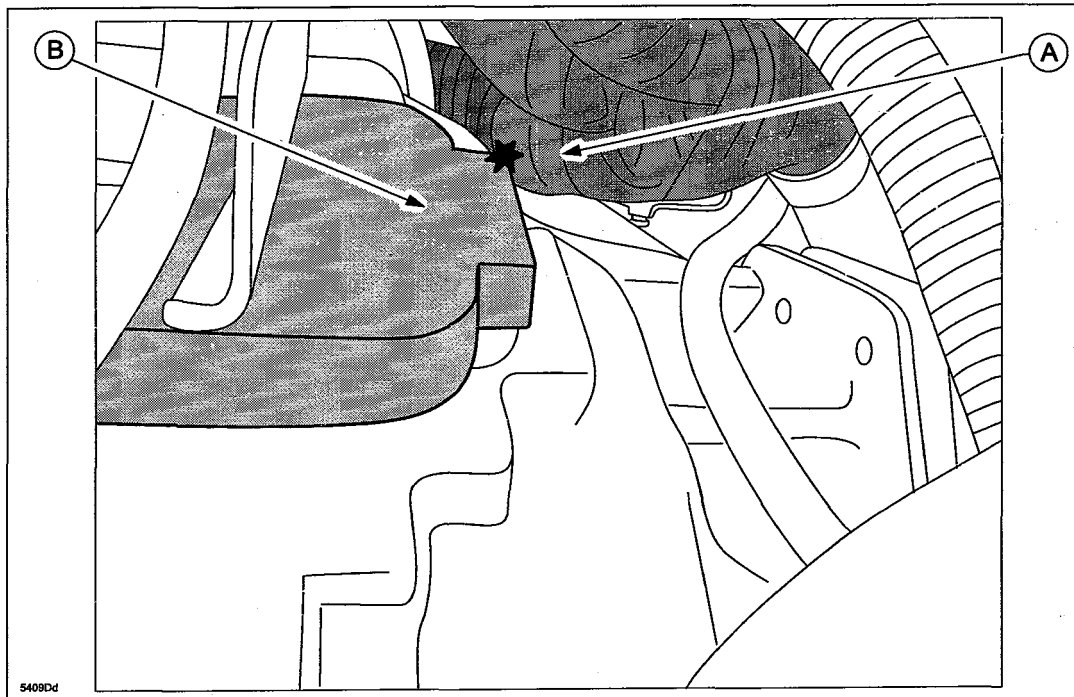
3. Carefully inspect the harness (A) in the area closest to the engine starter housing (B).
DOES THE HARNESS TOUCH THE ENGINE STARTER HOUSING?
 - YES – Go to next step.
 - NO – Go to PROCEDURE "B".

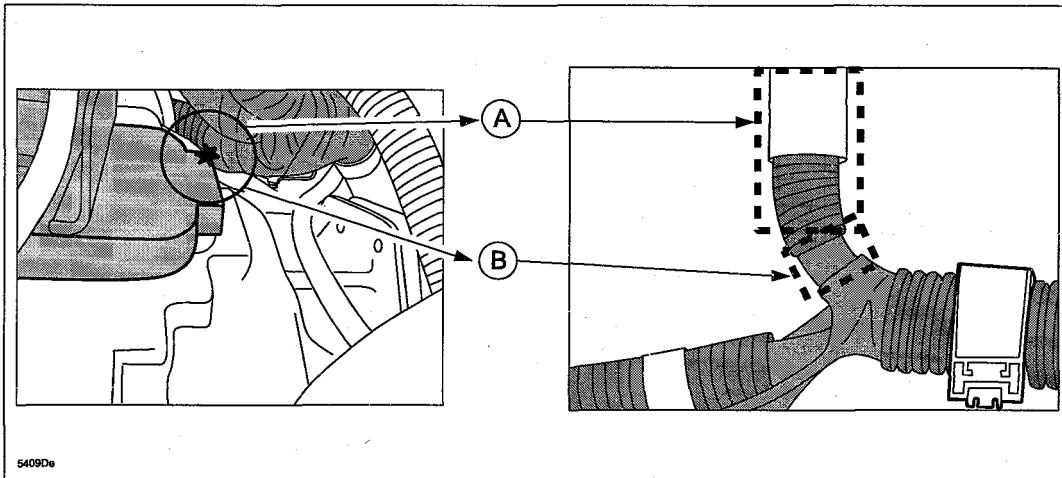
4. Inspect the vehicle's harness and compare to the illustration below to determine procedure.
- Starter contacts area of corrugated sheath (A) – Go to PROCEDURE "B".
 - Starter contacts area of tape (B) with no corrugated sheath – Go to PROCEDURE "C".

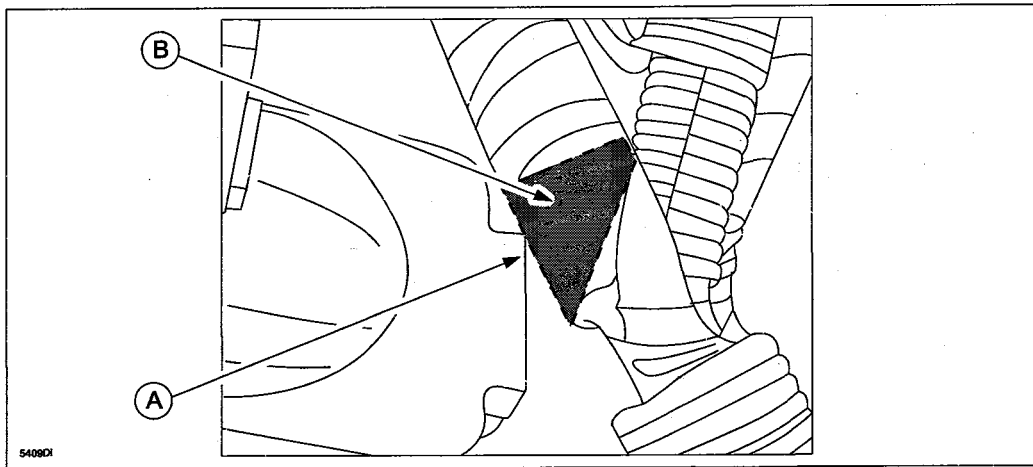
NOTE: This procedure prevents water entry if harness tape was damaged by engine starter housing contact.

IMPORTANT: IF VEHICLE IS EXPERIENCING MILS, BLOWN FUSES OR DRIVEABILITY CONCERNS THE EMISSION HARNESS WIRING MAY BE WORN THROUGH TO BARE COPPER CONDUCTOR WIRE AND TOUCHING THE ENGINE STARTER HOUSING.

1. Note the area of harness at the engine starter housing contact point (A) to be waterproofed as shown (B).
