# Recall Bulletin

## PRODUCT SAFETY RECALL

**SUBJECT:** Positive Battery Cable Routing - Reroute

**MODELS:** 2010 Chevrolet Camaro  
Equipped with a V8 Engine

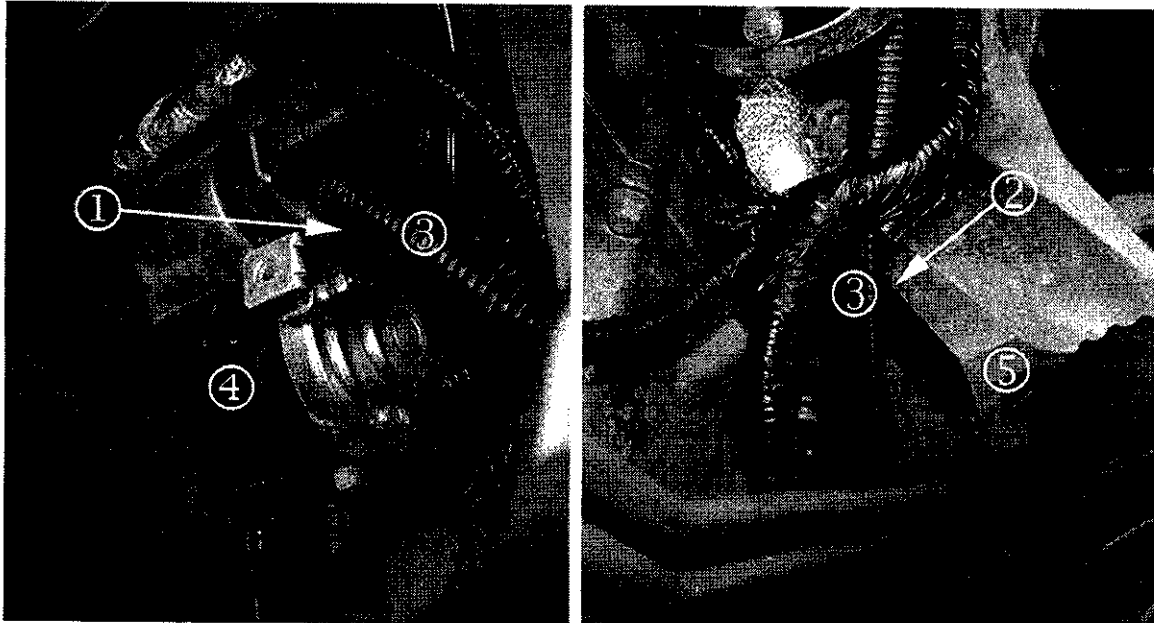
2271926

General Motors has decided that a defect, which relates to motor vehicle safety, exists in **certain** 2010 model year Chevrolet Camaro vehicles equipped with a V8 engine. Some of these vehicles have a condition in which the positive battery cable may contact the starter motor housing and cause wear on the cable insulation. If the insulation wears through to the cable, it could create a short. A short could result in a no start condition, cause the vehicle to stall without the ability to restart, or result in an engine compartment fire.

- (1) Battery Positive Starter Cable-to-Starter Contact Area
- (2) Motor Mount-to-Battery Positive Starter Cable Contact Area
- (3) Battery Positive Starter Cable
- (4) Starter
- (5) Motor Mount

4. Locate where the battery positive starter cable (3) contacts the starter (4) and motor mount (5). Refer to the illustration above.
5. Remove starter terminal nut and the battery starter cable from the starter terminal.
6. Move the battery starter cable away from the motor mount.
