Safety Recall Circular

Code: **40J2**

Subject: 2006-2009 Jetta (5th Generation) and 2009 Jetta SportWagen with 2.0L TFSI Engine and DSG Transmission

Inspect and, if Necessary, Replace Driveshaft Screws November 2009

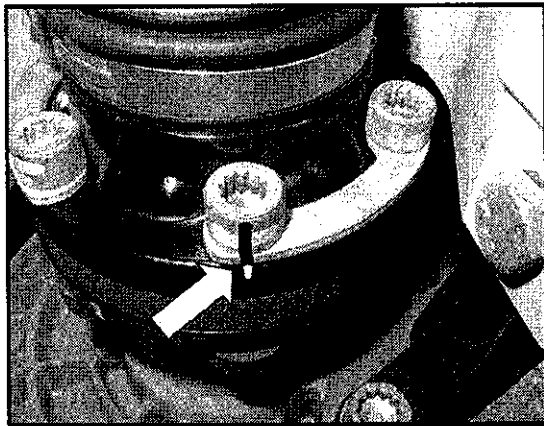
- ⇐ Mark all six screws in their current position -arrow- on each axle shaft
- Torque all six screws in a crosswise pattern to 50 Nm (37 lb-ft)
 - **IF** none of the six screws turn, torque all six screws on each respective driveshaft in a crosswise pattern to 70 Nm (52 lb-ft)
 - Reinstall noise insulation cover
 - Lower vehicle hoist

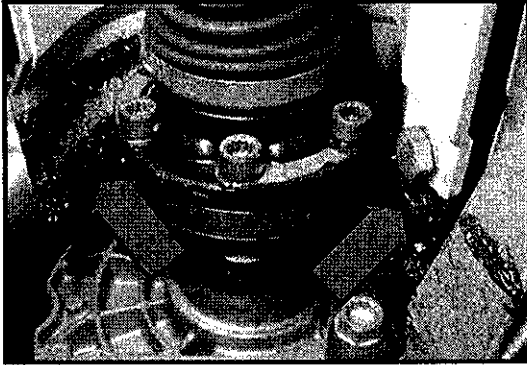
EXCESSIVE

- **IF** any of the six screws turn, check both inner driveshafts for **excessive** grease migration -arrows-

Tip: Grease migration commonly emits from bolt head area on damaged driveshafts

Tip: Grease migration due to a torn CV boot is not covered under this action

- **IF excessive grease migration is present on either driveshaft, that driveshaft must be replaced; go to Section B for driveshaft replacement**
- **IF excessive grease migration is not present; replace all six screws, part number N 909 91102, and all three bedplates, part number 1K0 407 357D, on the respective driveshaft**
- Pre-tighten bolts, one at a time, in a crosswise pattern to 10 Nm (7 lb-ft), then torque bolts, one at a time, in a crosswise pattern to 70 Nm (52 lb-ft)
- Reinstall noise insulation cover
- Lower vehicle on hoist

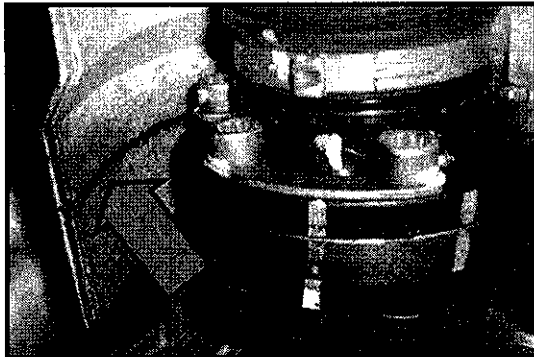
NORMAL

Tip: A small amount of grease -arrow- is normal

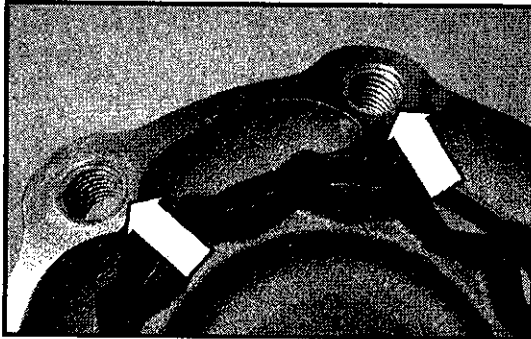
- ⇐ Examine the tapped holes -arrows- in the gearbox flange for damage
 - If damages to gearbox flange are found and cannot be repaired, contact **Campaign Helpline at 1-800-741-2919**
 - If no damage to gearbox flange is found, continue with work procedure
