# Safety Recall Circular

Code: 40J2

**Subject: 2006-2009 Jetta (5<sup>th</sup> Generation) and 2009 Jetta SportWagen  
with 2.0L TFSI Engine and DSG Transmission  
Inspect and, if Necessary, Replace Driveshaft Screws**

**REVISED**  
July 2009

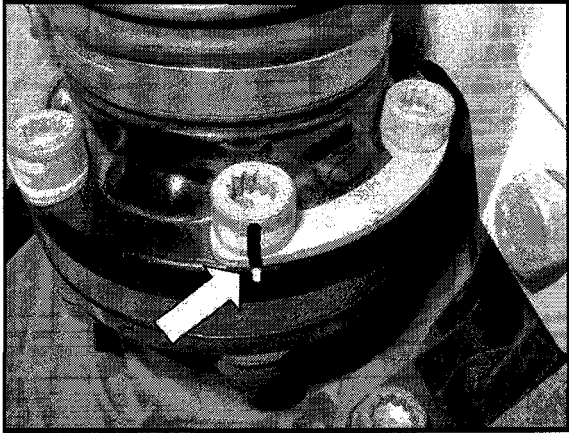
⇐ Mark all six screws in their current position  
-arrow- on each axle shaft

- Torque all six screws in a crosswise pattern to 50 Nm (37 lb-ft)
  - **IF** none of the six screws turn, torque all six screws on each respective driveshaft in a crosswise pattern to 70 Nm (52 lb-ft)
  - Reinstall noise insulation cover
  - Lower vehicle hoist

- **IF** any of the six screws turn, replace all six screws, part number N 909 91102, and all three bedplates, part number 1K0 407 357D, on each respective driveshaft
- Pre-tighten bolts, one at a time, in a crosswise pattern to 10 Nm (7 lb-ft), then torque bolts, one at a time, in a crosswise pattern to 70 Nm (52 lb-ft)
- Reinstall noise insulation cover
- Lower vehicle on hoist

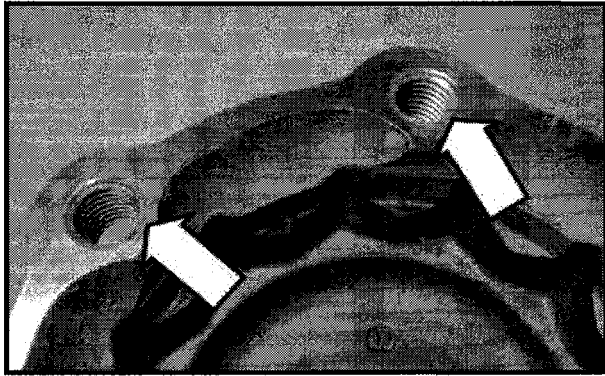
⇐ Examine the tapped holes -arrows- in the gearbox flange for damage

- If damages to gearbox flange are found and cannot be repaired, contact **Campaign Helpline at 1-800-741-2919**
- If no damage to gearbox flange is found, continue with work procedure
