Safety Recall Circular

Code: **40J2**

Subject: 2006-2009 Jetta (5th Generation) and 2009 Jetta SportWagen with 2.0L TFSI Engine and DSG Transmission
Inspect and, if Necessary, Replace Driveshaft Screws

REVISED
April 2010

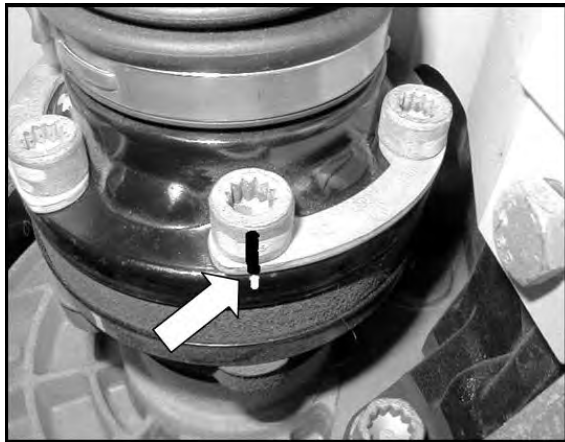
- ⇐ Mark all six screws in their current position -arrow- on each axle shaft
- Torque all six screws in a crosswise pattern to 50 Nm (37 lb-ft)
 - **IF** none of the six screws turn, torque all six screws on each respective driveshaft in a crosswise pattern to 70 Nm (52 lb-ft)
 - Reinstall noise insulation cover
 - Lower vehicle hoist

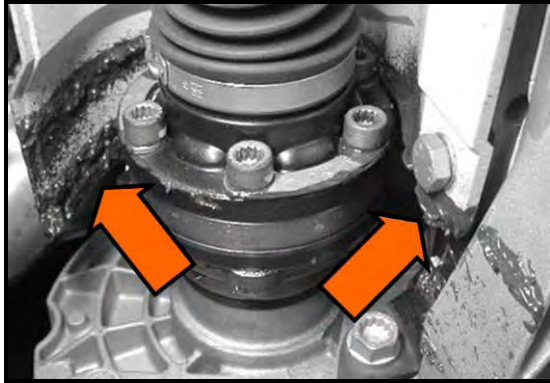
EXCESSIVE

- **IF** any of the six screws turn, check both inner driveshafts for **excessive** grease migration -arrows-

Tip: Grease migration commonly emits from bolt head area on damaged driveshafts

- **IF excessive** grease migration is present on either driveshaft, that driveshaft must be replaced; go to Section B for driveshaft replacement
- **IF excessive** grease migration is not present; replace all six screws, part number N 909 91102, and all three bedplates, part number 1K0 407 357D, on the respective driveshaft
- Pre-tighten bolts, one at a time, in a crosswise pattern to 10 Nm (7 lb-ft), then torque bolts, one at a time, in a crosswise pattern to 70 Nm (52 lb-ft)
- Reinstall noise insulation cover
- Lower vehicle on hoist

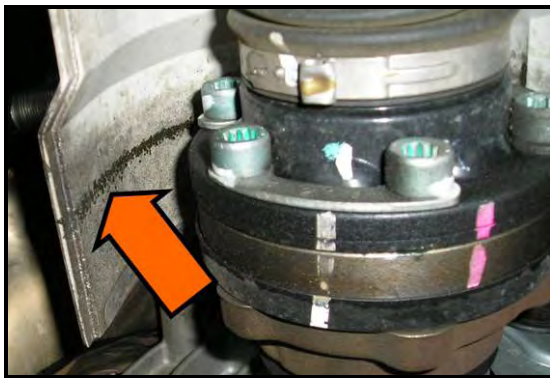
NORMAL

Tip: A small amount of grease -arrow- is normal

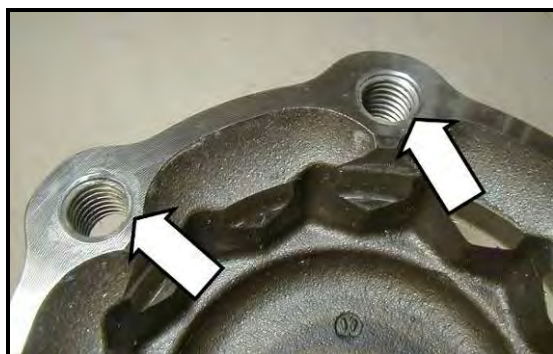
- ⇐ Examine the tapped holes -arrows- in the gearbox flange for damage
 - If damages to gearbox flange are found and cannot be repaired, contact **Campaign Helpline at 1-800-741-2919**
 - If no damage to gearbox flange is found, continue with work procedure
