# TEREX

### CAMPAIGN BULLETIN

**05-586-09**

**SUBJECT:** *Rod Weldment of 437250D Main Lift Cylinder*

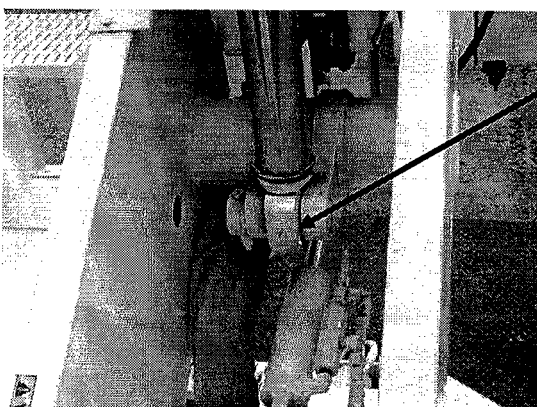
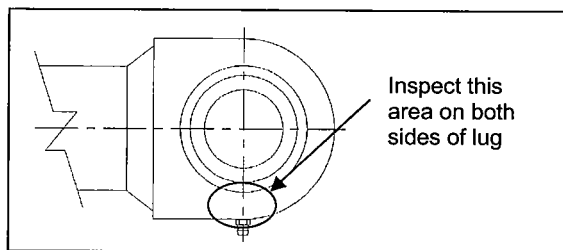
Terex Utilities has determined that material supplied for the lower boom lift cylinder rod eye on certain 437250 cylinders is not to specification and can fail. The supplier involved provided rod eye material used on HR37 or HR40 units built between 6/21/1999 through 1/30/2001.

**If the cylinder rod eye fails the boom and platform will fall.**

Inspect Lift cylinder rod end in this area on both sides. Clean off dirt and grease to see side of lug down to the bushing bore.

The owner or user must immediately perform a visual inspection of the cylinder rod eye in the area of the grease zerk. Clean off the dirt and grease to determine if a crack is evident near the ball bushing. If there are any indications of a crack remove the unit from service and contact Terex Utilities at 605-884-3892. If no cracks are detected contact the nearest Terex Utilities dealer to arrange replacement of the cylinder rod within 45 days. You may continue to use the unit if you inspect the rod eye daily to determine that no cracks are present.

Affected units, as shown on the owner letter, will have the cylinder rod replaced at no charge to the owner. Repair parts will be available beginning 5/15/09. All 437250D cylinder rods with the date codes listed above will be replaced.
