GROUP Campaign	MODEL 2001-2004MY Optima (MS)
NUMBER	DATE
SC 075	June 2009

SAFETY RECALL CAMPAIGN TECHNICAL SERVICE BULLETIN

REPAIR/REPLACEMENT OF SUBFRAME

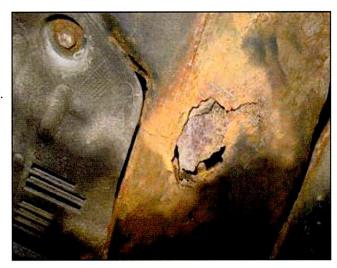
- 2. Inspect the entire subframe assembly for any external signs of severe corrosion/perforation.
 - a) If any perforation or open cavity is found in the subframe, do not continue repairing. Replace the subframe according to TSB GEN 026. If no signs of perforation or severe corrosion are found, continue to step (b).
 - b) Using a hammer, lightly tap the entire subframe in several areas to check for any material which may be nearing the perforation stage. If the hammer opens up a cavity in the subframe, replace the subframe according to TSB GEN 026.

Make sure to inspect for any corrosion cavity throughout the subframe, including the sides.

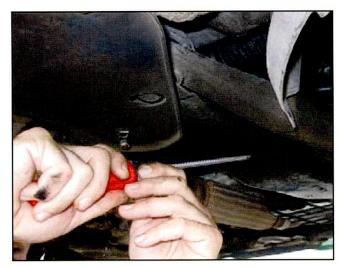
5. Debur the holes on both sides in several areas around the edges of the 40 mm hole so that an accurate judgment of the subframe material thickness can be made.

Failure to perform this deburring step may cause a false "pass" on the subframe condition in the following step.

If the metal burrs are left around the hole, they may block the thickness gauge and indicate that the subframe is thicker than it actually is.

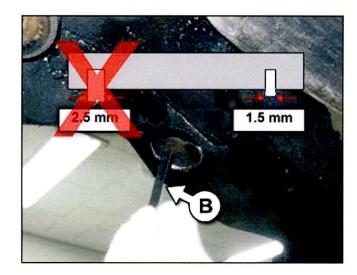
Referencing the 1.5 mm side (smallest width) of the thickness gauge, attempt to slide the thickness gauge over the edge of the hole in several different locations on both left/right rear inspection sites.

- a) If the thickness gauge (B) is able to pass over the subframe material, it has failed the 1.5 mm minimum thickness test. Replace the subframe according to TSB GEN 026.
- b) If the gauge will not pass over the subframe material, the corrosion preventive treatment can be performed. Proceed to the next step.
- 7a. In preparation for drilling the 40 mm hole-saw site three (3) in the right front, the following method must be used to insure proper drilling location. Locate the center point of the right side subframe bushing bolt, use a straight edge to draw a horizontal line for 19 mm inboard. From the end of the 19 mm horizontal line, use a straight edge to draw a vertical line for 294 mm. From the end of the 294 mm vertical line, mark this location as the center point for drilling. Drill this location using the 40 mm hole-saw. (Drill Speed Recommendation: 380 ~ 470 rpm).
