## SAFETY RECALL

Sr09-10

| <b>SUBJECT : INSPECTION AND REPLACEMENT OF DRAG<br/>LINK SPHERICAL PLAIN BEARING ROD END</b> | |

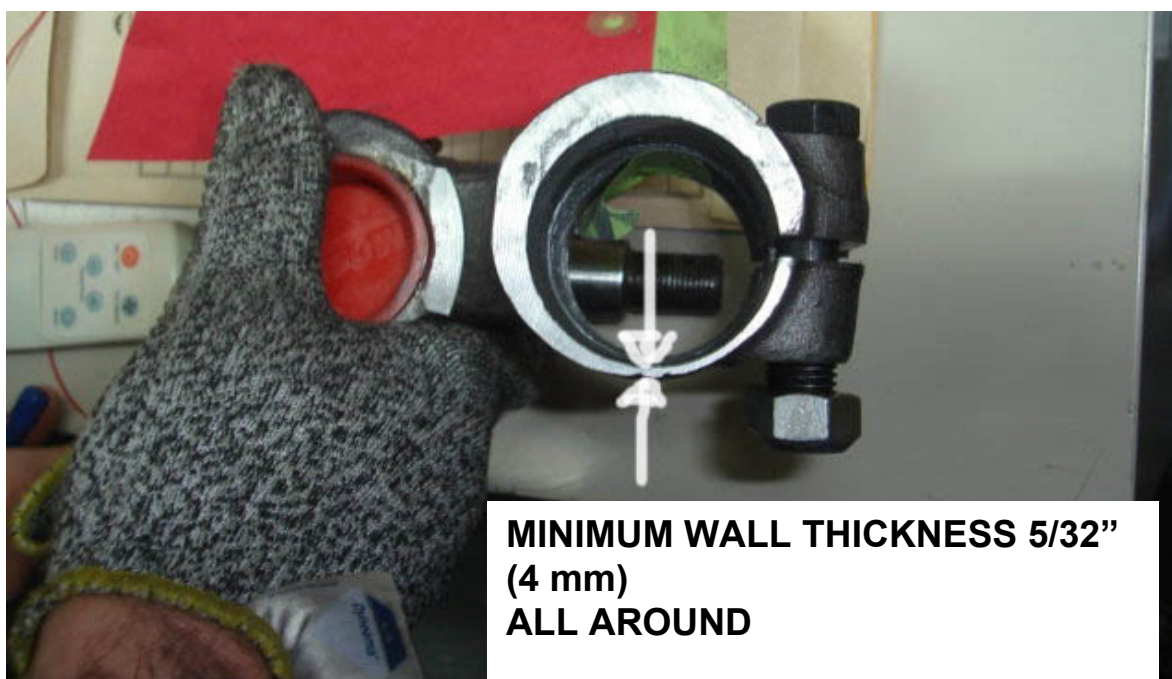
FIGURE 2

Inspect inventory parts ideally using a vernier caliper or an outside caliper and steel ruler (Refer to figure 2).

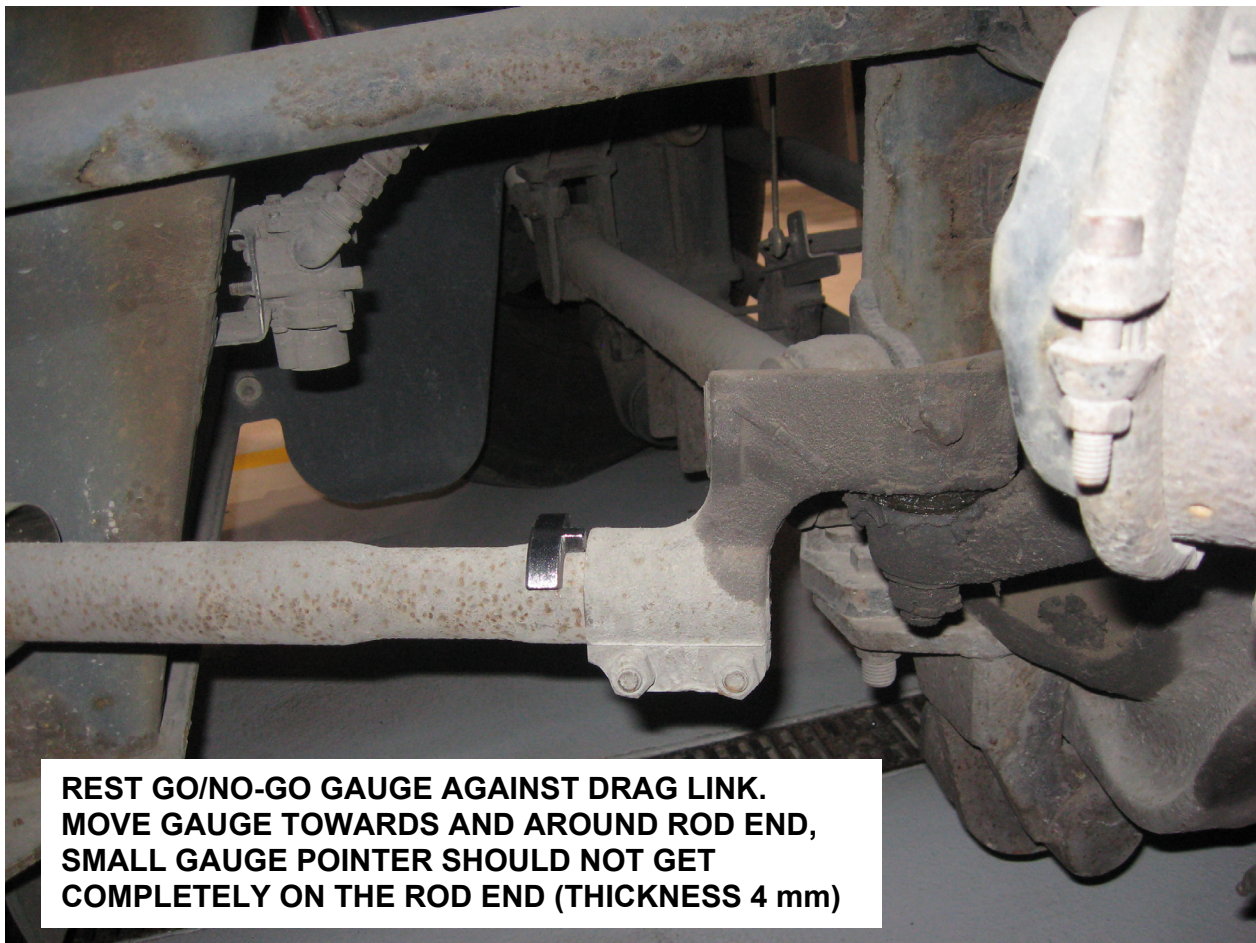
FIGURE 3

1. Raise vehicle in order to inspect already installed parts.
2. Clean drag link surface near the rod end and also spherical plain bearing rod end to ensure proper measurements (Refer to figure 3)
3. Use supplied go/no-go gauge (169159) to check wall thickness of the drag link spherical plain bearing rod end located near front L.H. side wheel without having to remove drag link. **Minimum wall thickness is 4 mm (0.158 inch or 5/32")**. While resting go/no-go gauge against drag link, if you can get the gauge completely on the rod end up to 10 mm (3/8") from the rod end extremity, rod end must be replaced (Refer to figures 3, 4 and 5).

| Control thin sections of rod end. |

4. If measurement is outside tolerances, part 610991 must be replaced.
