## Product Recall

Subject: RECALL 09V-219 – Emergency Exit Window Release Mechanism

RECALL #09V-219

SUBJECT: EMERGENCY EXIT WINDOW RELEASE MECHANISM

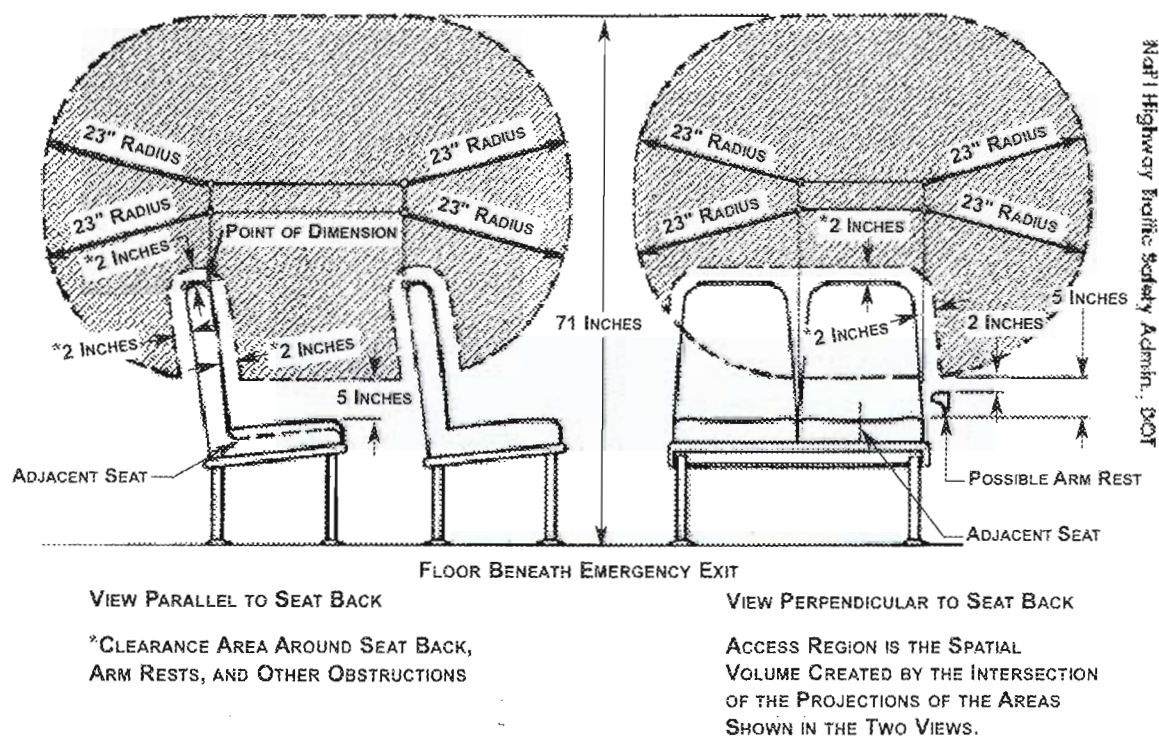
**FIGURE 1 - LOW-FORCE ACCESS REGION FOR EMERGENCY EXITS HAVING ADJACENT SEATS**

A minimum of two inches is required between an emergency push-out release handle and the adjacent seat. Check to see if your push-out window release handles are within the two inch minimum requirement.

If the handles are closer than two inches to any portion of the seat, continue with this repair. **Figure 1**
