Safety Recall Circular

Code: **66D6**

**Subject: 2007-2009 Touareg
Roof Edge Spoiler**

August 2009

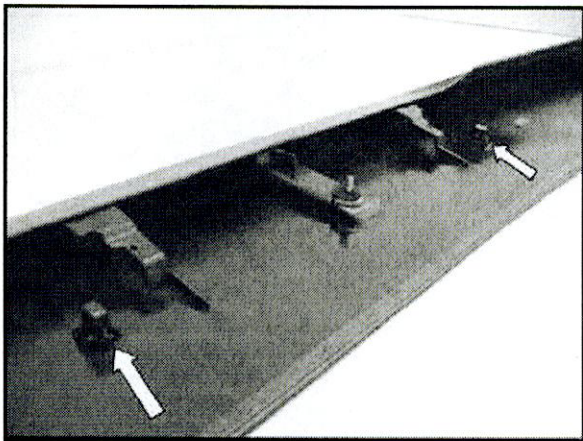
Tip: Broken off clips -arrows- do not affect the fit of the spoiler and can be removed before the assembly

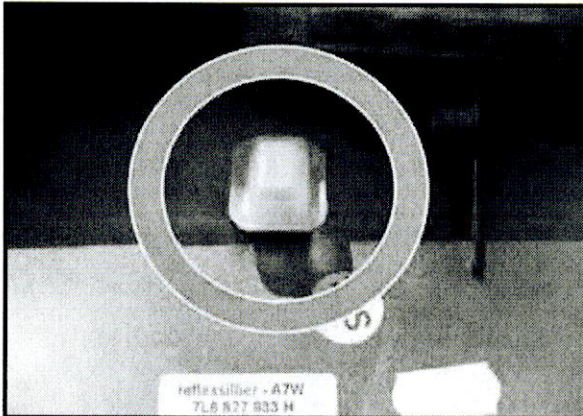
Tip: To avoid leaks, the two relevant clamping pieces -circle- must be reinstalled into the rear hinged window

- Reinstall the two clamping pieces, if necessary

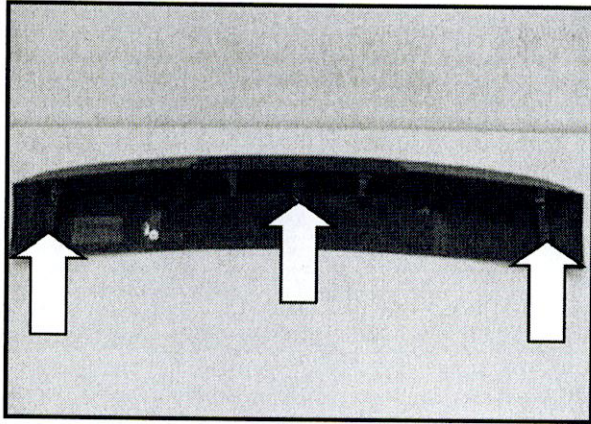
- ⇐ On these three points -arrows- reinforcements will be bonded
- ⇐ Inspect mounting points -arrows- for damage. **If damage is found, contact Campaign Helpline at 800-741-2919**
