Recall Campaign 09V-257: Repair Airbag Harness

E82, E88 (1 Series)

NEW E90, E92, E93 (3 Series)

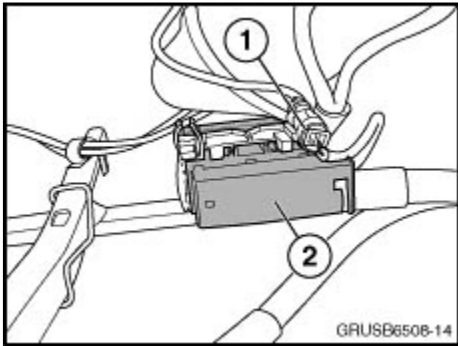
There may be incorrect wiring crimps in the airbag harness at the plug connectors located under the front seats. This wiring affects the seatbelt tensioner and front side airbag circuits.

The crimps may fail, causing the airbag warning lamp in the instrument cluster to be illuminated. In this case, the front side airbag or seat belt tensioner may not deploy in the event of an accident.

3. Move both the driver and passenger seats to the full rearwards and upwards position
