## TRW Automotive Commercial Steering Systems

### Service Procedure # COL-194

#### IGEN 3 Intermediate Shaft Weld Location Inspection Procedure

TRW Steering I Shaft Weld

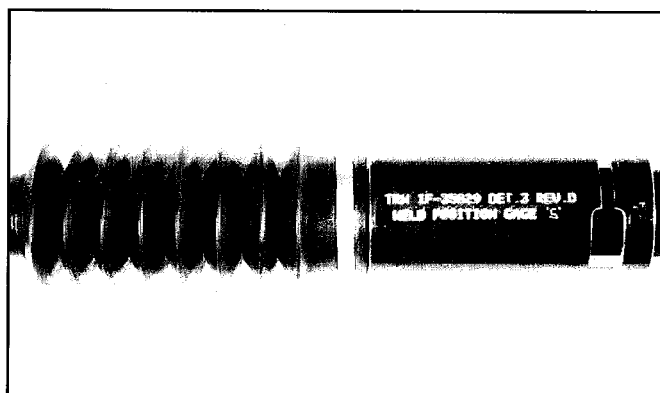
Figure 3

1. Check the weld using the TRW weld position gauge (IF-35029 DET.3 REV-D). Place the template end of the gauge against the base of the seal boot as shown **Figure 3** with the gauge placed over the top of the part number stamp location.

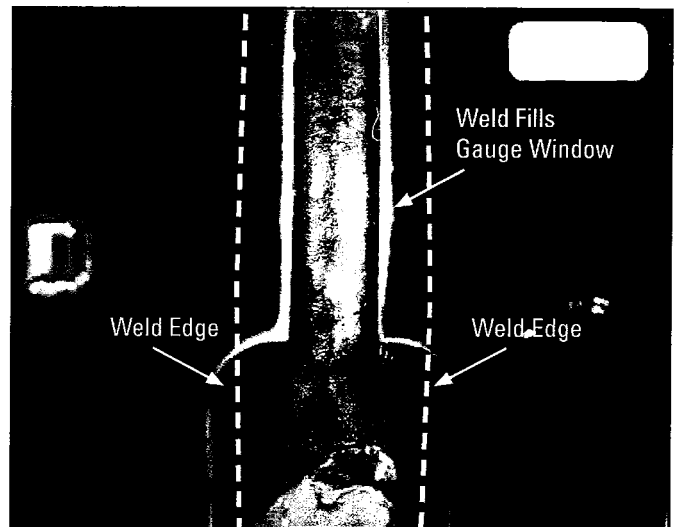
Figure 4

2. Visually inspect the position of the weld bead in reference to the small gauge window (3/16" width). The full circumference of weld seam must be inspected in the gauge window. **Figure 4**

- The weld bead must completely fill the gauge window.
- No joint line between the 2 tubes should be visible, the edges where the tubes join should be covered by the weld.
- The parent tube should not be visible in the narrow section of the gauge window.

- 2a. **Part Passes** if the weld bead completely fills the narrow gauge window **Figure 4**. Mark the parts that pass inspection with yellow or white paint mark adjacent to the part number stamp. **Figure 1**

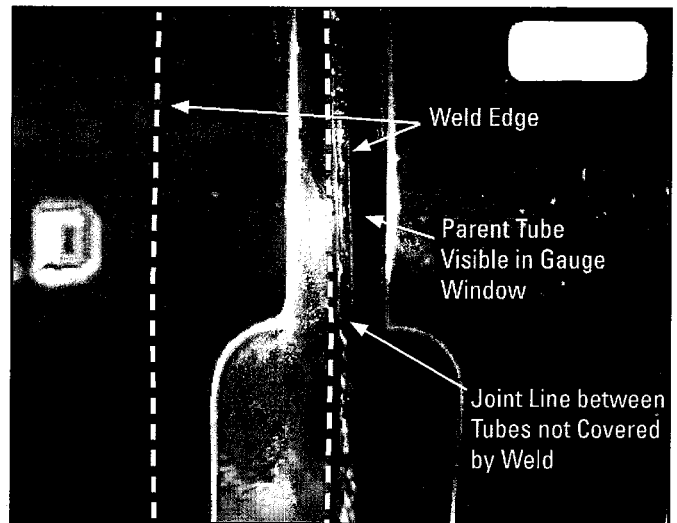
Figure 5

- 2b. **Part Fails** if any of the following are seen in the inspection.

- The weld bead does not completely fill the narrow gauge window.
- The parent tube is partially visible in narrow gauge window.
- The joint line between the 2 tubes is visible at any point around the circumference of the shaft. **Figure 5**

Remove intermediate shaft and replace.

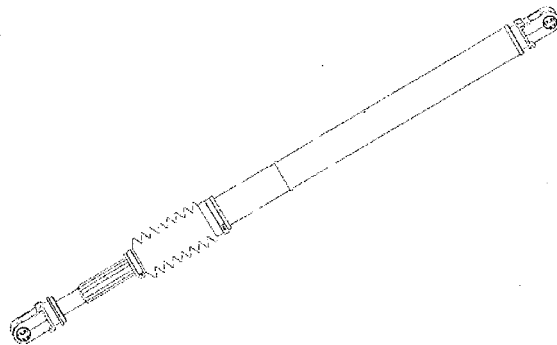
The weld around the IGEN3 steering shaft tube that secures the spline tube to the intermediate tube may be mislocated. (i.e., not fully over the seam created when the tubes are pressed together). Mislocated welds may result in torsional and axial strength thresholds of the shaft falling below acceptable levels.

This situation may impact the operator's ability to steer or control the vehicle and increase the risk of an accident.

This recall will include an inspection of the steering shaft and, when necessary, replacing defective parts.

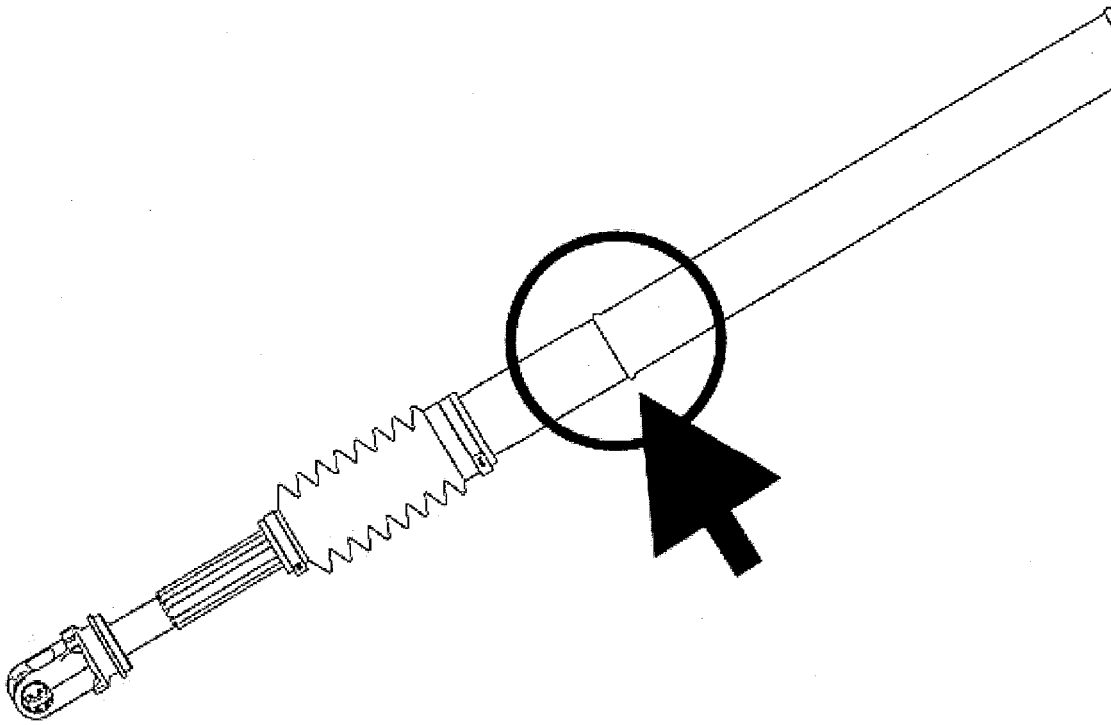
The weld around the IGEN3 steering shaft tube that secures the spline tube to the intermediate tube may be mislocated. (i.e., not fully over the seam created when the tubes are pressed together). Mislocation of this weld may allow the splined tube and non-splined tube to rotate relative to one another during a low speed, high torque turn, vehicle maneuver, possibly resulting in loss of steering control and increasing the risk of an accident.

This recall will include an inspection of the steering shaft using TRW Weld Position Gage # IF-35029 DET.3 REV-D (being supplied no-charge to all Kenworth dealers, attn: Service Manager, by TRW in their kit # GK0001) and, when necessary, replacing defective parts.
