# TRW Automotive Commercial Steering Systems

## Service Procedure # COL-194

### IGEN 3 Intermediate Shaft Weld Location Inspection Procedure

July 2009

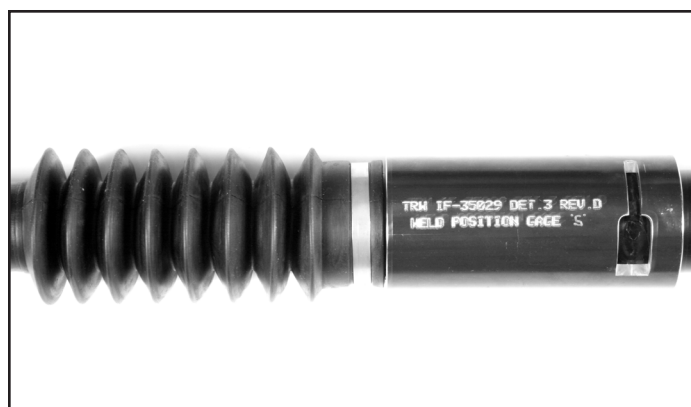
Figure 3

1. Check the weld using the TRW weld position gauge (IF-35029 DET:3 REV-D). Place the template end of the gauge against the base of the seal boot as shown **Figure 3** with the gauge placed over the top of the part number stamp location.

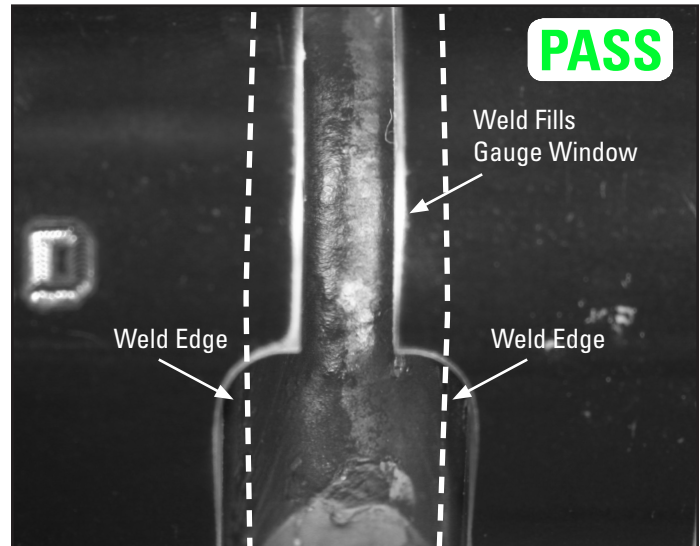
Figure 4

2. Visually inspect the position of the weld bead in reference to the small gauge window (3/16" width). The full circumference of weld seam must be inspected in the gauge window. **Figure 4**

- The weld bead must completely fill the gauge window.
- No joint line between the 2 tubes should be visible, the edges where the tubes join should be covered by the weld.
- The parent tube should not be visible in the narrow section of the gauge window.

- 2a. **Part Passes** if the weld bead completely fills the narrow gauge window **Figure 4**. Mark the parts that pass inspection with yellow or white paint mark adjacent to the part number stamp. **Figure 1**

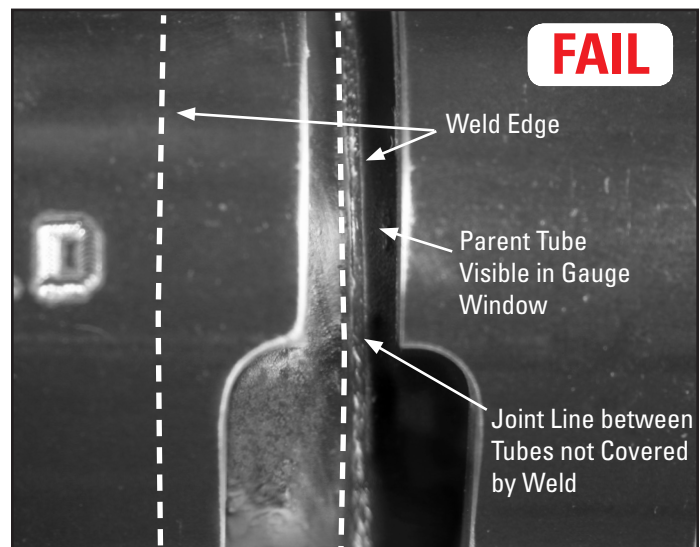
Figure 5

- 2b. **Part Fails** if any of the following are seen in the inspection.

- The weld bead does not completely fill the narrow gauge window.
- The parent tube is partially visible in narrow gauge window.
- The joint line between the 2 tubes is visible at any point around the circumference of the shaft. **Figure 5**

Remove intermediate shaft and replace.

3. **All failed parts must be returned** through normal warranty procedures.
