BMW Motorrad USA Service Information Bulletin

****Notice of Recall 09V-319****

Subject: Replacement of the fuel-pump electronics

Model: R 1200 GS (K25), R 1200 GS Adventure (K25/02), R 1200 GS facelift (K25/11), R 1200 GS Adventure facelift (K25/12)

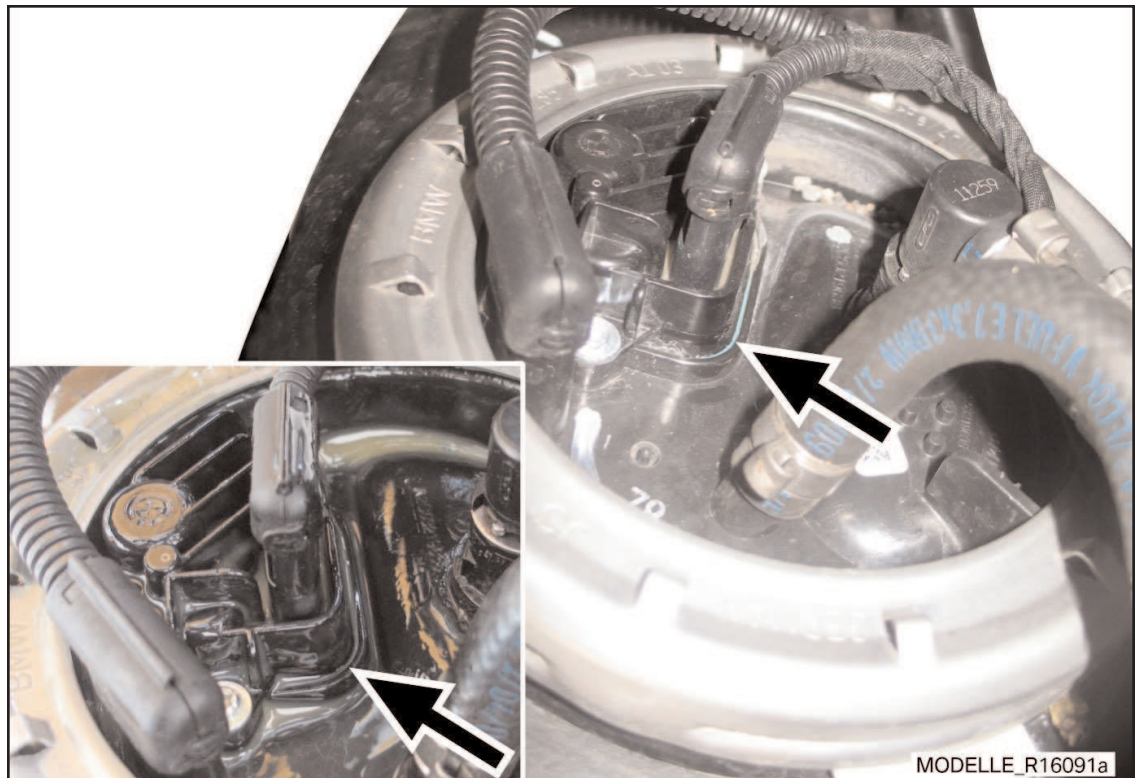
Illustration: Fuel-pump electronics before (large image on right) and after spraying with protective-Wax-Spray (small image on left); this example shows the R 1200 GS facelift (K25/11).

Finishing work: In order to ensure a 100% seal after replacement, the sealing area around the fuel-pump electronics (between fuel-pump electronics and fuel-pump flange) must be sprayed with a protective-wax spray i.e Wurth Protective Wax, (see arrows in the illustration below).
