Girardin Minibus

Recall Campaign

TITLE: 09-031-FSC/09-031-FSU

PRODUCTS: G5 commercial buses model year 2006 through 2009

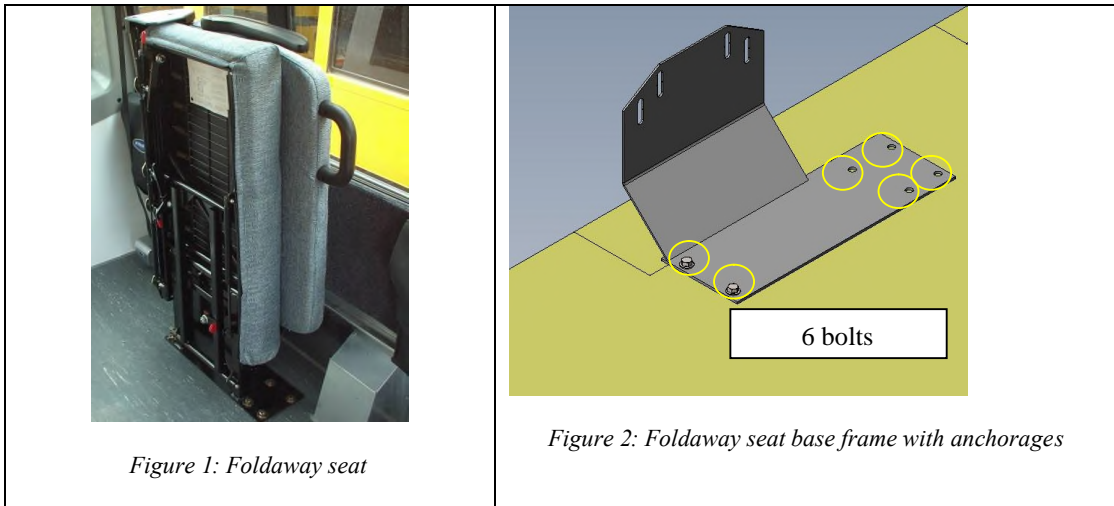
- 1- Localize the foldaway seat frame base and their anchorages.

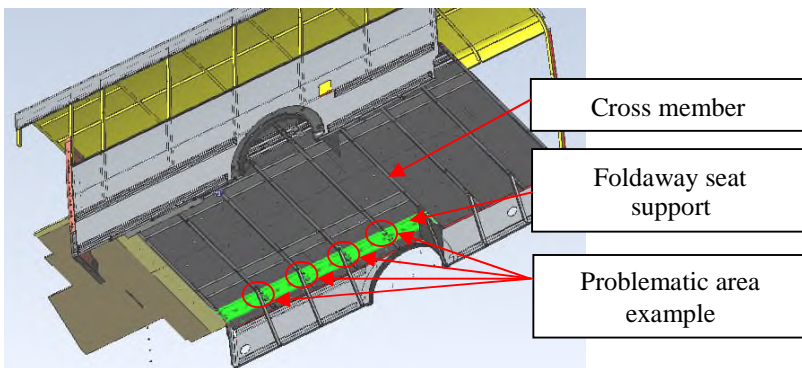
Figure 3: Underneath view with seat support (green)

- 2- Localize the foldaway seat support by the vehicle underneath. 1 or 2 seat bolt could be installed in a weaker floor section.

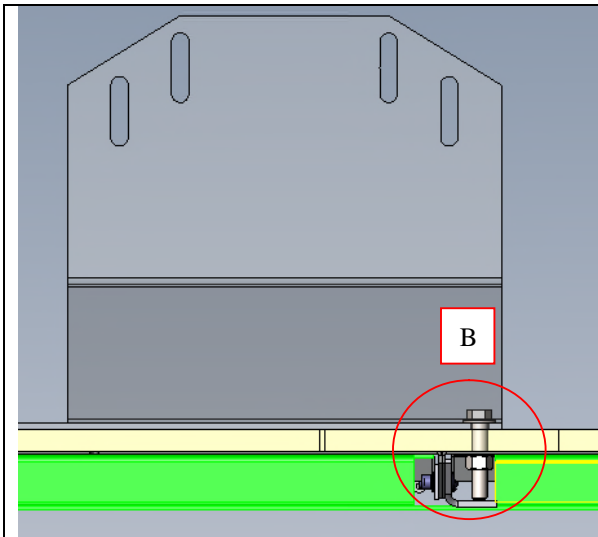
Figure 7: Bolt location vs cross member & seat support

- 3- All the seat installation bolts shall be located in the seat support (green part in figure 8). No bolt shall be installed as shown on figure 9.
