This Service Information bulletin supersedes SI B72 02 09 dated August 2009.

NEW Recall Campaign 09V-327: Belt Tensioner Harnesses

E89 (Z4) produced up to March 19, 2009

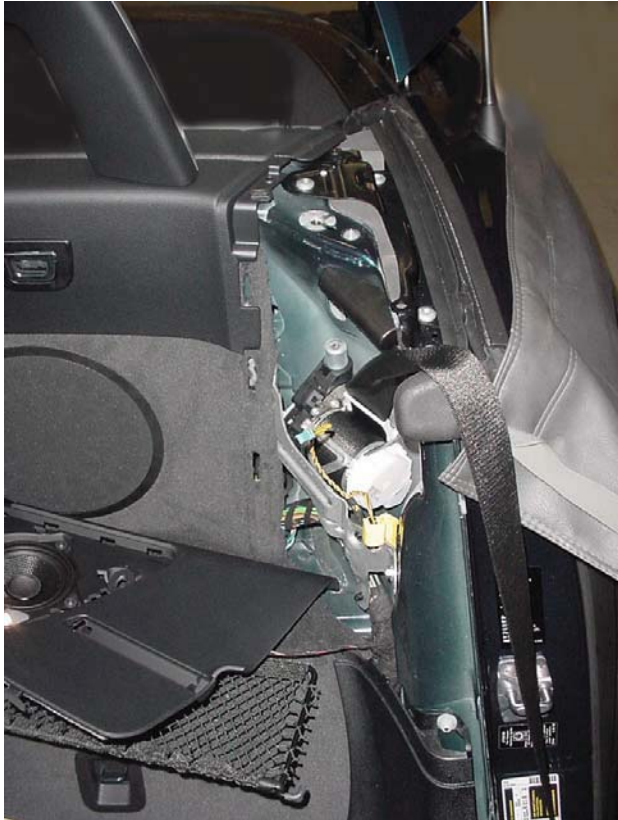
The photo shows the upper trim piece already removed, along with the storage area net disconnected.

The lower trim piece (arrow) still needs to be removed.

4. Remove B-pillar trim. Refer to TIS operation [51 43 120](#) and [51 43 125](#).

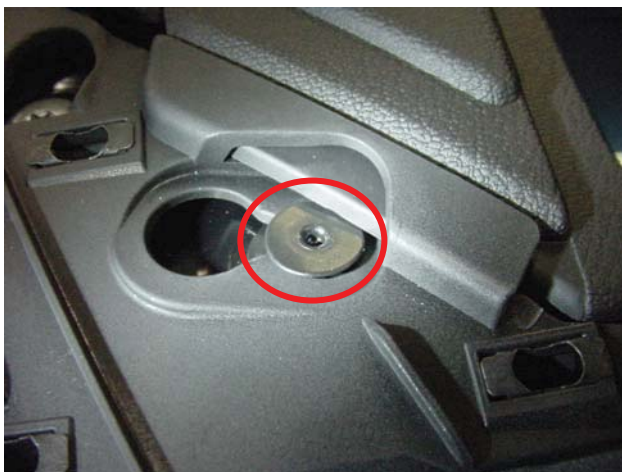
Note: When removing the top trim piece, there is no need to remove the round plug (circled) from the body. Carefully slip the trim piece over the plug, tilt the trim piece upwards and rearwards, and work it off the plug.

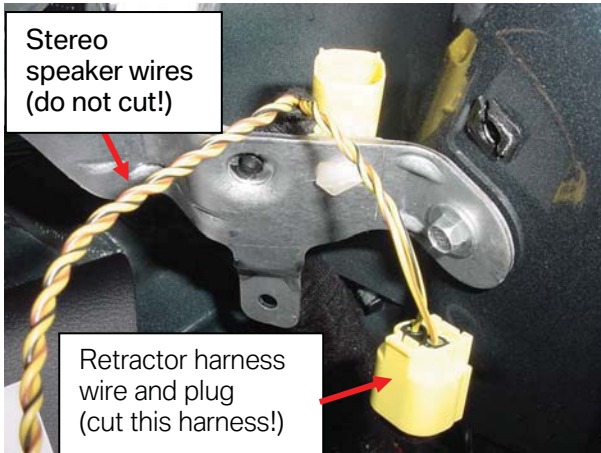
Note: The other yellow twisted wire is for the stereo system speaker- do not mix up which harness you cut!

6. Access the wiring harness near the safety belt retractor.

Disconnect the plug (arrow) from the vehicle harness going to the retractor.

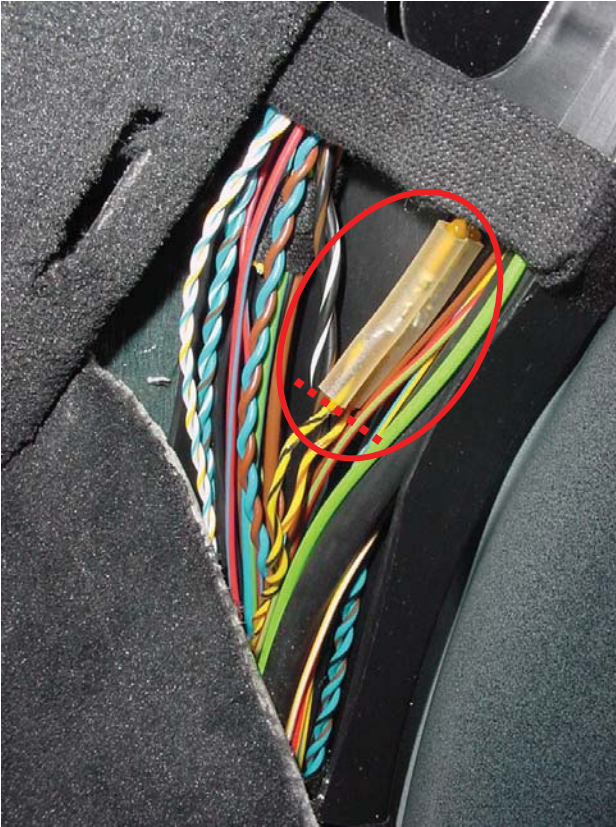
9. There will already be two heat shrink tubes tucked into the wire harness (circled) from a previous repair.

Pull the tubes and the yellow twisted wires out enough to cut them immediately below the shrink tubing (shown with dotted line).

The previously installed repair harness can now be removed.

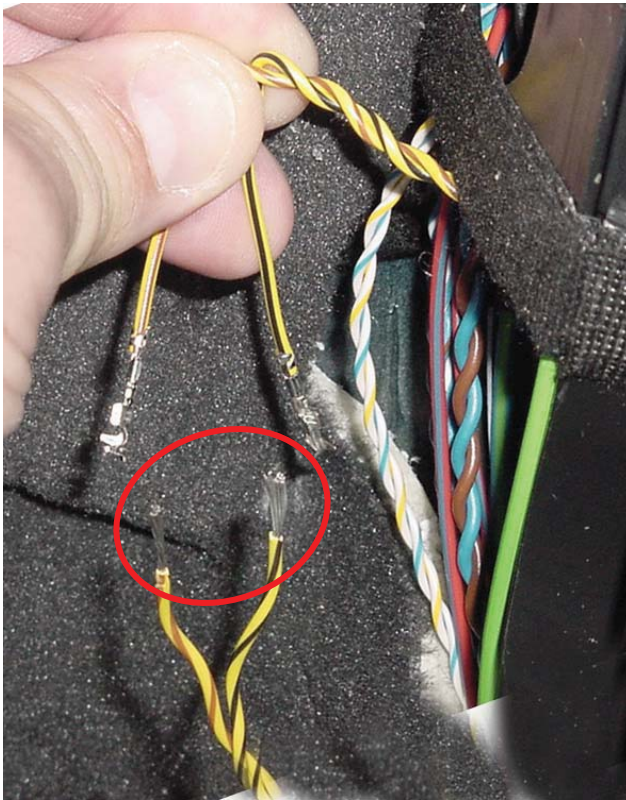
The photo shows the new repair harness (top) with the stripped wires from the vehicle harness.

12. Cut the two repair harness wires slightly below (toward the front of the car) the heat-shrink tubing. For more information on repairing airbag cables, refer to REP 61 00 ... (Repairing airbag cables)

Strip 4 mm (3/32") of insulation from each wire (circled) of the vehicle harness that was cut.

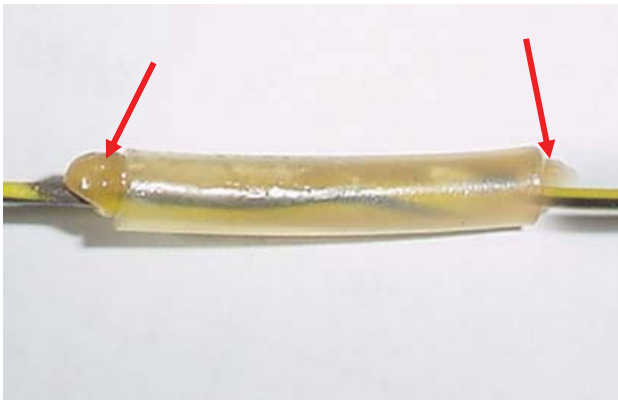
Note 1: Sealant will ooze out of each end (arrows) to indicate full shrinkage. This feature is an additional protection for durability.

15. Position the heat-shrink tubes so they are centered over the crimp.

Use a heat gun to fully shrink the tubes.
