# TOYOTA CUSTOMER SERVICES

Volume: XVI  
Number: TC09-021  
Date: 08/26/2009  
☒ Action  
☒ Retain  
☐ Information

To: All Region/Private Distributor General Managers/Vice Presidents  
From: Gary Smith,  
Corporate Manager, Service Technology & Compliance  
Subject: Safety Recall (Special Service Campaign) – 90H  
Certain '09 – '10 Corolla, Corolla Matrix and '08 – '09 Scion xD Vehicles Equipped with 2ZR-FE  
(1.8 liter) engine  
Brake System Vacuum Port (Phase 1 – 19 Cold States)

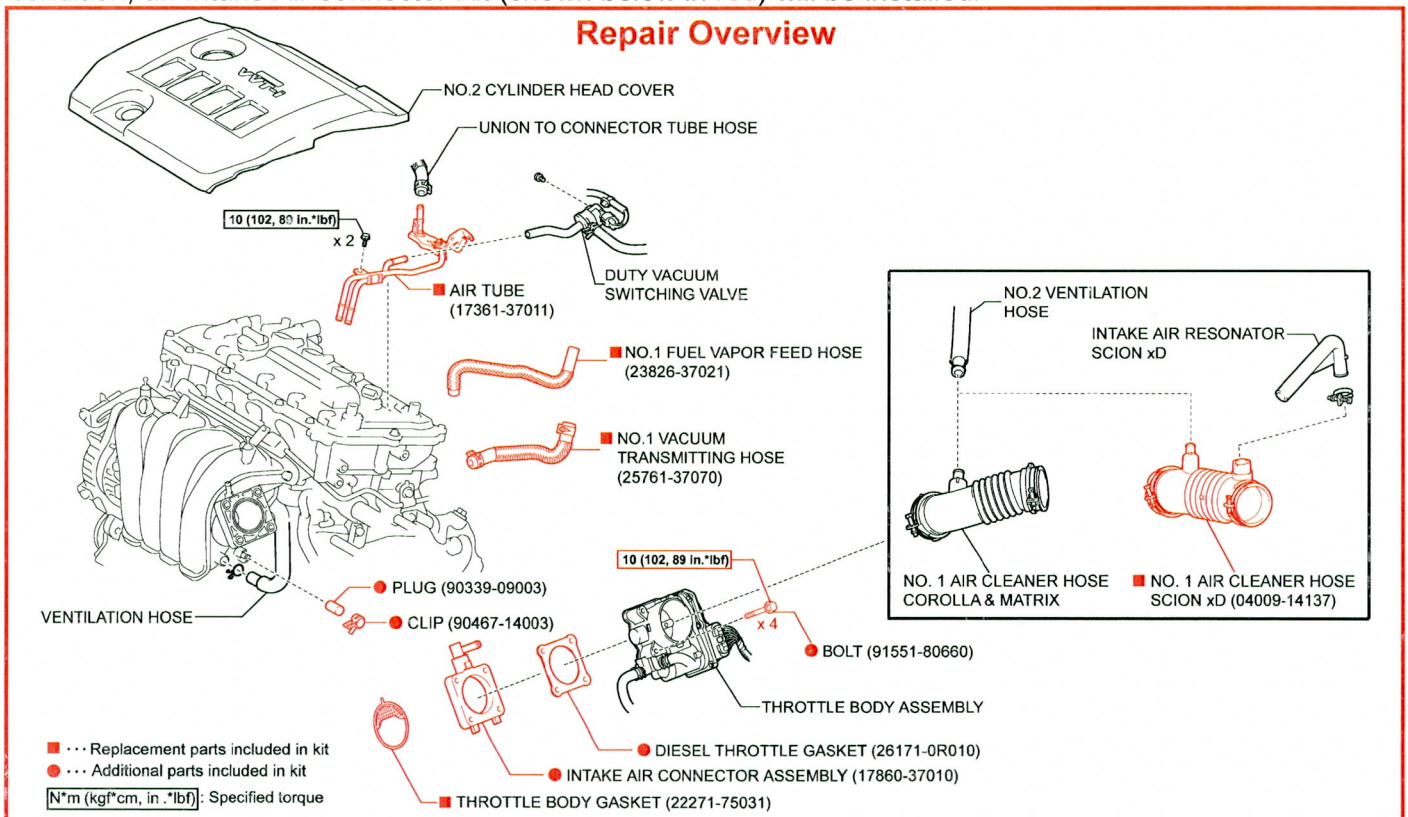
If the vehicle is operated in extremely low temperatures, there is a possibility that condensed moisture from a positive crankcase ventilation (PCV) port may seep into the brake system vacuum port ("port") and freeze. The port is located inside the intake manifold and provides vacuum assist for the brakes.

Should this condition continue, ice may slowly accumulate at the port and in the worst case, ultimately plug the port. As a result, power assist to the brakes would gradually decrease (eventually to zero), and the increased pedal pressure required could lead to greater vehicle stopping distances. To correct this condition, an Intake Air connector Kit (shown below in red) will be installed.
