TECHNICAL INSTRUCTIONS

**SPECIAL SERVICE CAMPAIGN 90H (SAFETY RECALL)
FOR VEHICLES IN**

BRAKE VACUUM PORT ON THE 2ZR-FE (1.8 LITER) ENGINE

**2009 – 2010 COROLLA & COROLLA MATRIX
2008 – 2009 SCION xD**

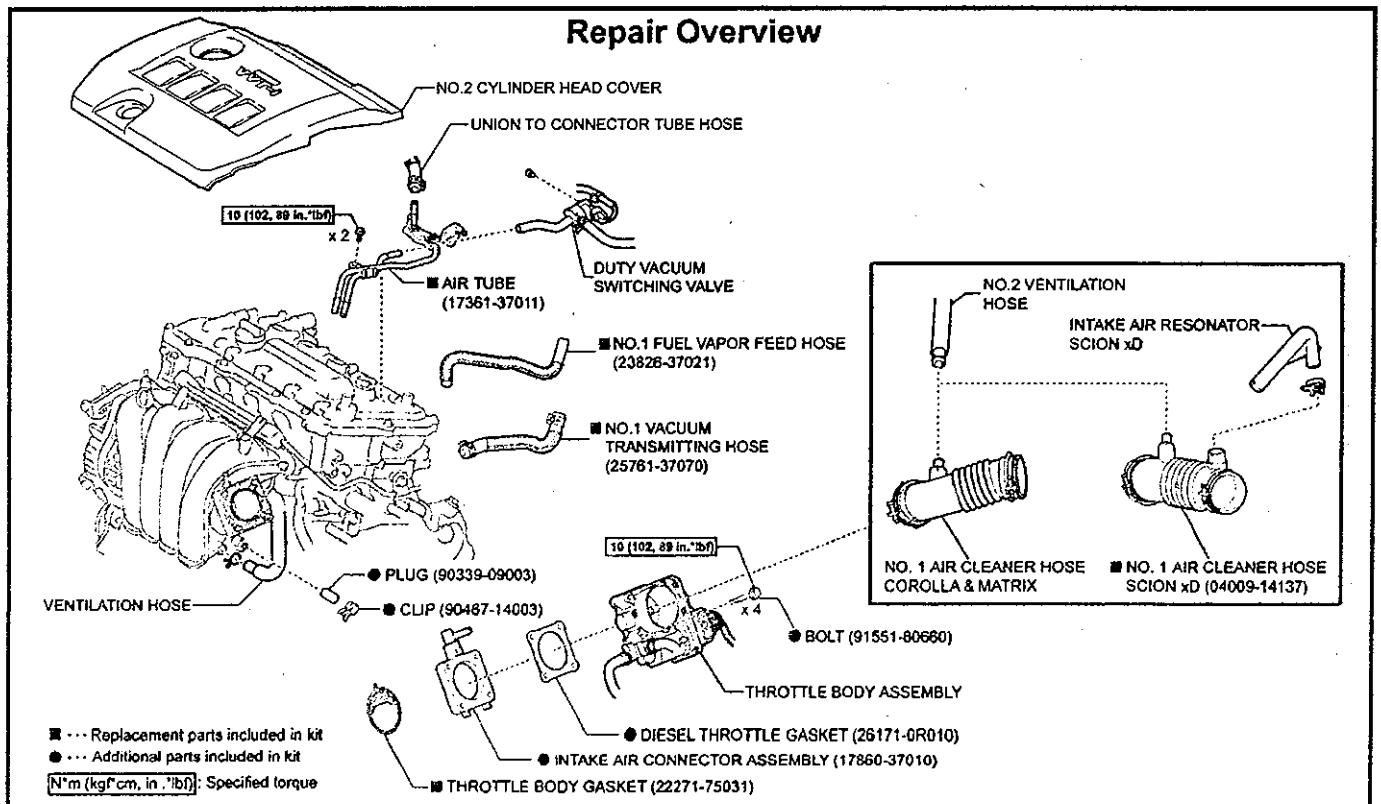
If the vehicle is operated in extremely low temperatures, there is a possibility that condensed moisture from a positive crankcase ventilation (PCV) port may seep into the brake system vacuum port ("port") and freeze. The port is located inside the intake manifold and provides vacuum assist for the brakes.

Should this condition continue, ice may slowly accumulate at the port and in the worst case, ultimately plug the port. As a result, power assist to the brakes would gradually decrease (eventually to zero), and the increased pedal pressure required could lead to greater vehicle stopping distances. To correct this condition, an Intake Air connector Kit (shown below in red) will be installed.

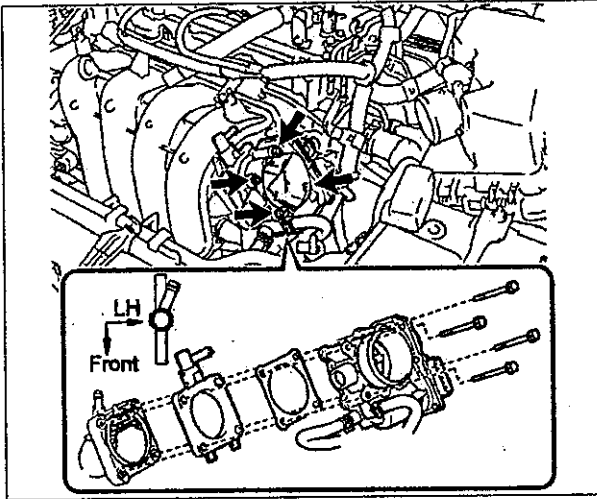
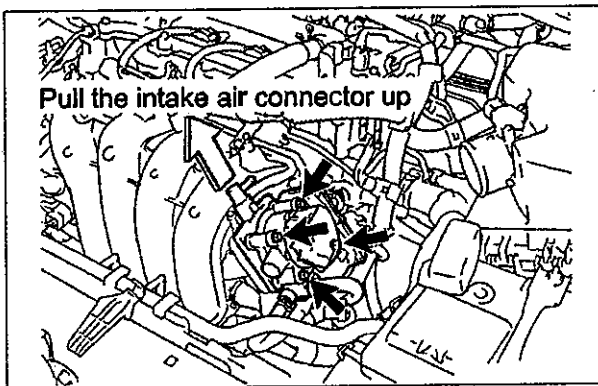
Ensure that the air intake connector is properly aligned with the throttle body by pulling upward on the air intake connector hose fitting while tightening the bolts. Failure to do this may result in a whistling noise during light throttle application.

- c) Reinstall the throttle body assembly with a **NEW** intake air connector, **NEW** gasket and 4 **NEW** bolts in the order shown in the illustration.
- d) Verify that the gasket is properly positioned.

- e) While pulling up the intake air connector, lightly tighten the 4 bolts and then torque the 4 bolts in a criss-cross pattern to 10 N·m (102 kgf-cm, 89 in-lbf).

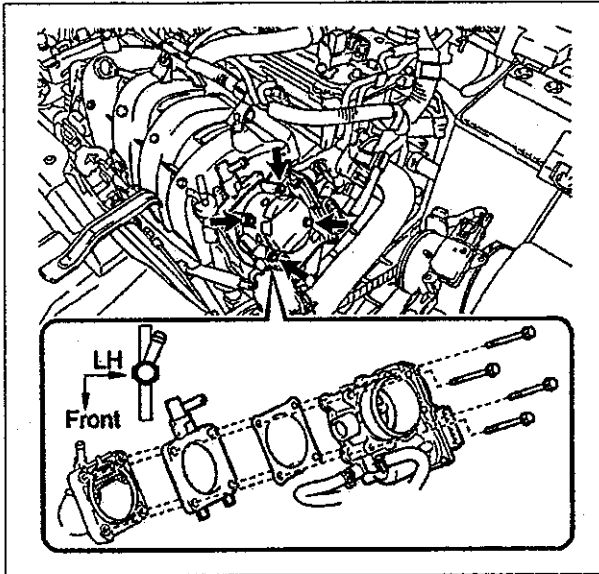
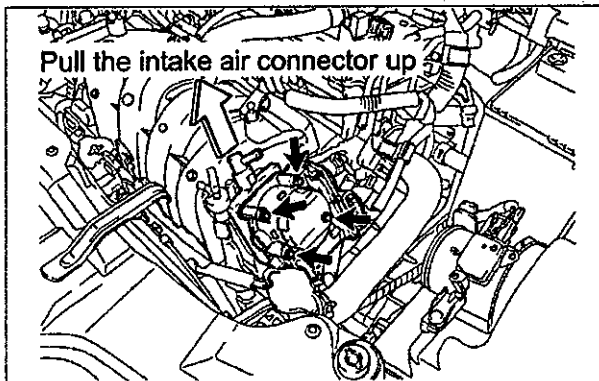
Ensure that the air intake connector is properly aligned with the throttle body by pulling upward on the air intake connector hose fitting while tightening the bolts. Failure to do this may result in a whistling noise during light throttle application.

- c) Reinstall the throttle body assembly with a **NEW** intake air connector, **NEW** gasket and 4 **NEW** bolts in the order shown in the illustration.
- d) Verify that the gasket is properly positioned.

- e) While pulling up the intake air connector, torque the 4 bolts to 10 N·m (102 kgf·cm, 89 in·lbf).
