## Subject: Rack and Pinion Steering Inner Tie Rod Ends

**Models Affected:** Specific Freightliner Cascadia, Century Class S/T, Columbia, and Coronado vehicles manufactured November 11, 2004, through July 20, 2009, with rack and pinion steering.

June 2010  
FL557AB  
NHTSA #09V-357  
REVISED NOTICE

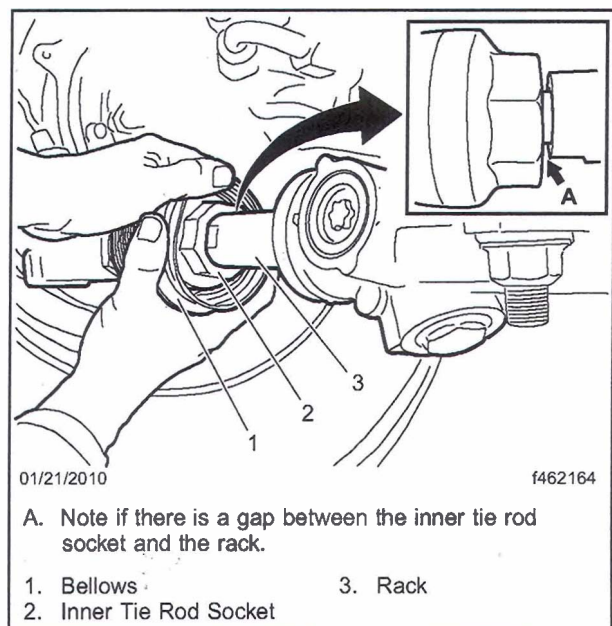
**Fig. 2, Inner Tie Rod Inspection**

9. Visually inspect the connection between the rack and the inner tie rod. Note if there is a gap present between the inner tie rod socket and the rack ( Fig. 2, Items 2, 3, and A). This information will be used in step 32.
10. Place a jack under the left side of the front axle and jack up the driver-side steer tire, making sure the passenger-side tire remains firmly on the ground. Support the vehicle with a jack stand.
11. Remove the cotter pin and castellated nut and disconnect the driver-side outer tie rod from the tie rod arm.
12. Install the holding fixture as follows.
