## BMW Motorrad USA Service Information Bulletin

### **\*\*Notice of Recall 09V-384\*\***

**Subject:** Checking/Replacing Multifunction Switch

**Model:** K 1300 S (K40/11) and K 1300 GT (K44/31)

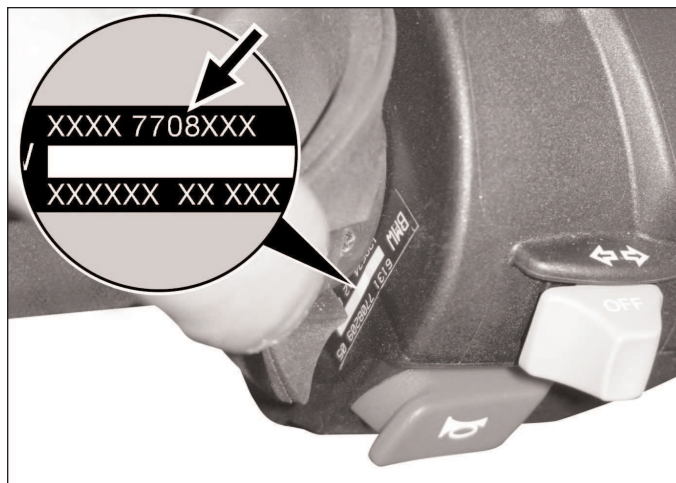
**Aftersales Solution:** Before proceeding with replacement, check the construction status of the left and right multifunction switches:  
Part No. 7 725 xxx = current status: Replacement is **not** necessary  
Part No. 7 708 xxx or 7 712 xxx = old status: Replacement **is** necessary

The part number is printed in the top part of the black label affixed to the side of the multifunction switch (see illustrations). Always check the switches on **both** sides.

Illustration: Checking the part number of the left multifunction switch (ease up the rubber grip)

**Replacement required:** Proceed in accordance with the instructions in the repair manual (RSD Repair & Service Data DVD). Refer to 00 60 204 Campaign, replace multifunction switch.

**Note:** Make sure that the left multifunction switch is not opened in the removal process. Switches with damaged part-number labels cannot be accepted for billing under warranty conditions.

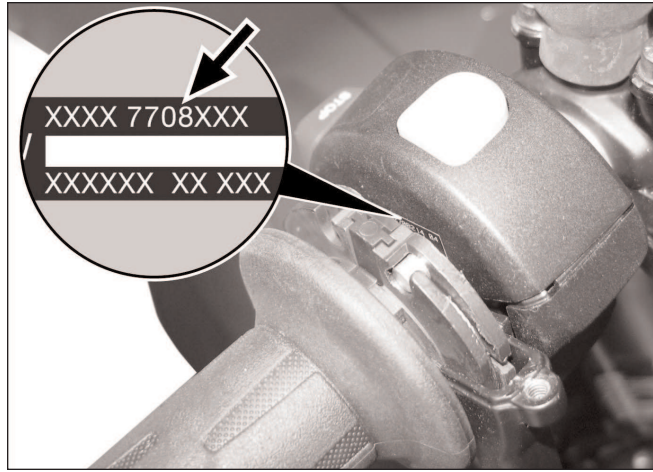
Illustration: Checking the part number of the right multifunction switch (cover of cable pull has to be removed)
