TECHNICAL INSTRUCTIONS

SAFETY RECALL 9LG

ACCELERATOR PEDAL MODIFICATION

2006 – 2010 MODEL YEAR LEXUS IS250, IS250 AWD, IS350

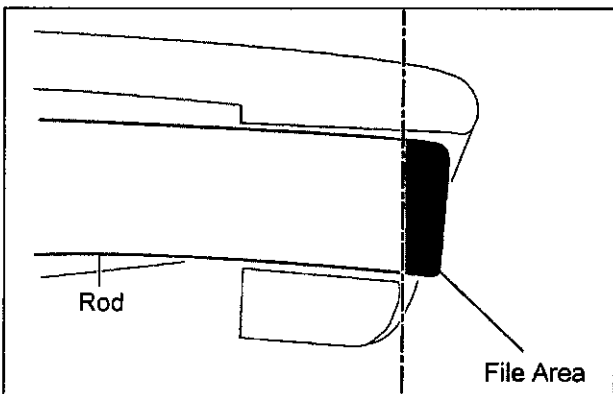
3. CHECK THE ROD LENGTH

- a) **Confirm the pedal rod is not damaged.** Put a **NEW pedal foot pad** onto the existing pedal rod and while lining up the pin holes, confirm that the rod does not extend past the end of the foot pad. **Do not install the pin yet.**

If the rod is OK:

- Skip to step 5.

If the rod is NG:

- Continue with step 4 and file the pedal rod.
